HERITAGE IMPACT ASSESSMENT

1 ISABELLA STREET
Brampton, ON

25 Aug 2022

MEGAN HOBSON CAHP
M.A. DIPL. HERITAGE CONSERVATION
Built Heritage Consultant
mhobson@bell.net

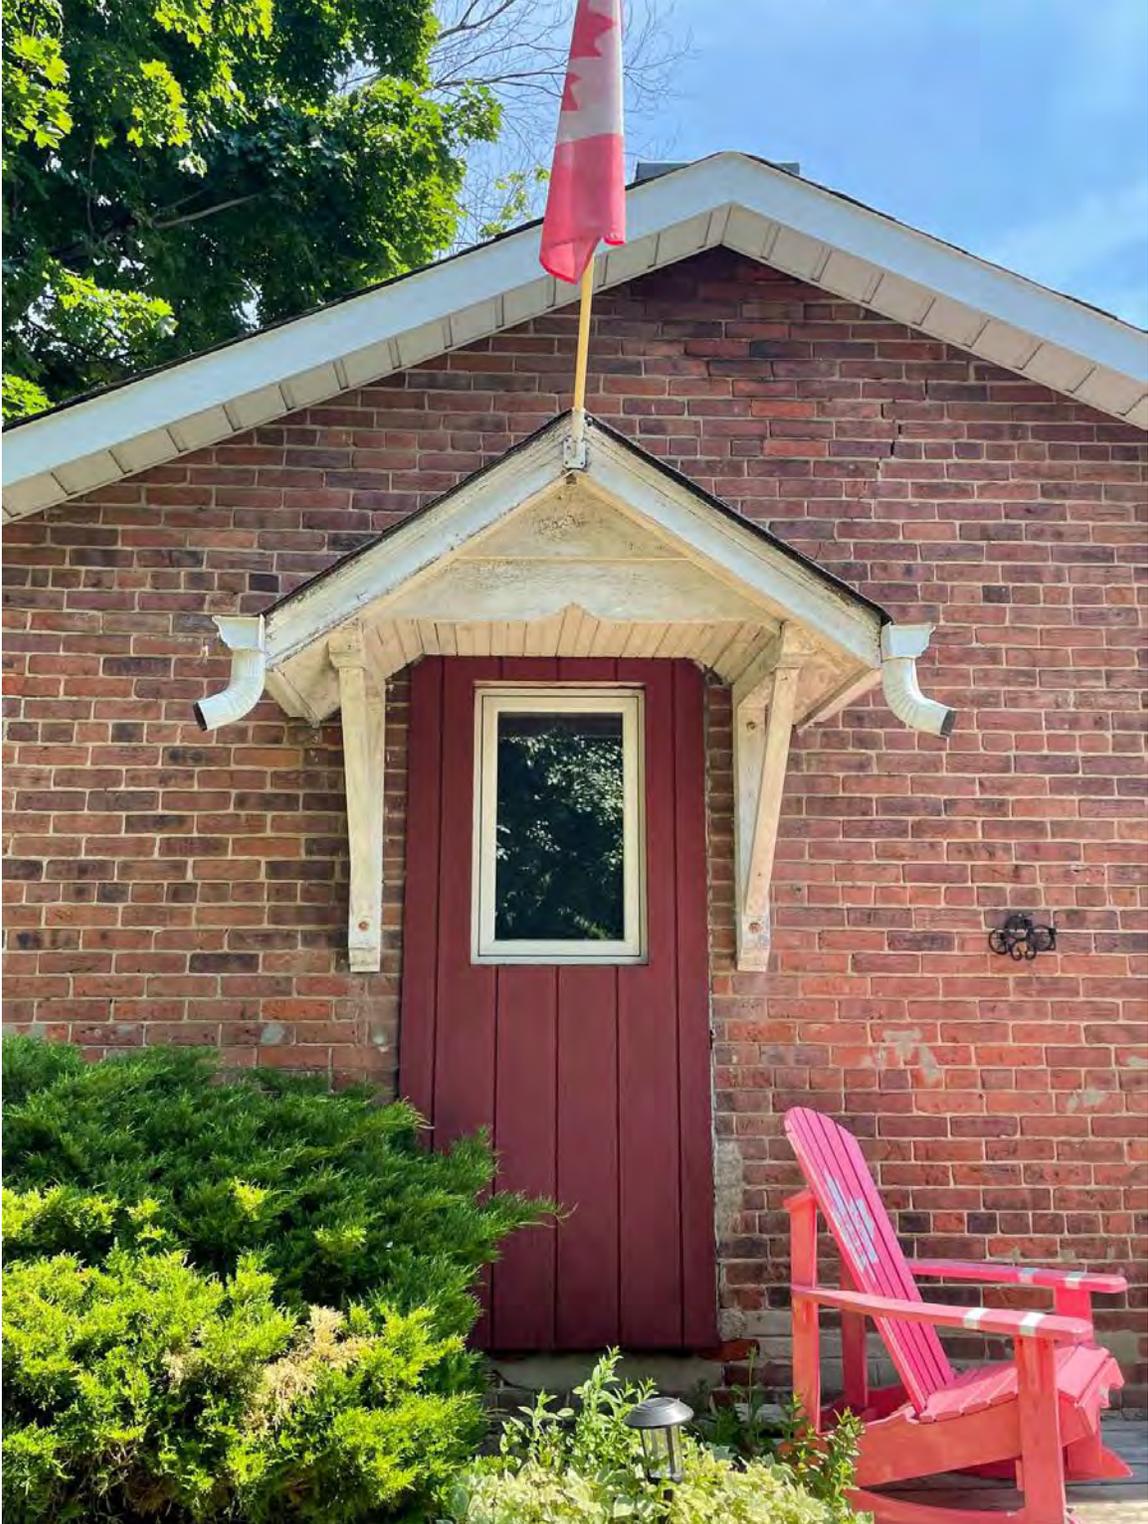
REAR ELEVATION – a back door has been recently blocked up with wood framing and cladding and converted to a window – it has a wooden roof above that is bolted into the masonry – given the Arts & Crafts influenced style of this feature and its simple construction, it probably dates from the 1920s or 30s.

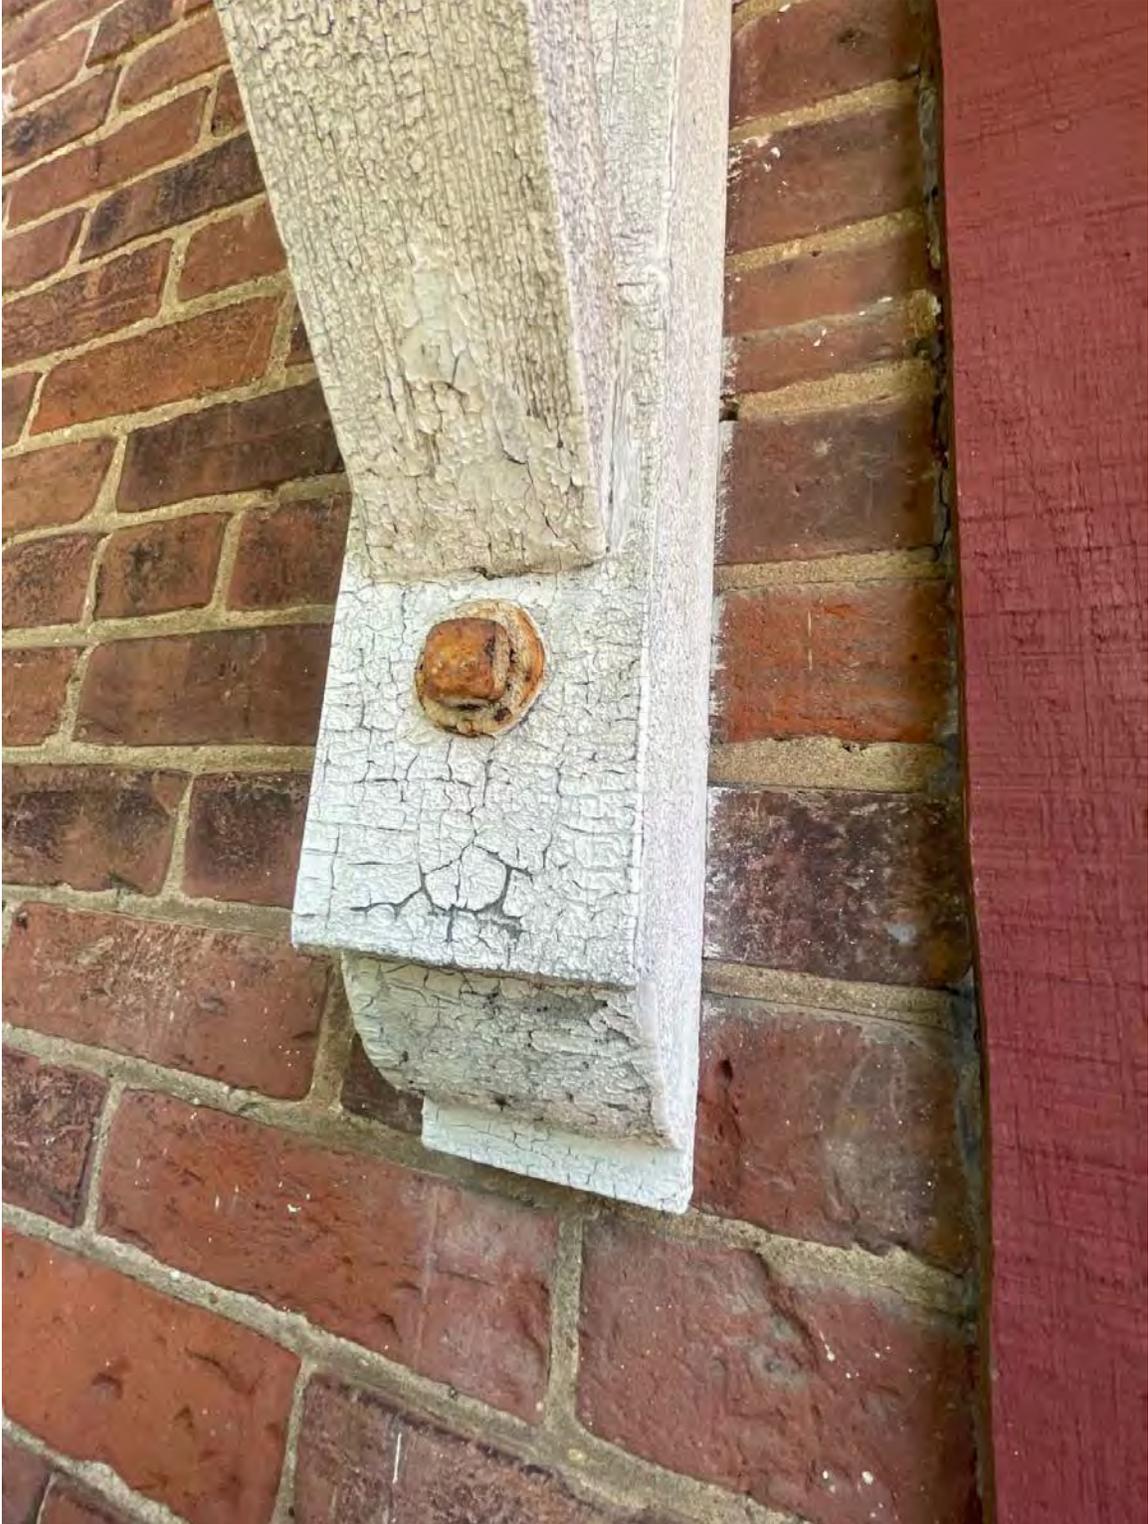
BACK DOOR – detail of the metal bolt that anchors the wood bracket into the masonry

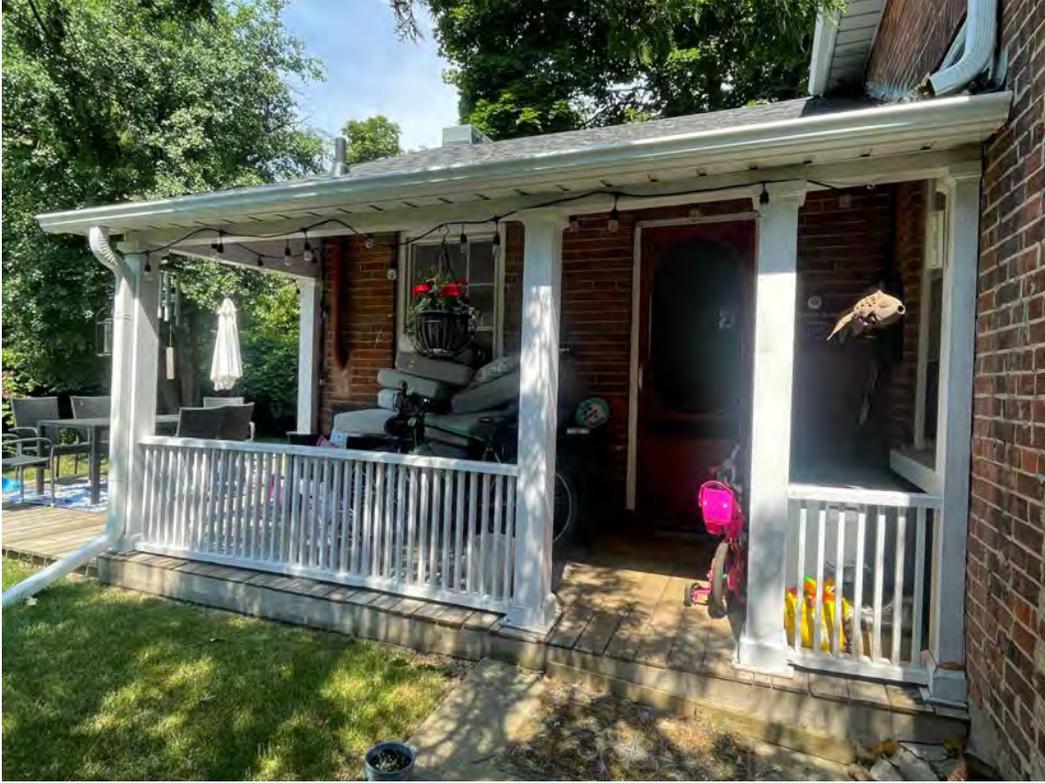
SIDE PORCH – the porch deck, posts and railings appear to be fairly recent

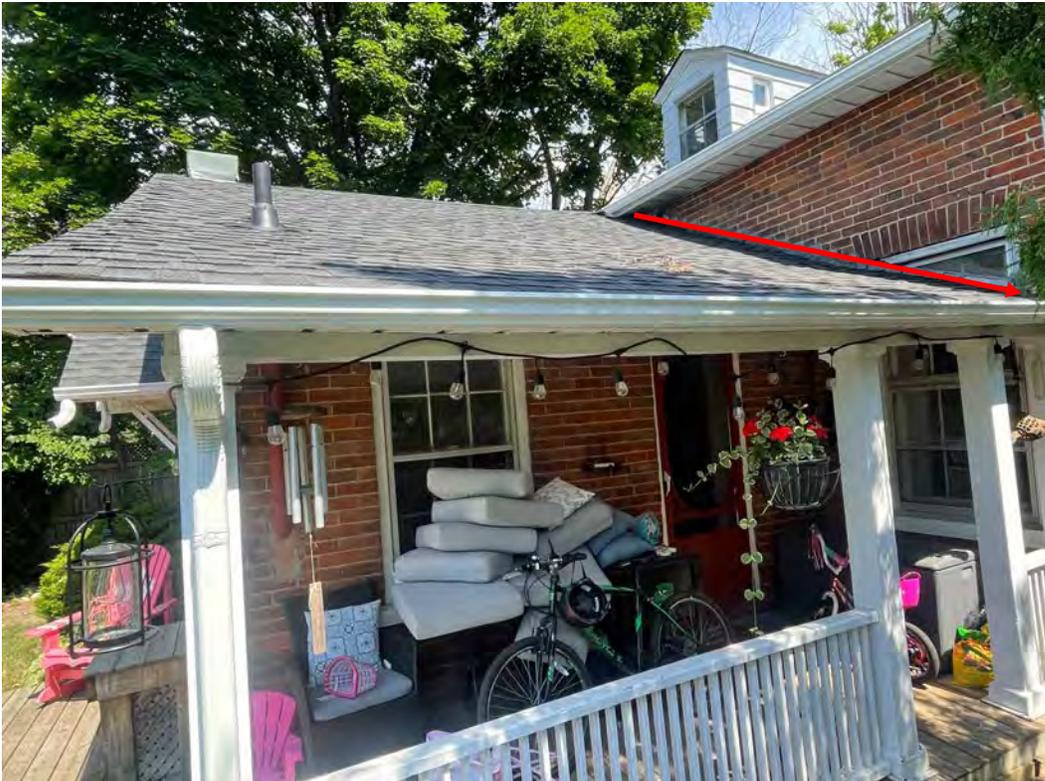
SIDE PORCH – the gable roof of the tail section extends over the porch and overlaps one of the windows

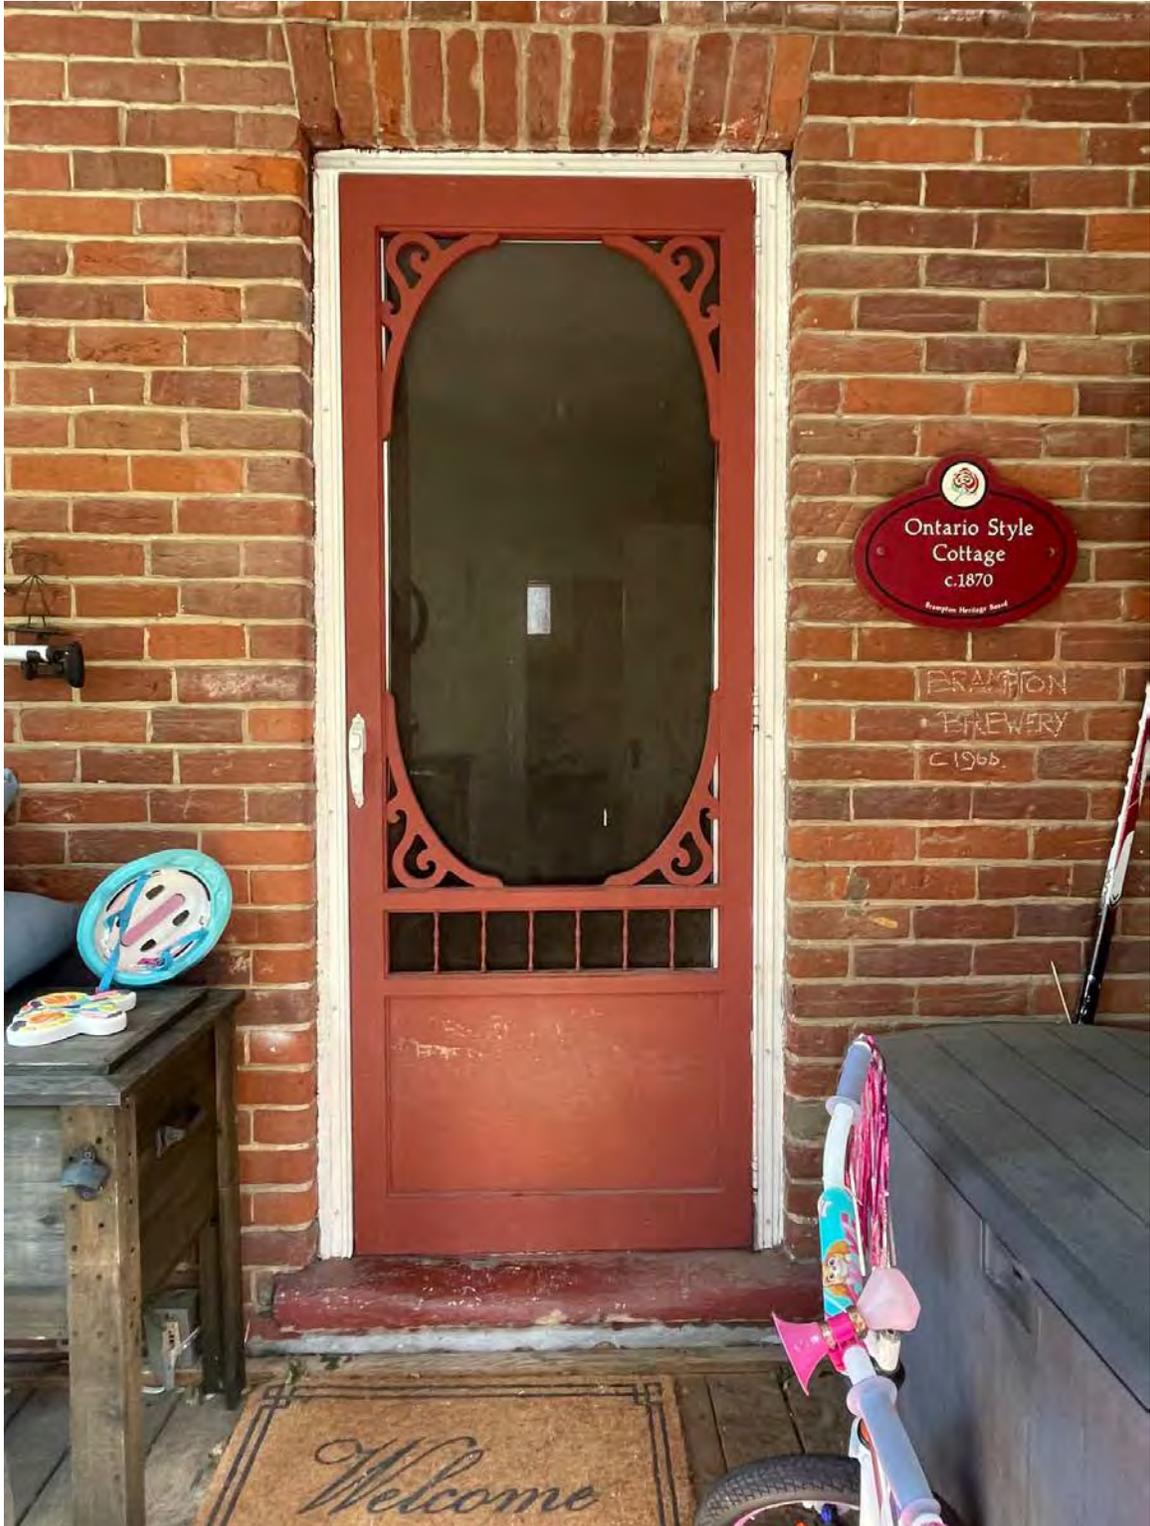
SIDE DOOR – the opening has a flat brick arch

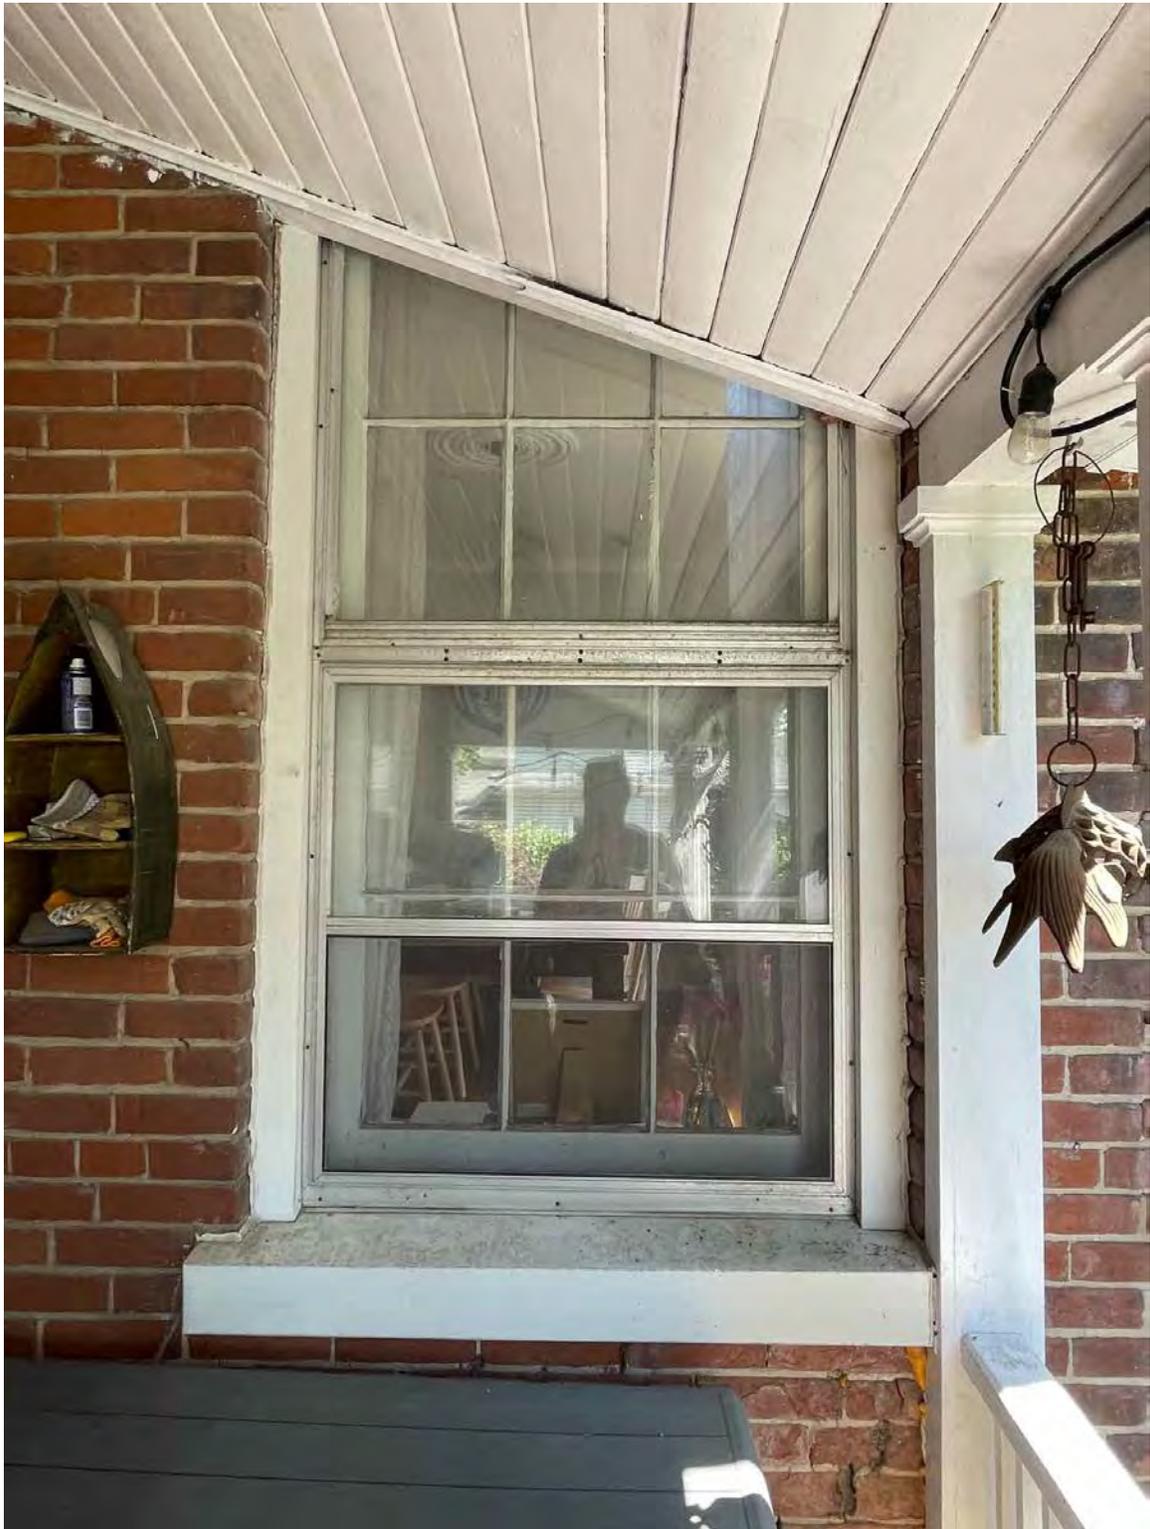
SIDE PORCH – the roof overlaps a window indicating that the porch was probably an early addition built in the late 19th or 20th century

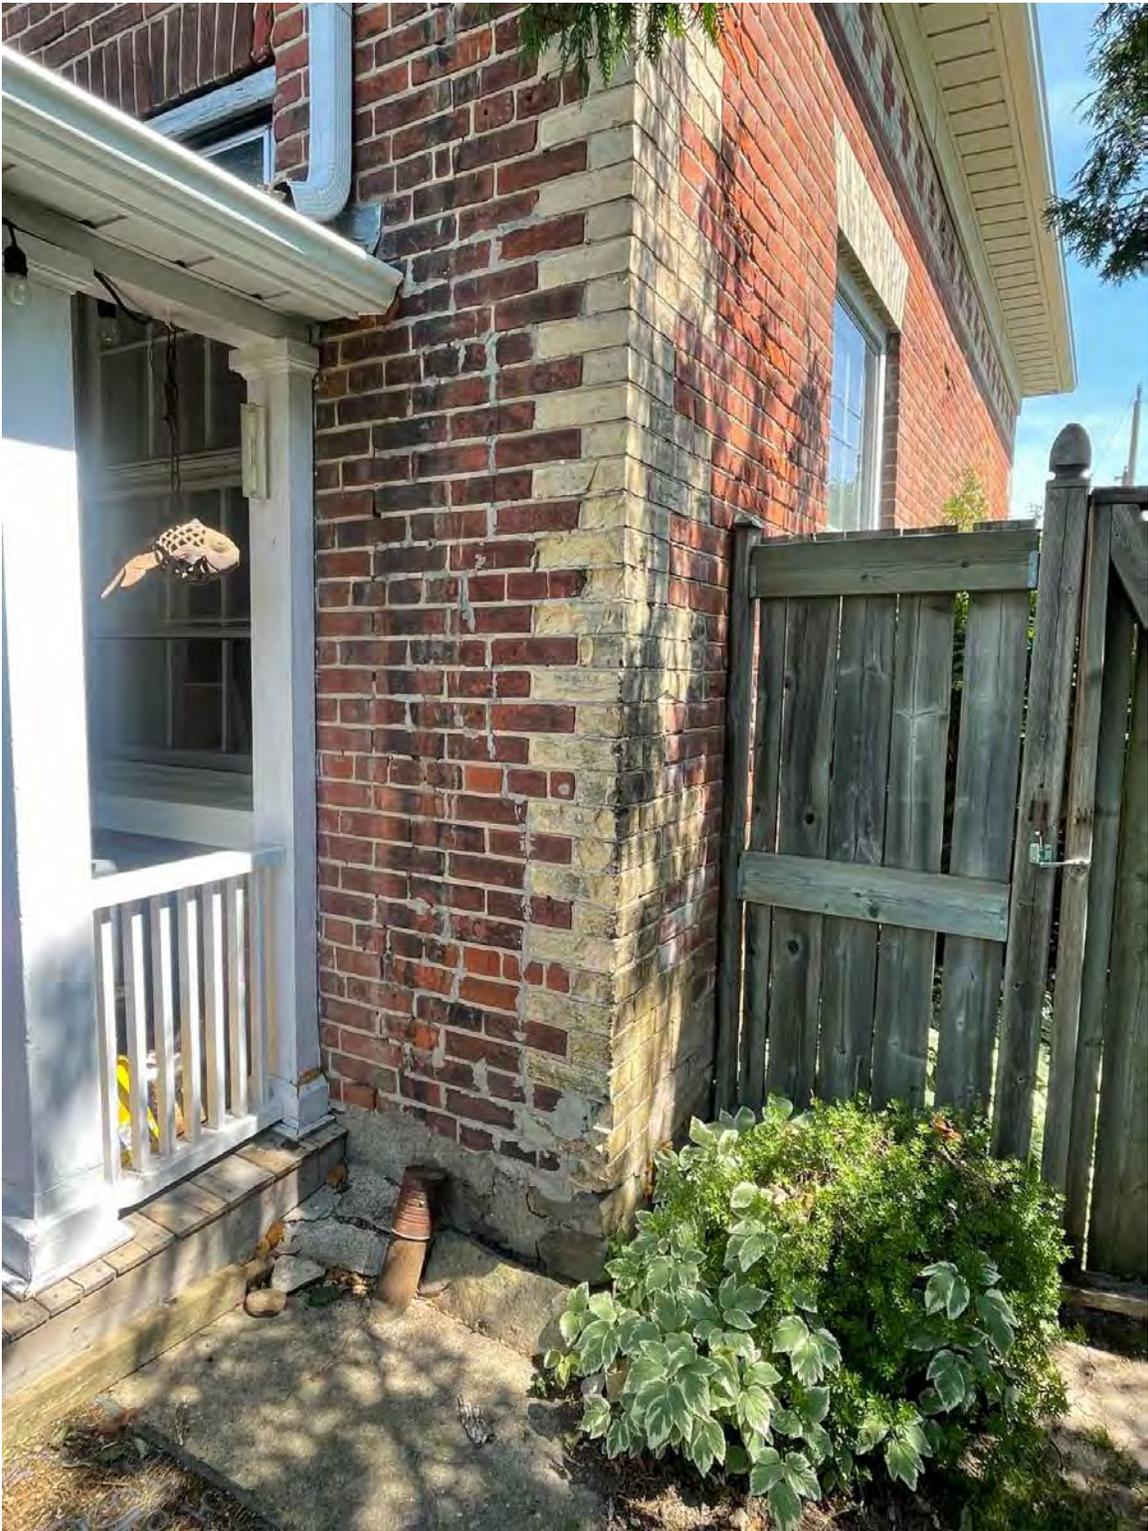
BACK CORNER – some open mortar joints and spalling of the buff brick

It is recommended that repairs and alterations to the masonry be carried out by an experienced heritage mason using an appropriate lime mortar and that bricks removed to make new openings through the existing masonry walls be salvaged so they can be used for repairs elsewhere.

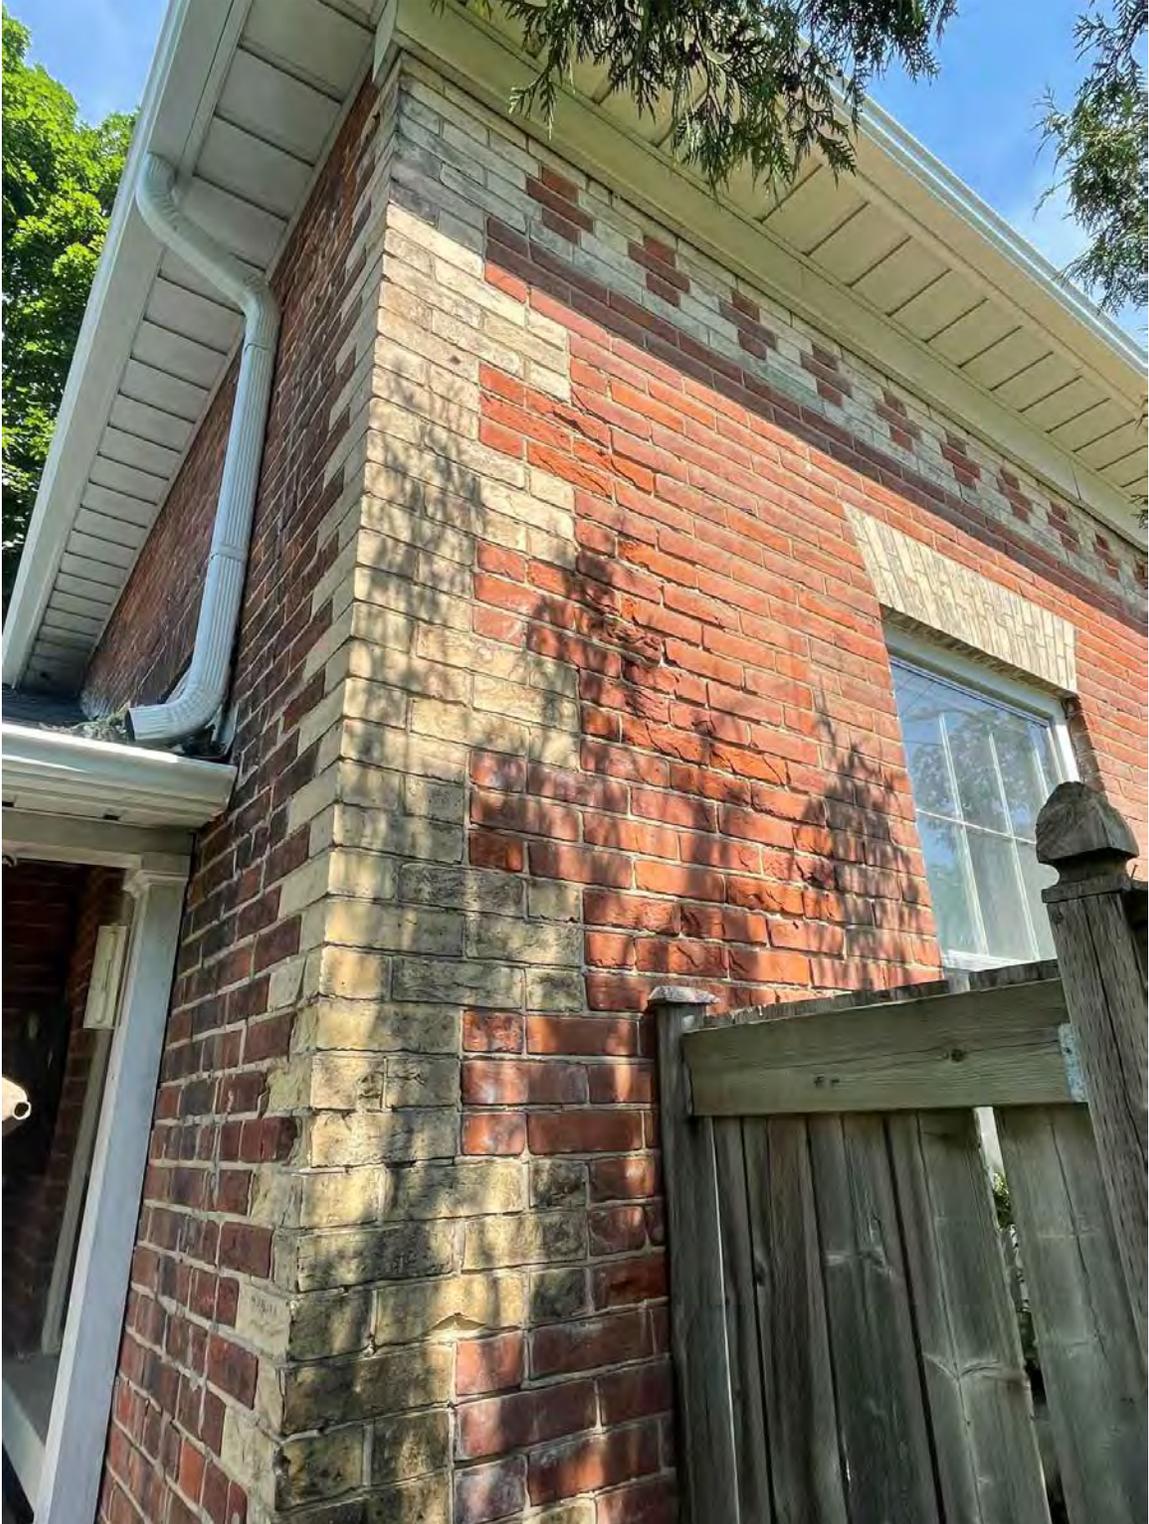
BACK CORNER – buff brick corner quoin and decorative frieze

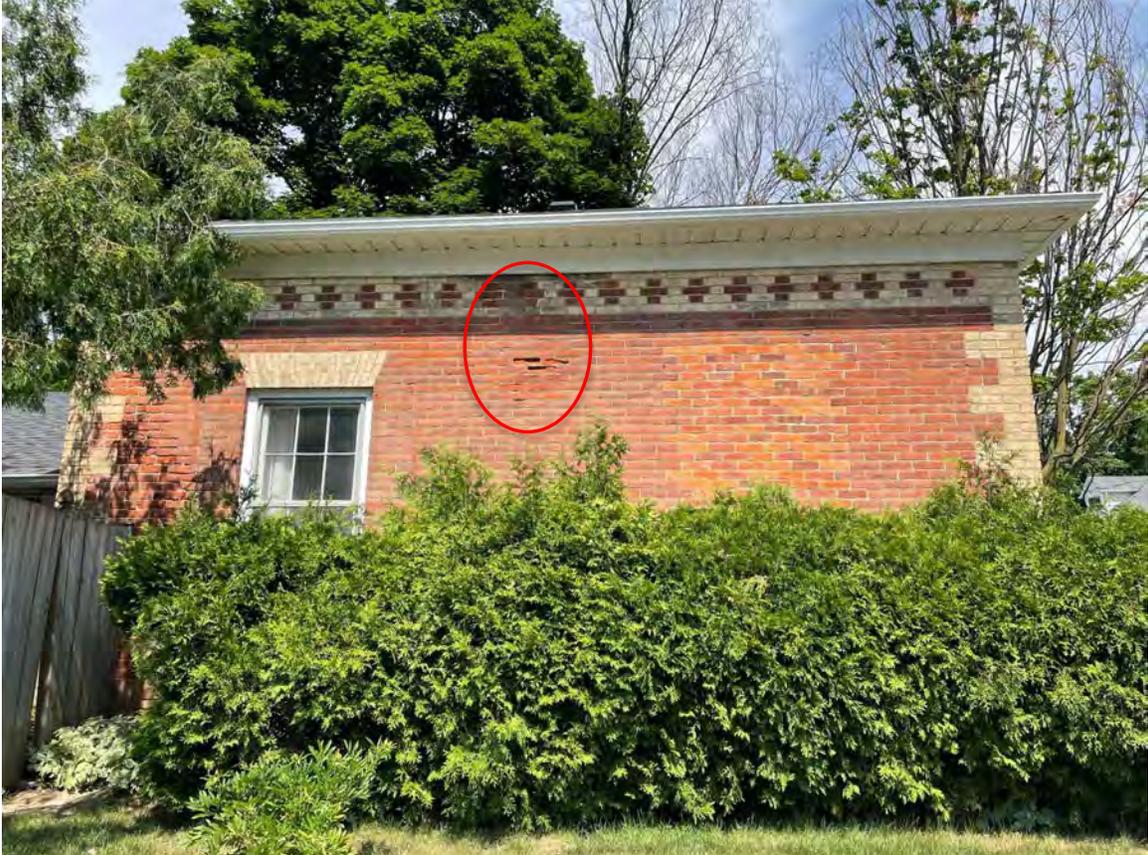
DAVID STREET ELEVATION – note spalled area of brick indicating that there may have been a chimney above, similar to the other side elevation – note the bricked in window

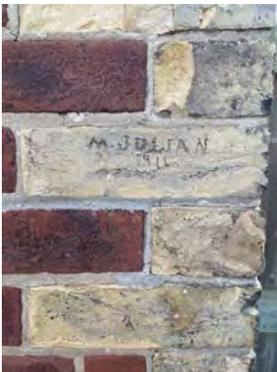
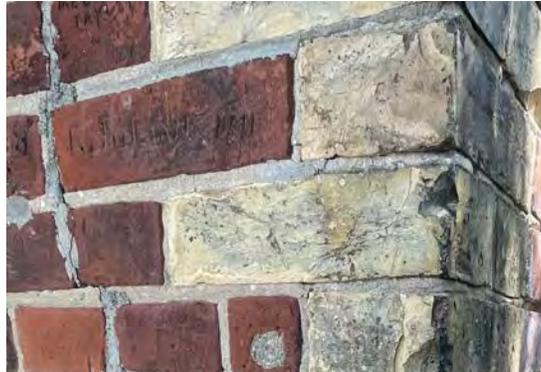
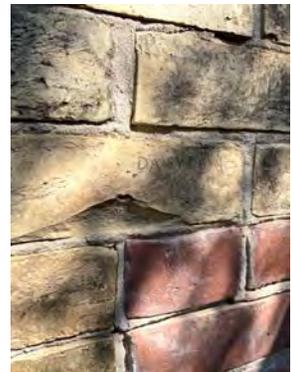
Names carved into the brick in the early 20th century

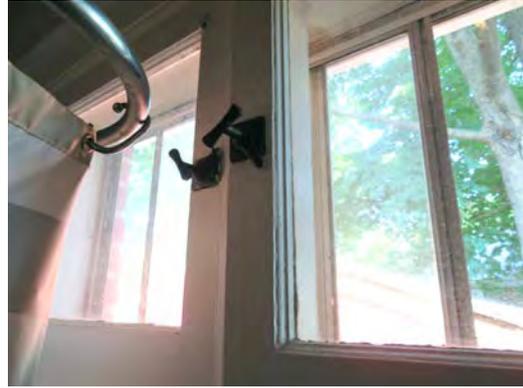
CASEMENT WINDOW IN BATHROOM

RECOMMENDED SALVAGE: brick removed to make two new openings should be salvaged so that it can be used to carry out repairs elsewhere: - 1. an existing window in the bathroom will be enlarged to create a doorway so a small amount of brick will be removed at this location - 2. an existing window in the kitchen that was originally a door will be reinstated so no brick will be removed at this location - 3. The side door probably dates from the c.1920/30s renovations and is not listed as a heritage attribute. If it is to be replaced it could be reused as an interior door, stored on site in a dry location, or removed by an architectural salvage company for reuse elsewhere

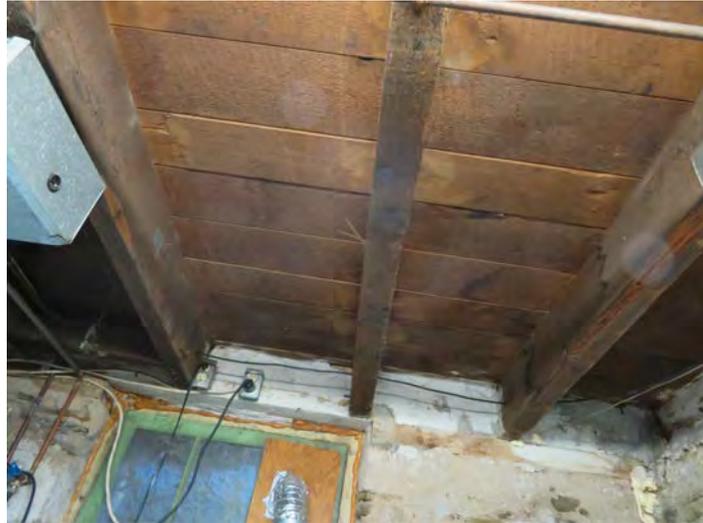
FLOOR FRAMING - circular sawn lumber & wide spacing of the joists are consistent with a mid-19th century date of construction

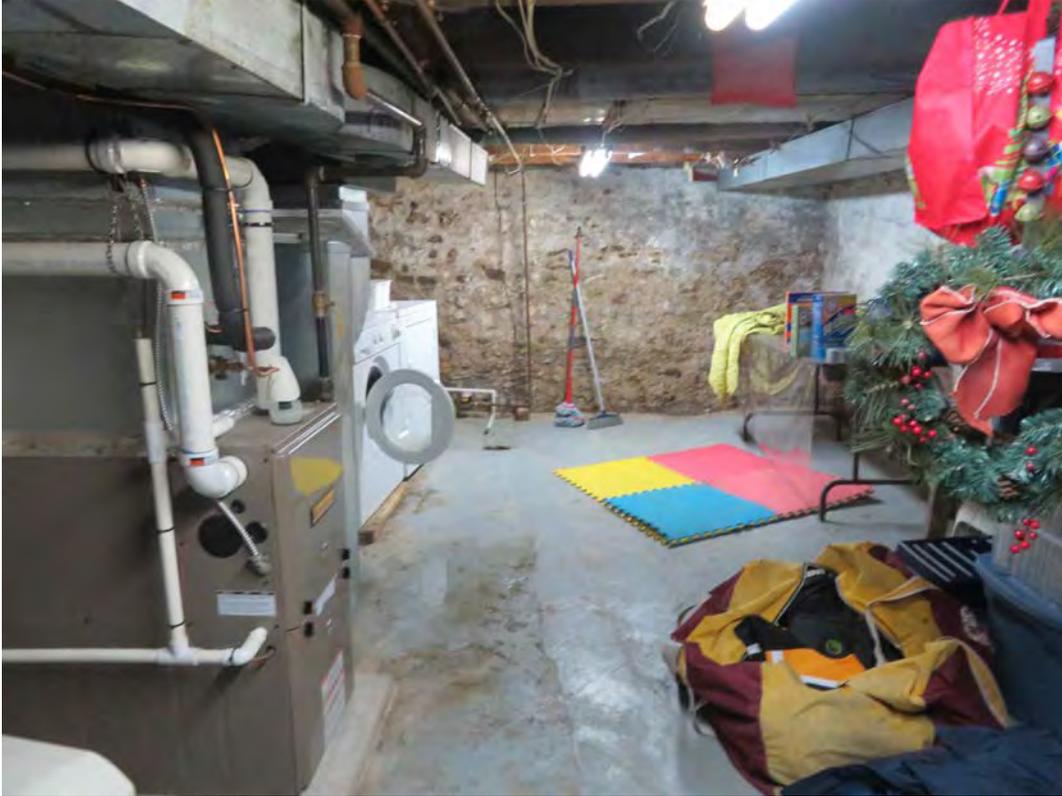
BASEMENT FURNACE ROOM – rubble stone foundation & full basement in this area

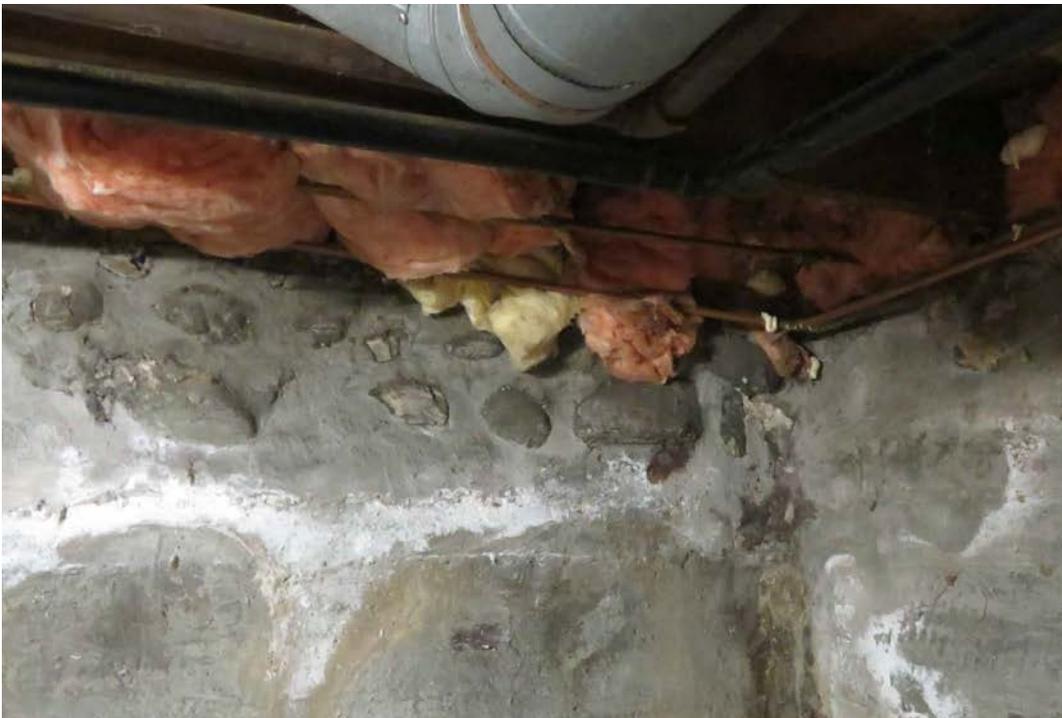
BASEMENT – rubble and concrete below the rear section – originally a crawl space that was later excavated and underpinned

It is recommended that excavations around the c.1850s rubblestone foundation be undertaken in sections so that temporary shoring can be installed if necessary. Due to the fact that this section of the basement was shallow and has already been underpinned with concrete, these concerns are expected to be minor and a *Conservation Plan* is not required.

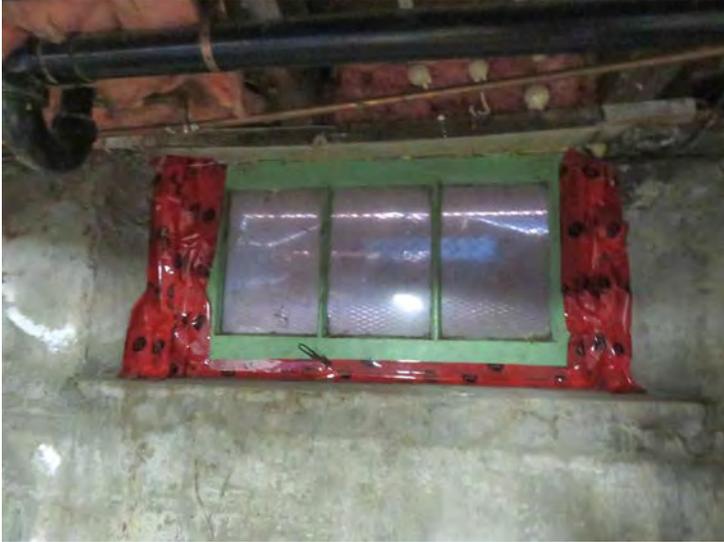
BASEMENT WINDOW – a popular window style in the 1920s & 30s

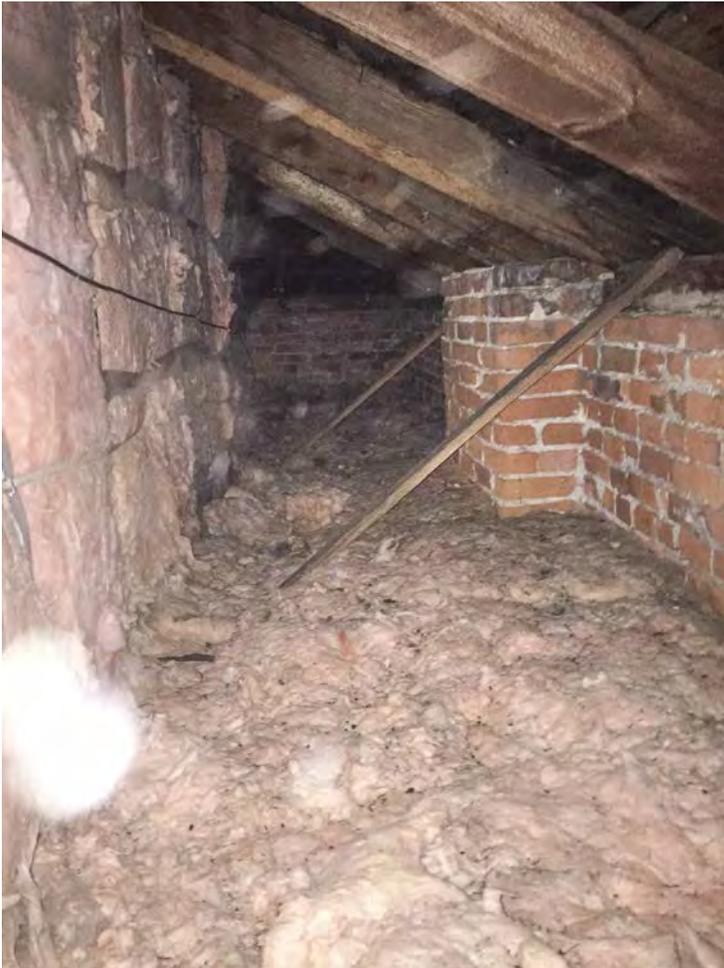
ATTIC – unfinished area under the eaves on the David Street side – the base of a chimney is visible, confirming that there was originally a matching chimney on this side

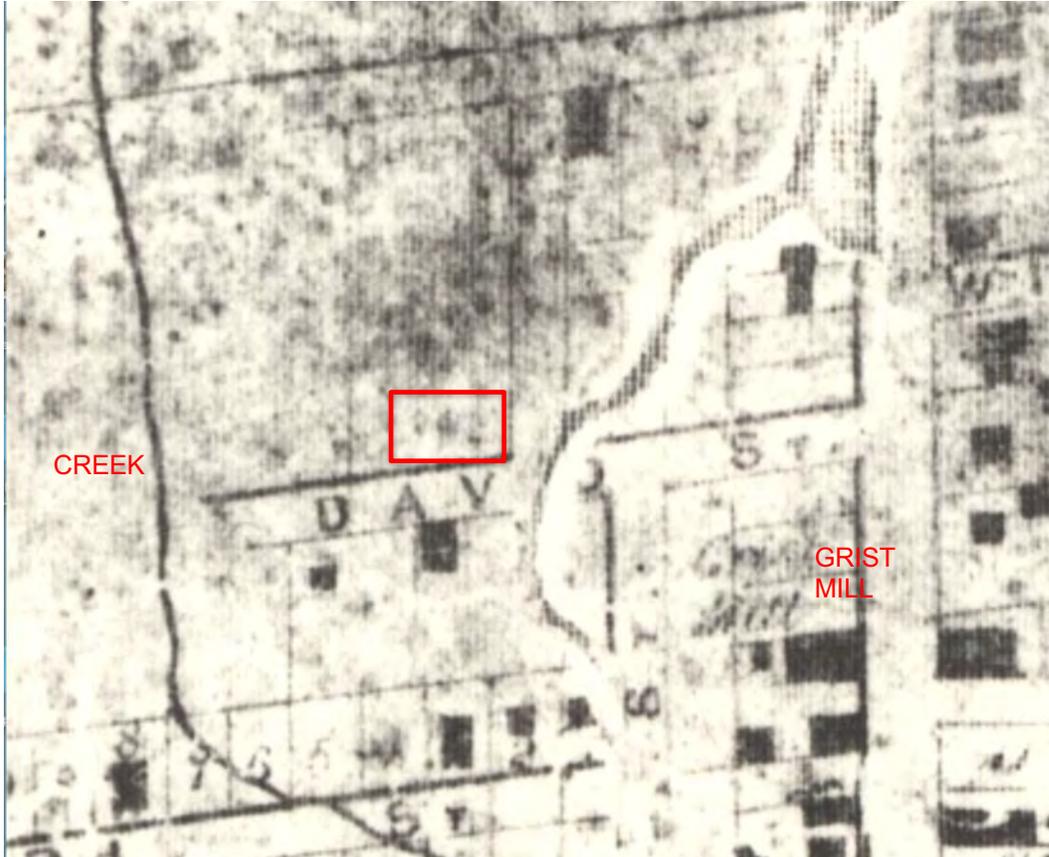
1859 TREMAINE MAP OF BRAMPTON – the subject dwelling does not appear – there is a Grist Mill & a creek nearby [PAMA]

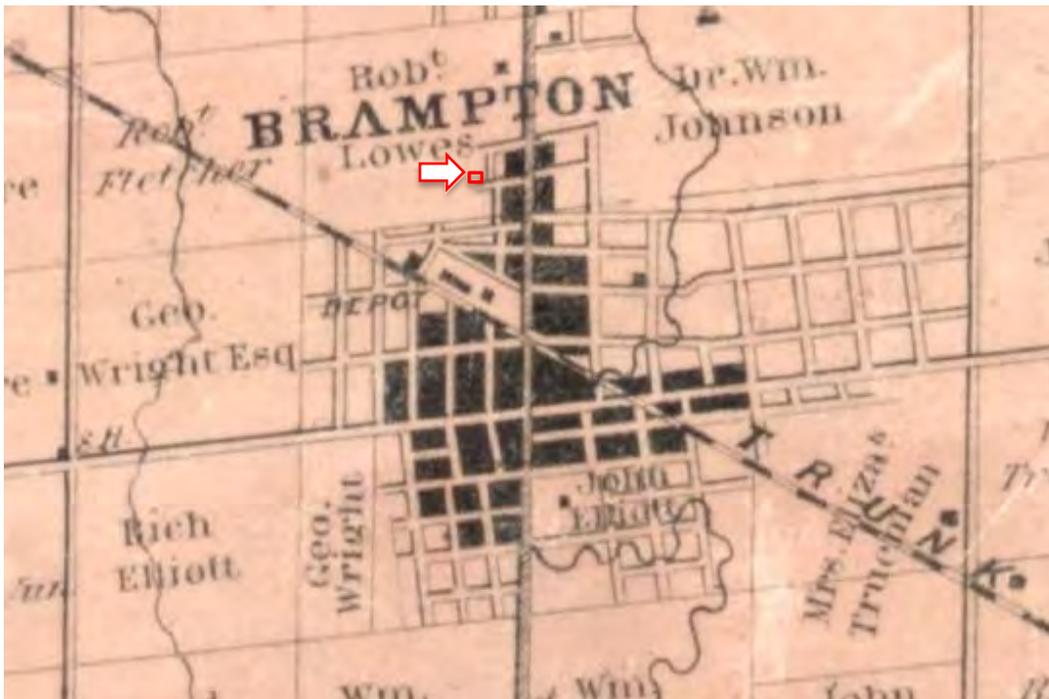
1859 TREMAINE MAP OF PEEL COUNTY – the corner of Isabella & David is on the edge of town [PAMA]

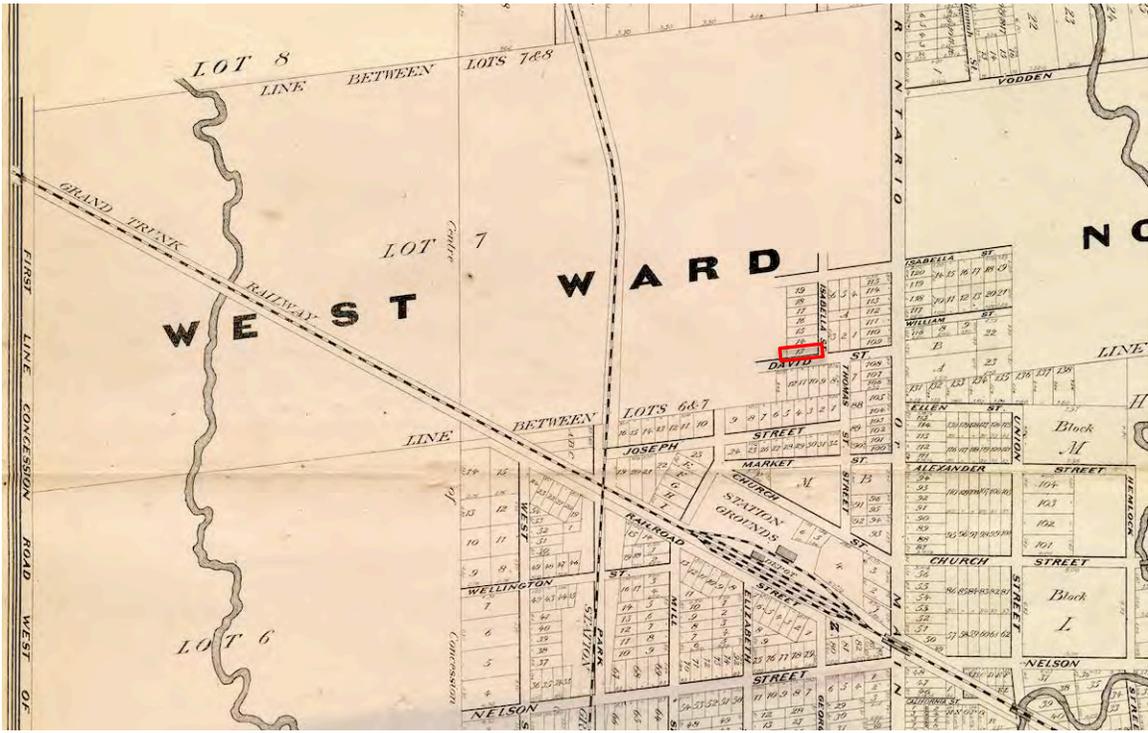
1877 PEEL COUNTY ATLAS – West Ward – building lots have been laid out along Isabella Street including Lot 13 where the subject dwelling is located – Isabella Street is still at the northwest edge of Town. The subject dwelling is part of a residential neighbourhood on the west side of Main Street, north of the Grand Trunk Railway line. [PAMA]

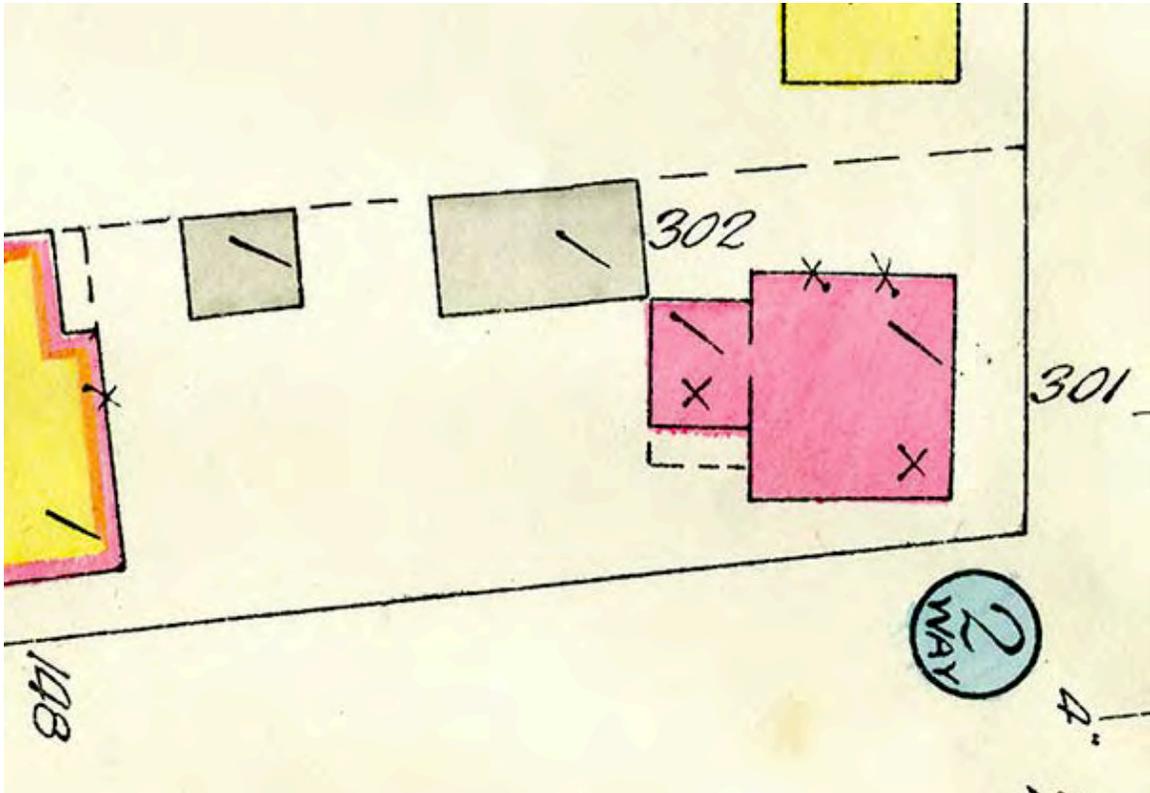
1917 FIRE INSURANCE PLAN, SHEET 7 – the subject dwelling appears with its current configuration including a 2-storey main block with a square plan and a 1-storey tail with a porch facing David Street. The two frame buildings shown here have been demolished. The larger frame building has a separate street address indicating that it was a separate household. It may have been an older dwelling or a stable that was converted to a dwelling. [PAMA]

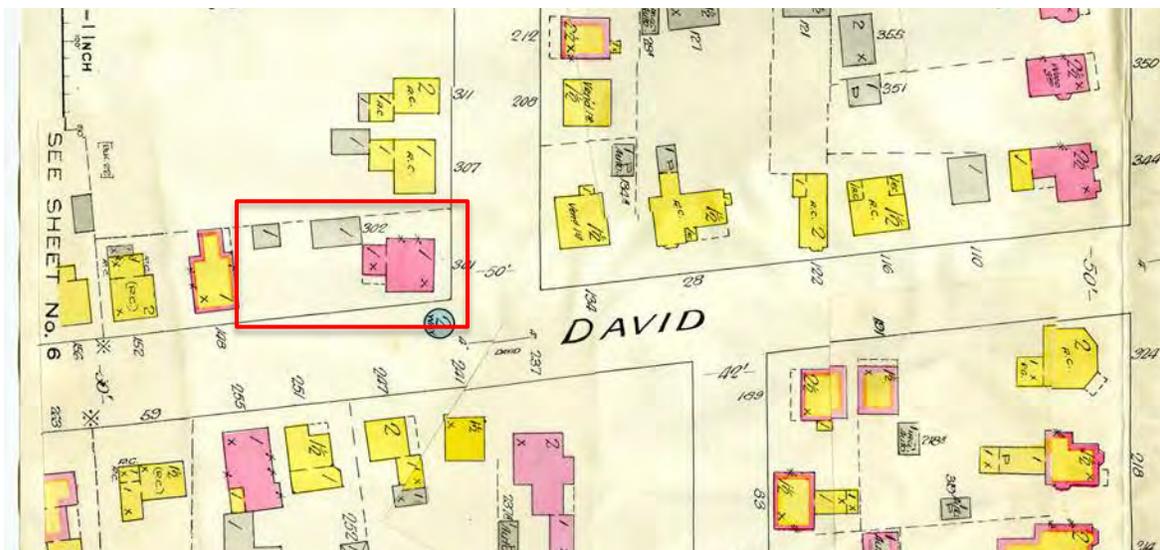
1924 FIRE INSURANCE PLAN – no changes to the subject property since the 1917 Fire Insurance Plan. The brick dwelling identified as 301 Isabella Street is the subject dwelling. The two frame outbuildings have been demolished; one appears to be converted to a dwelling because it is identified as 302 Isabella Street and the other is probably a privy. [PAMA]

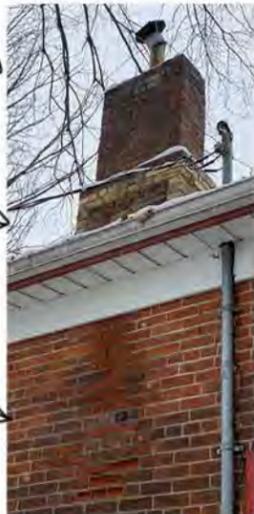
EXISTING BRICK DAMAGE

ORIGINAL CHIMNEY

NON SYMPATHETIC CHIMNEY EXTENTION

- 'A' PROPOSED:**
- REMOVE UPPER CHIMNEY
 - CAP ORIGINAL CHIMNEY
 - REPAIR BRICK
 - VERIFY NECESSARY STRUCTURAL MEMBERS

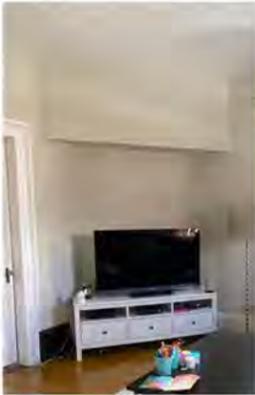
INTERIOR CHIMNEY SUPPORT

CHIMNEY NOT IN USE

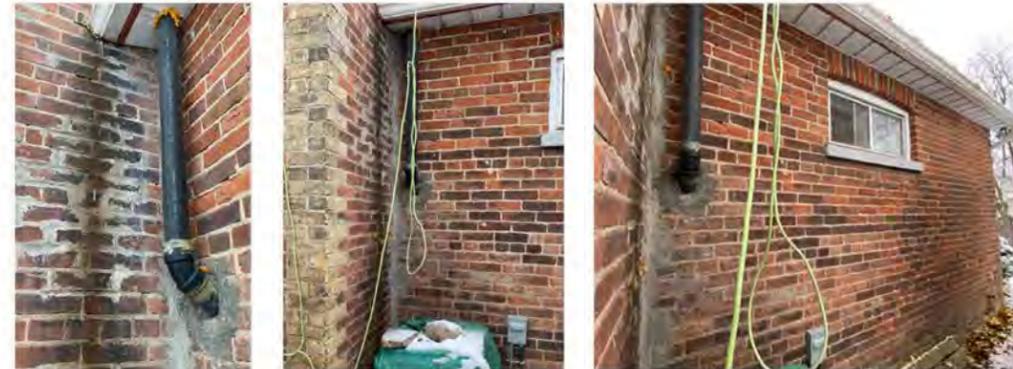
← EXTENSIVE BRICK DAMAGE
POOR BRICK REPOINTING
NORTH EXPOSURE
SHADDED & WET

- 'C' PROPOSED:**
- ADDITION PROVIDES FOR WEATHER PROTECTION OF BRICK AND FOUNDATION
 - IMPROVE GRADE SLOPE TO DRAIN WATER AWAY FROM BLDG
 - ROOF VENTING ON NORTH SIDE TO NOT BE SEEN FROM STREET
