HERITAGE IMPACT ASSESSMENT

1 ISABELLA STREET
Brampton, ON

25 Aug 2022

MEGAN HOBSON CAHP
M.A. DIPL. HERITAGE CONSERVATION
Built Heritage Consultant
mhobson@bell.net

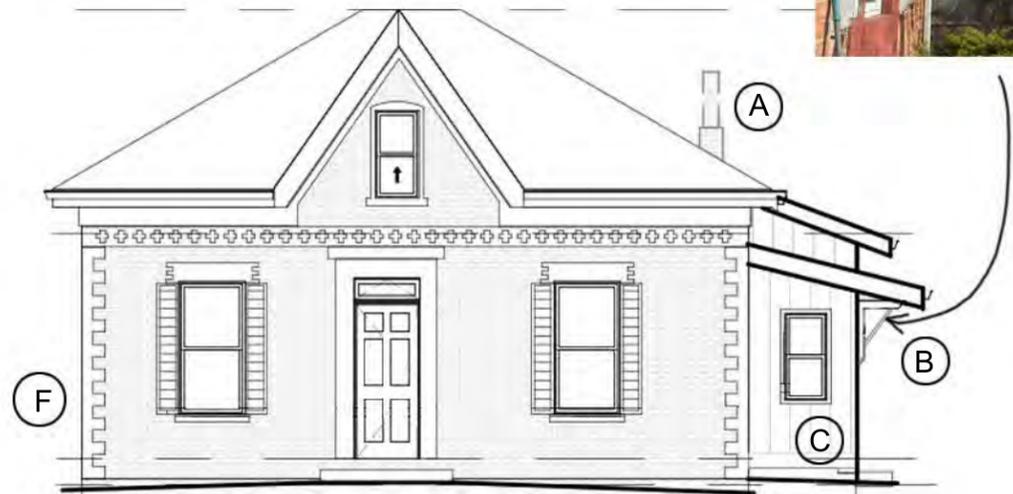
ISABELLA STREET VIEW

← EXTENSIVE BRICK DAMAGE
POOR BRICK REPOINTING
NORTH EXPOSURE
SHADDED & WET

- 'C' PROPOSED:**
- ADDITION PROVIDES FOR WEATHER PROTECTION OF BRICK AND FOUNDATION
 - IMPROVE GRADE SLOPE TO DRAIN WATER AWAY FROM BLDG
 - ROOF VENTING ON NORTH SIDE TO NOT BE SEEN FROM STREET

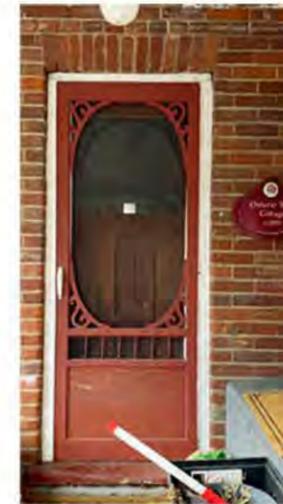
EXISTING 1870 REAR ADDITION AND PORCH

- 'F' PROPOSED*:**
- REMOVE OVERGROWN HEDGES
 - SLOPE GRADE AWAY FROM BLDG
 - REPAIR BRICK & FNDN
 - NEW LOWER PLANTINGS AWAY FROM WALL TO KEEP DRY AND AVOID SOIL EROSION

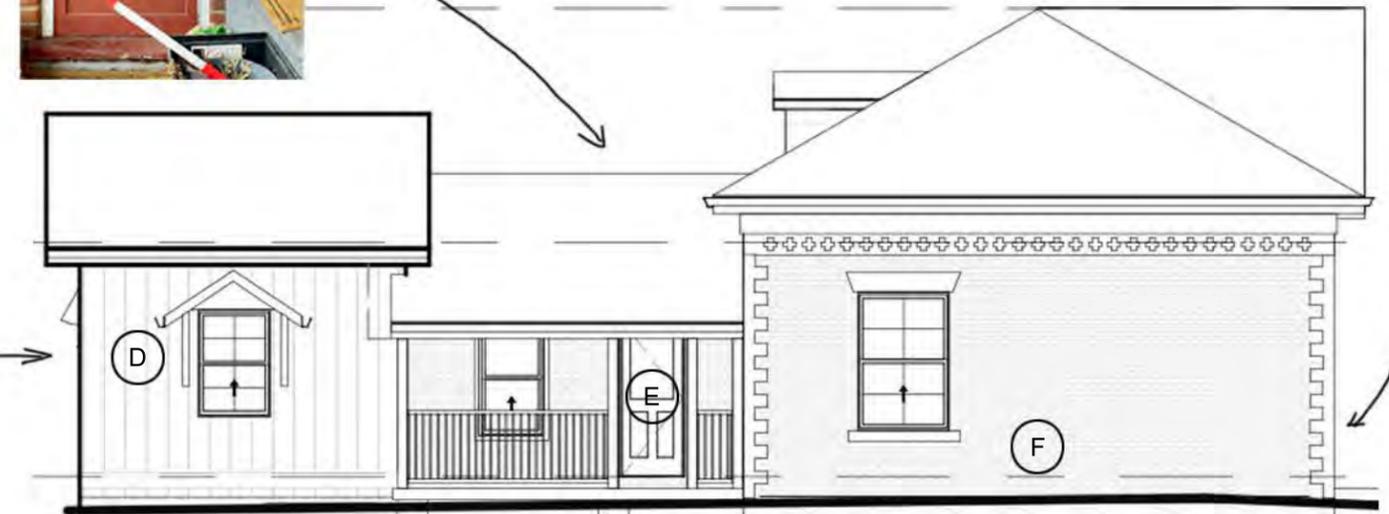
DAVID STREET VIEW

VERIFY EX. PORCH POST FOUNDATION
