RE: Heritage Brick Replacement at 21 Church Street East, Brampton

Re: Exterior Repairs at Genesis Lodge

QUOTATION

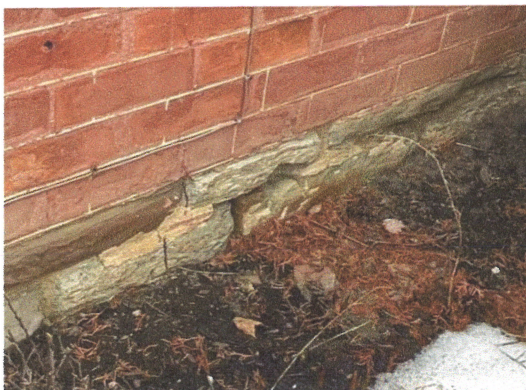
Gaps at Foundation

4. Replace parging on the driveway side of the building with heritage permeable parging.
5. Infill holes and gaps in foundation and close to grade with heritage mortar.

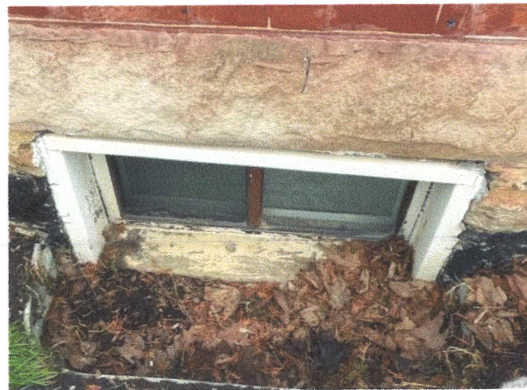
Caulking & Painting Req. at Basement Window

6. Strip paint from basement window and repaint with primer and 2 top-coats, caulk window after repainting. Dig to extend depth of the window well and install clear stone for drainage.

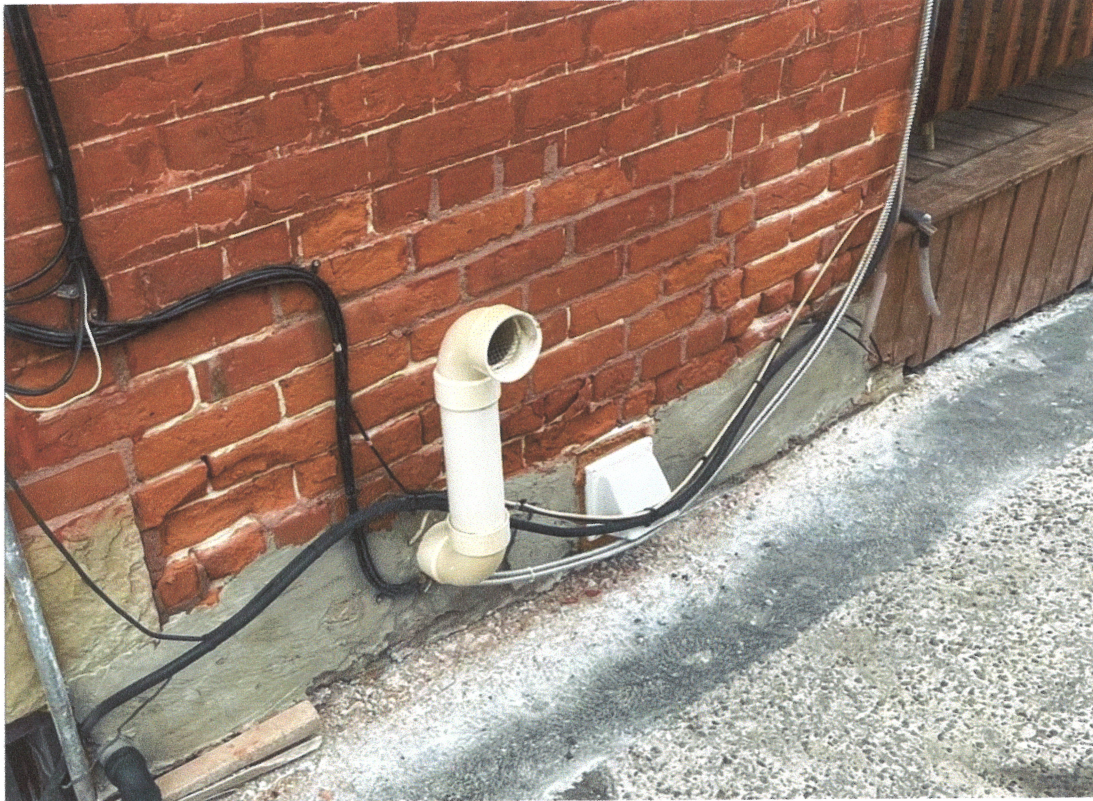
Previous repairs have been completed using Portland cement-based mortar which can accelerate damage to the heritage bricks and mortar in surrounding areas.

Deteriorated Brickwork and Parging above Foundation. Previous hard repointing visible

3. Cut-out deteriorated or inappropriate hard mortar close to grade and re-point using heritage mortar. The joint will be colour matched to the base mortar and textured to mimic a heritage joint. Allowance for 30 ft².

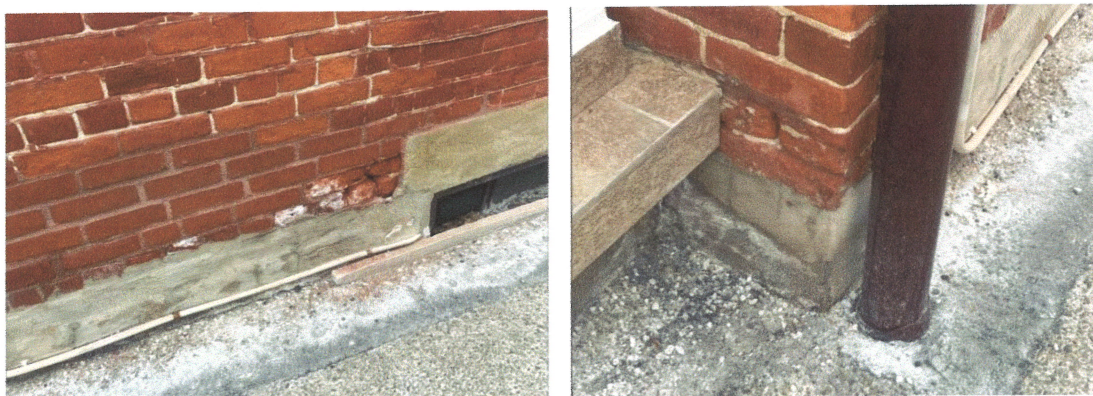
Deteriorated Masonry at Foundation and Open Joints (Typ).

1. Provide a 45 ft. elevating lift for access and lay down protection mats on grass areas.
2. Remove deteriorated bricks and replace with matching reclaimed or new heritage style clay bricks. Allowance for 80 bricks.

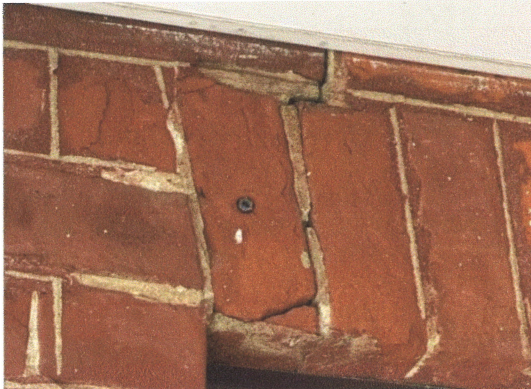
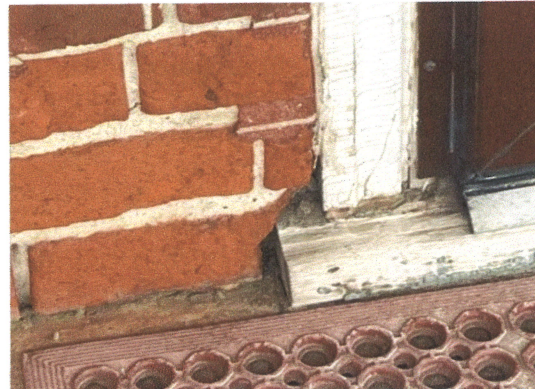
Structurally, the building appears in sound condition considering the age of the property. There are areas where movement has occurred at window arches which is typical for a building this age. There are also areas where there are open masonry joints and deteriorated bricks (mainly close to grade).

Movement at Voussoir Brick (Arch Brick) Gap Beside Door Frame

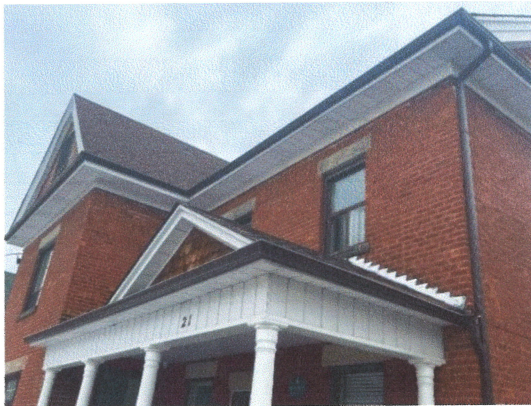
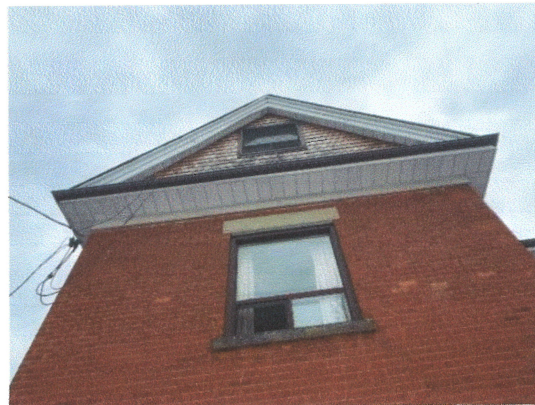
The gables have been cedar shingled within the last 10 years but do not match the original green colour.

Window sills and stone lintels are dirty with environmental staining.

Cedar Gables & Dirty Sills and Lintel Stones

7. Apply green wood stain to cedar shingles at 4 gables to closely match heritage colour.
8. Steam clean stone sills and lintels using the DOFF Integra cleaning system.
