## CONSERVATION PLAN

### **Haggertlea**

28 Elizabeth Street North  
Brampton, ON L6X 1S2

Date: 23 August 2023

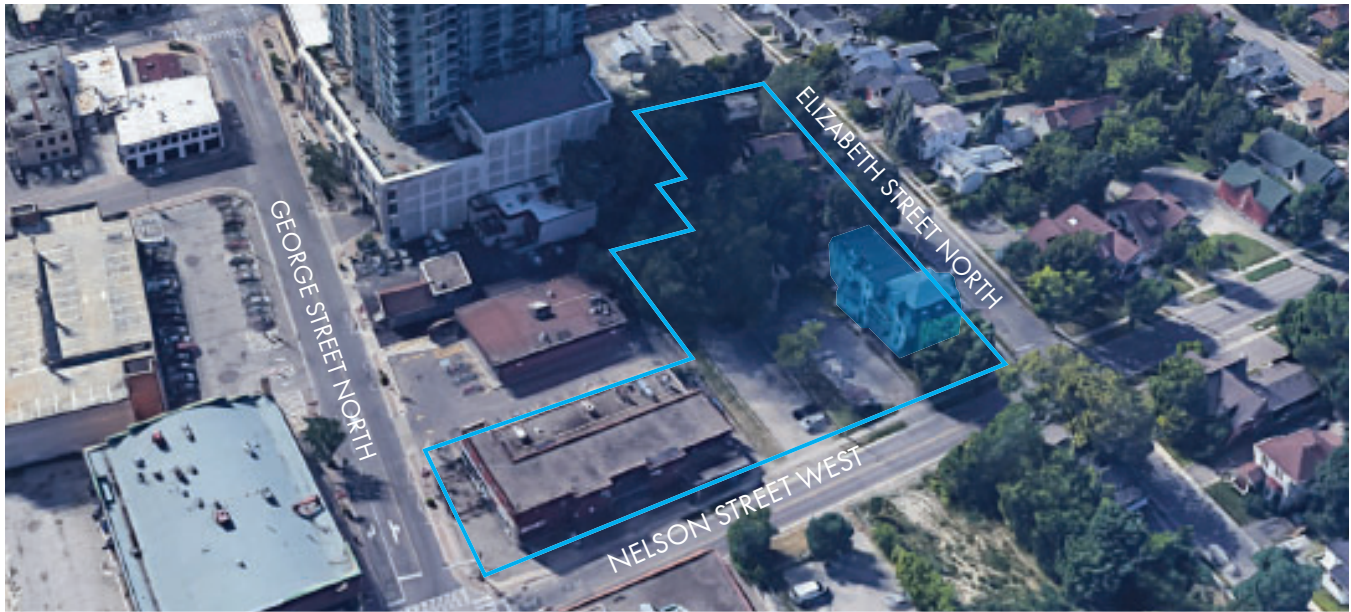
Fig. 1.1. Aerial image of the site, outline approximated in blue, with the heritage building shaded in blue.

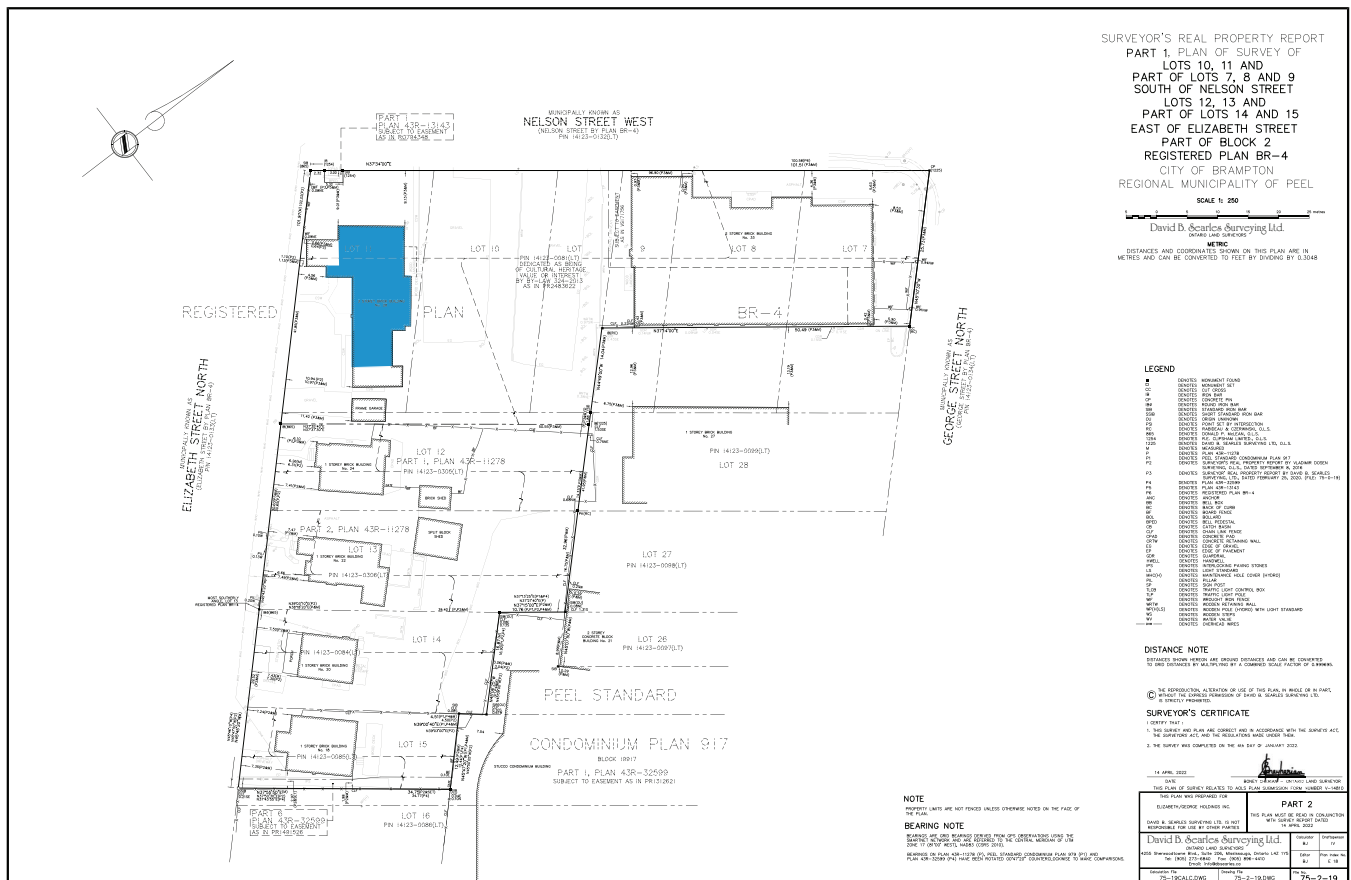
Fig. 1.2. Topographic survey of site with existing structures highlighted

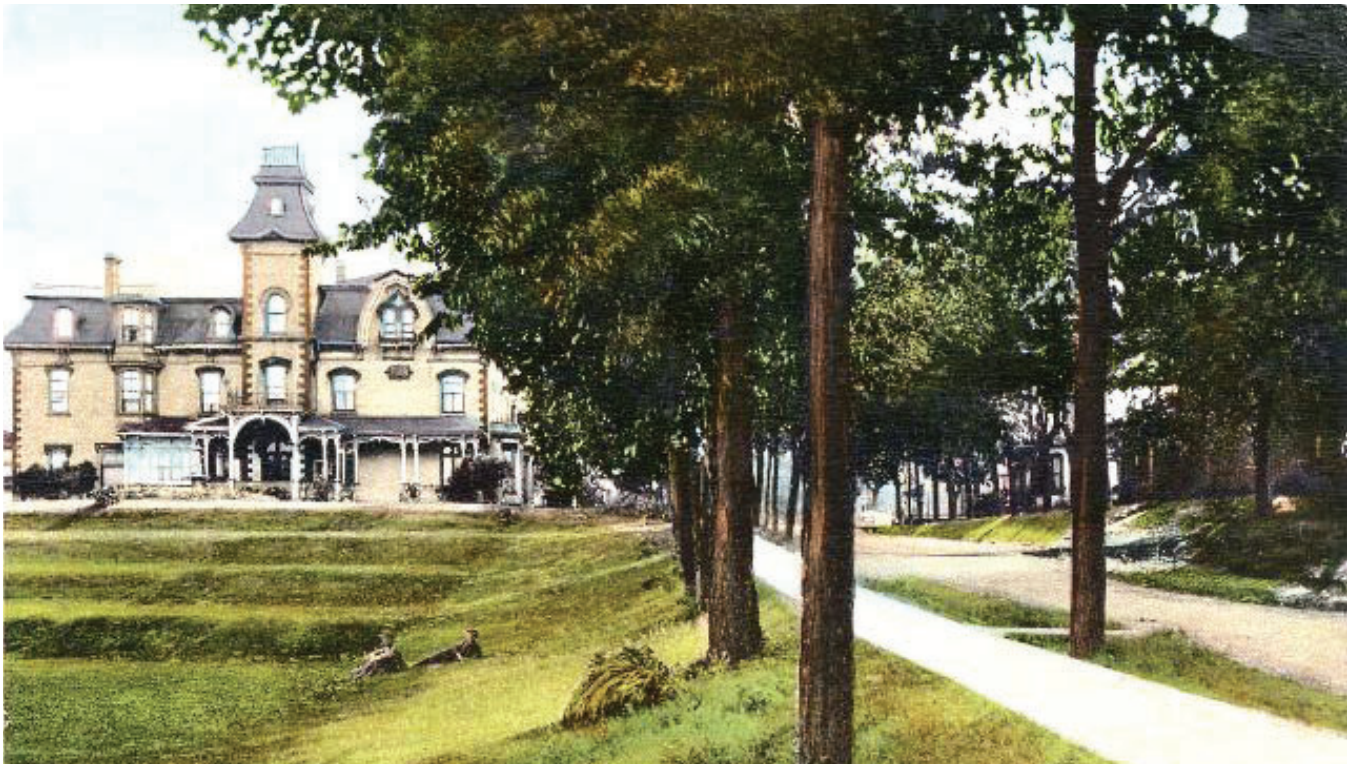
Fig. 1.3. View of Haggertlea, the bowling green and terraces, along Nelson Street West. (Circa 1910, Retrieved from the Frost Postcard Collection)

Based on archival information (Fig. 1.3.) and through coordination with MHBC, a species of high-branching deciduous trees similar to the original trees will be planted.

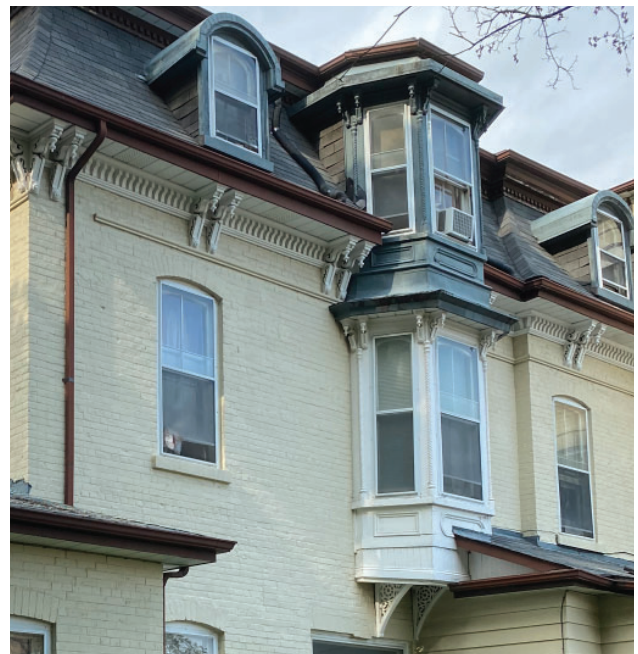
Fig. 1.4. Two storey bay window with brackets and decorative spindles, as well as concave mansard roof, and other attributes.

- Remove paint from bricks and clean all surfaces; exposing original dichromatic brickwork.
- Conserve all original window units; including the two-storey detailed bay window with brackets and spindles; repair where required.

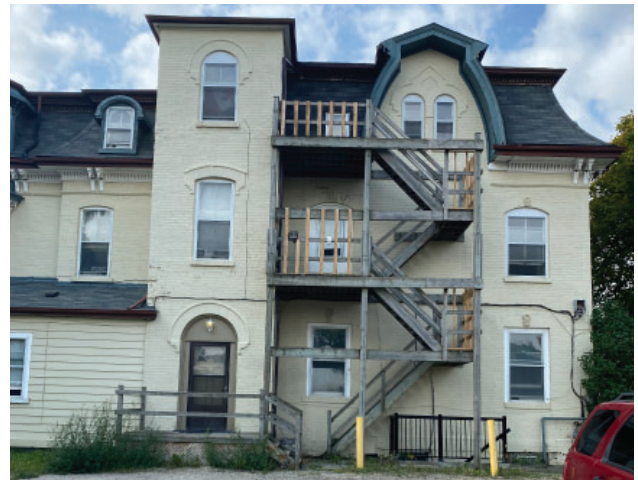
Fig. 1.5. East elevation, showing the remnant of the central tower.

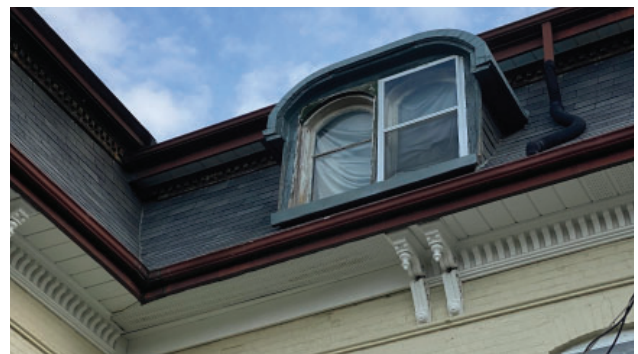
Fig. 1.6. West elevation, showing bracketed cornice and dormer.

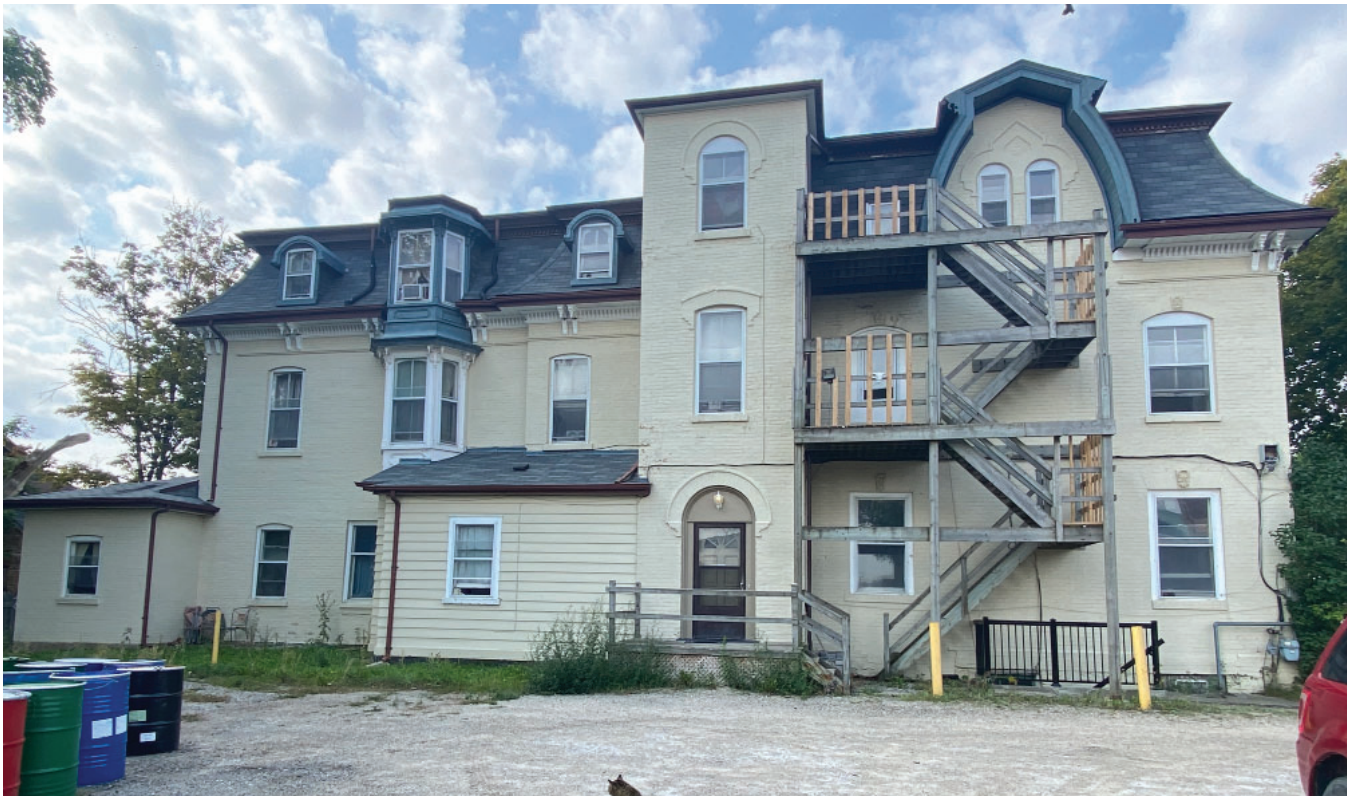
Fig. 2.1. East elevation (Primary elevation)

At the east elevation, which was the original front elevation, the fire escape will be removed, and the brick repaired. At the south end of this façade, the corner of the building will be repaired following the removal of the 1925 addition. Below the bay window, a missing brick pier that divided two windows will be reinstated. The most visible work on the façade will include the repair of the tower, complete with reconstruction of another approximately half-storey of masonry above the current extents, terminating below the concave mansard roof.

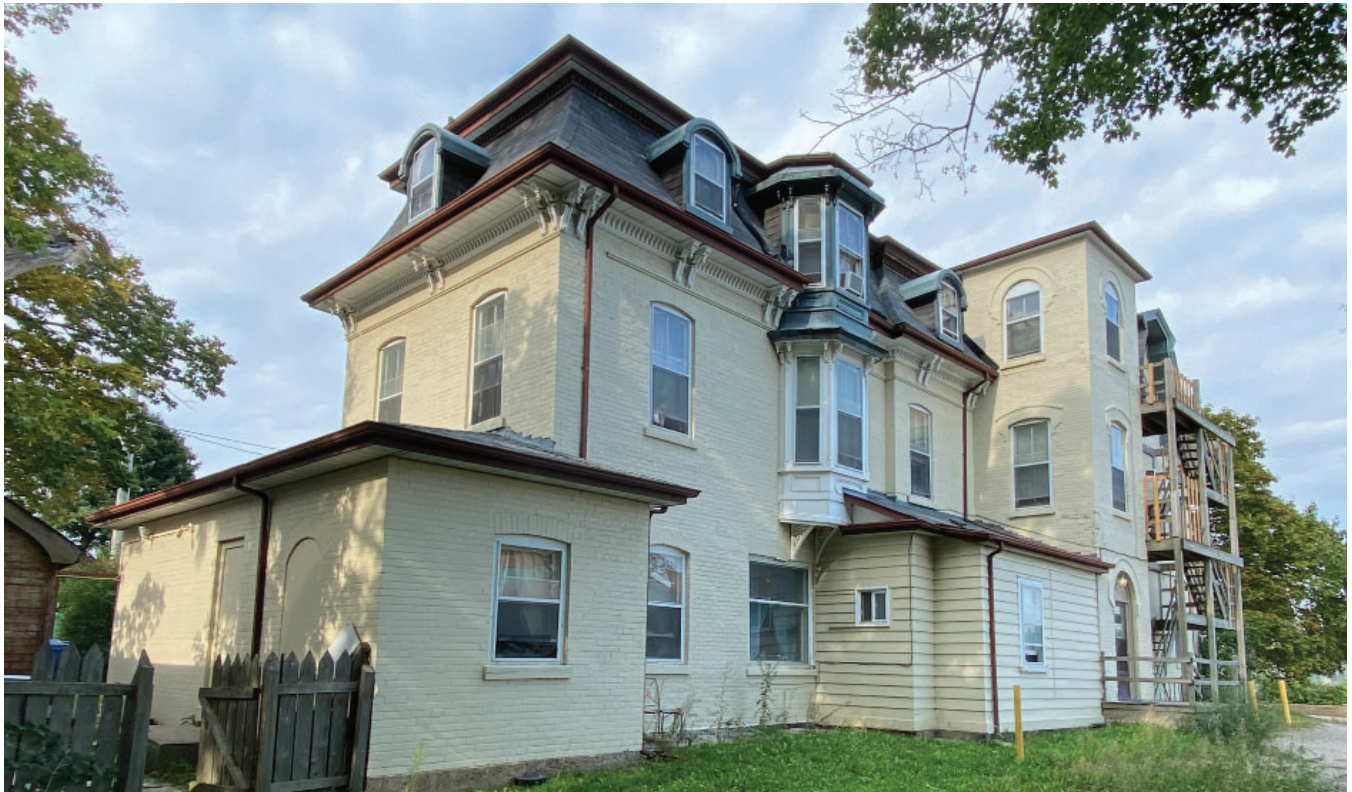
Fig. 2.2. South elevation

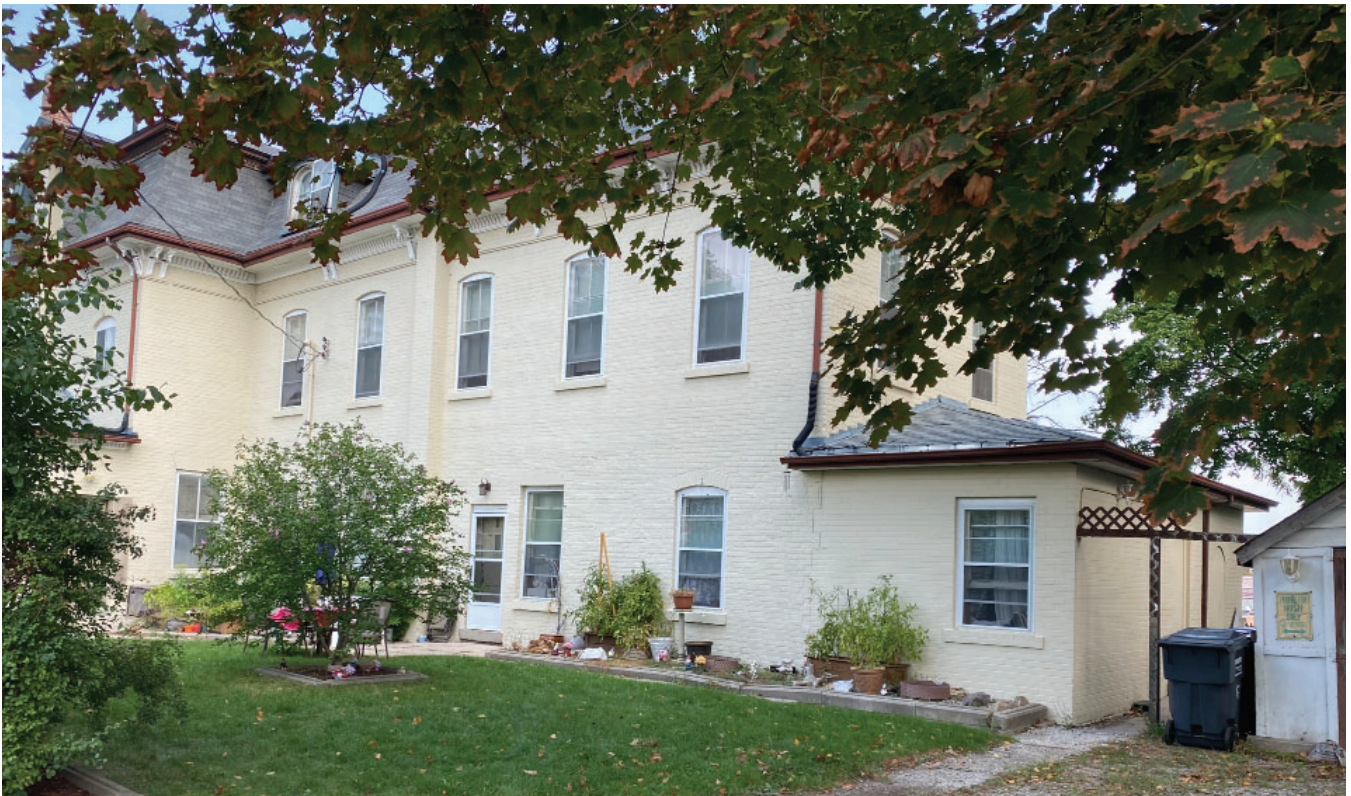
Fig. 2.4. Partial West elevation

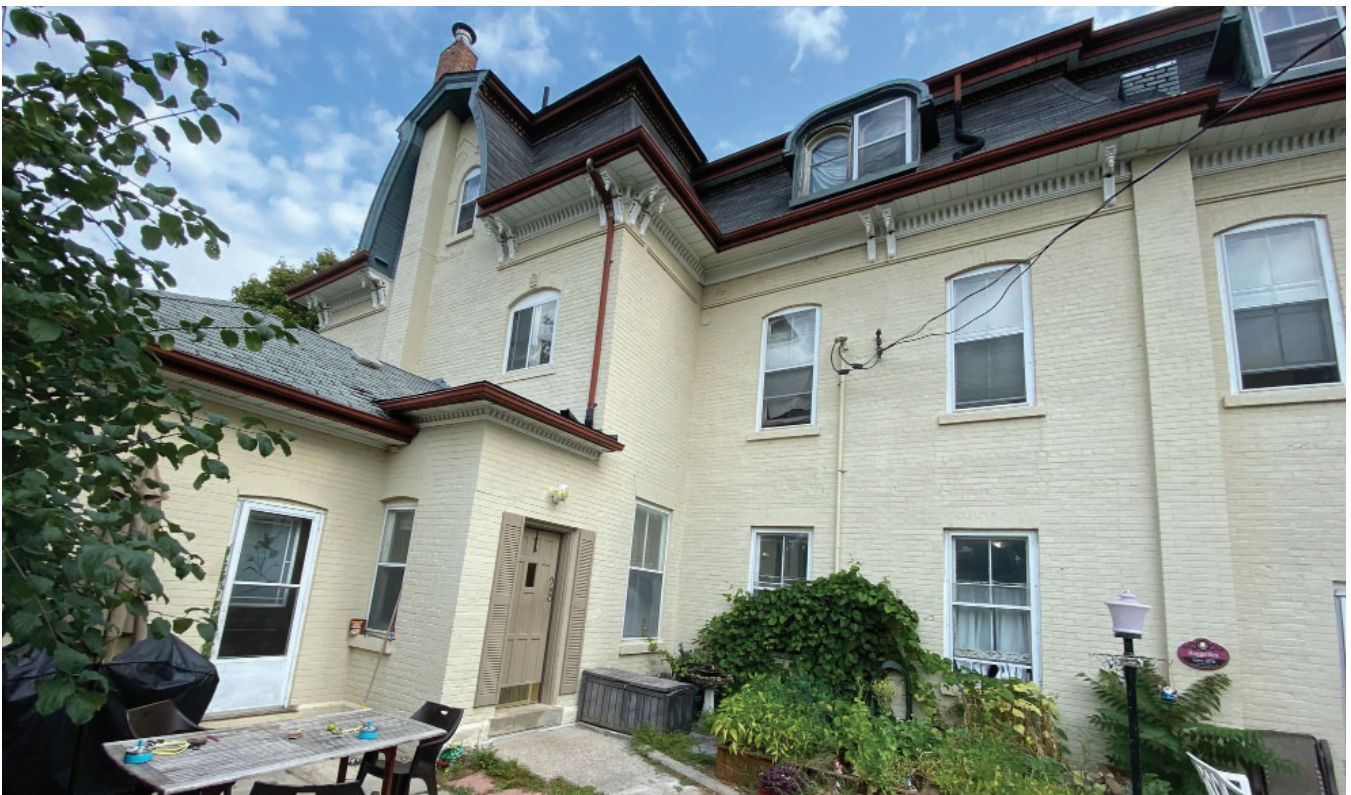
Fig. 2.3. Partial West elevation

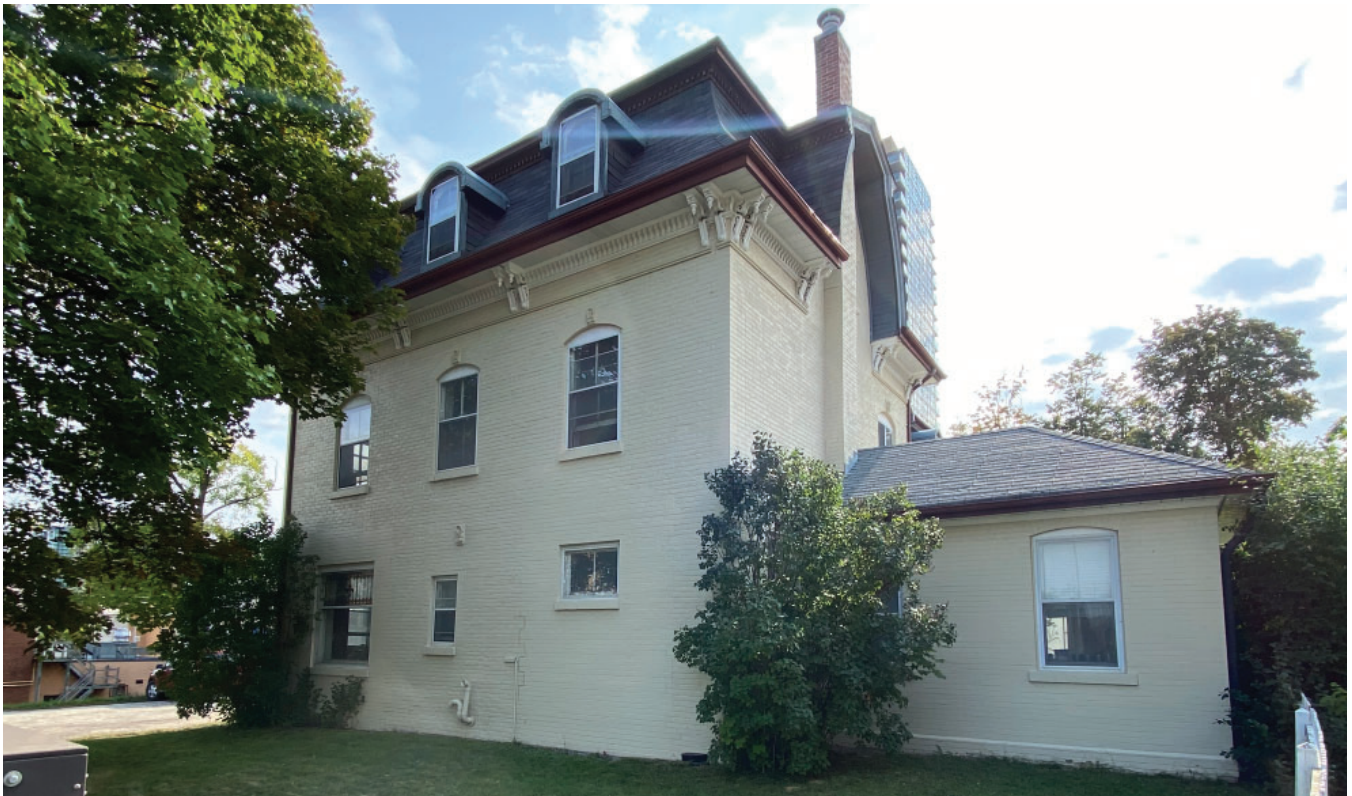
Fig. 2.5. North elevation

At the ground level, on the north elevation, further investigation into the non-original openings will be completed with the removal of the exterior paint. As the adaptive reuse plan for this area has not yet been developed, further modifications to this area of the facade will be proposed in conjunction with the reuse. Any new openings should respond to the scale of the former bay windows, removing the poorly matched brick in those areas. It would also consider the relocation of the stained glass window to elsewhere in the building. At the west elevation, the openings covered by the addition will be reopened, and new wood windows installed to match the adjacent. At the south portion of the west elevation, the ground floor openings have been modified over time. Based on the visual differences in the brick, as well as different window headers, the southernmost window is believed to be original due to the presence of the flat segmental arch complete with decorative brickwork at the skewback, set within the abutment. The presumed original arrangement would likely have been a set of two windows. Further confirmation of the window arrangement can be confirmed once the paint has been removed from the brick. The

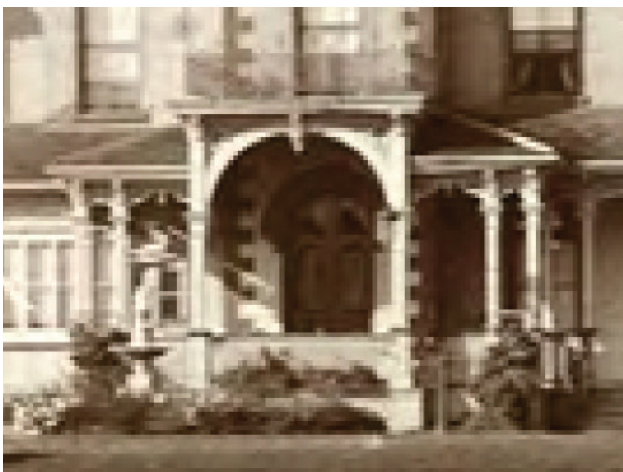
Fig. 3.3. The central entrance doors were paired, with arched lites, and quarter circle lites with arched sills above.

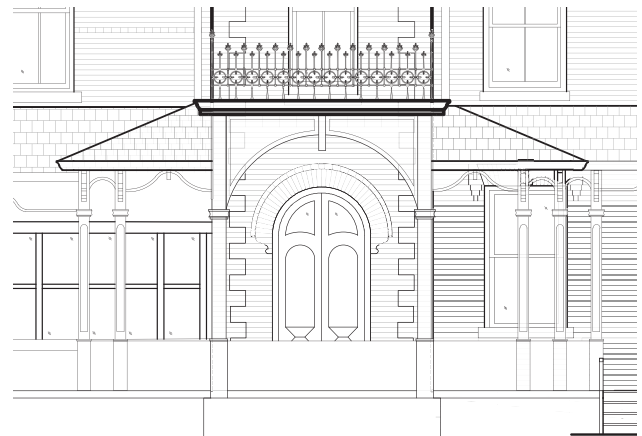
Fig. 3.4. The proposed reconstructed central entrance doors and porch, based on photographic documentation.

Along the primary east elevation, the ornate porch will be reconstructed, connecting with the existing enclosed porch, which will be investigated for original material beneath the siding. If the enclosed porch is found to have original materials which are in a repairable state, the porch will be cataloged, dismantled and reconstructed when the relocation of the building is complete. The missing porch will be reconstructed using the archival photographs as a reference, as well as a period study in order to determine appropriate details not visible within the archival documentation.

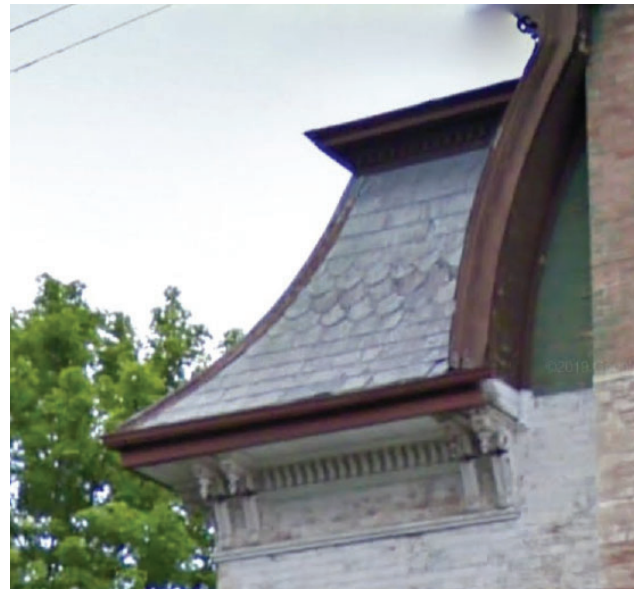
Fig. 3.5. The concave mansard roof, with the original cladding showing scalloped shingles and ridge caps.

Asphalt shingles will be specified in two formats, in order to align with the original roofing pattern, which had a four rows of lighter coloured scalloped shingles at approximately the midpoint of the mansard roof. At each of the mansard roof hips, a new custom metal ridge cap will be installed at each of the ridge corners, similar to the original design.

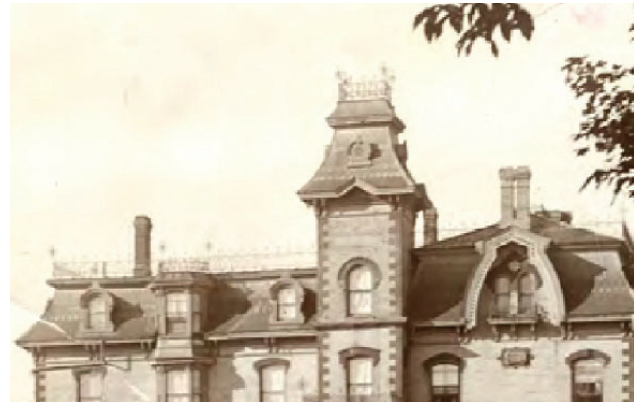
Fig. 3.6. A partial east elevation, showing the missing iron crestwork along the peak of the mansard roof and tower.

- Restore missing decorative cornice details, including wood brackets and dentils, to match existing.
- Restore missing iron cresting where applicable at existing and/or restored condition to match archival documentation.

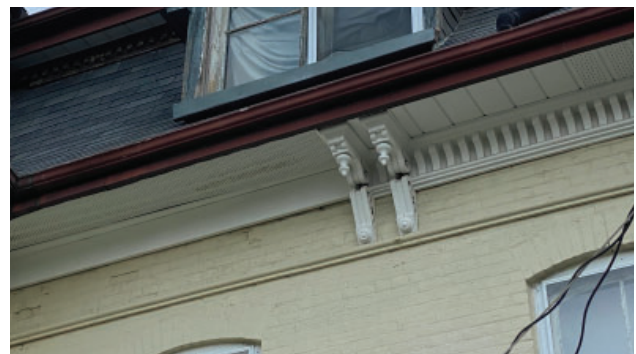
Fig. 3.7. Left, an area where the soffit and dentils have been removed. On the right, the historic woodwork is intact.

At both the soffit and the peak of the mansard roof, the decorative woodwork including cornices and brackets will be retained, repaired as necessary either using wood dutchmen, or replacement of deteriorated components, and repainted. Where the decorative woodwork is missing, it will be reinstated. The original wood soffit will also be reinstated where it is not present.

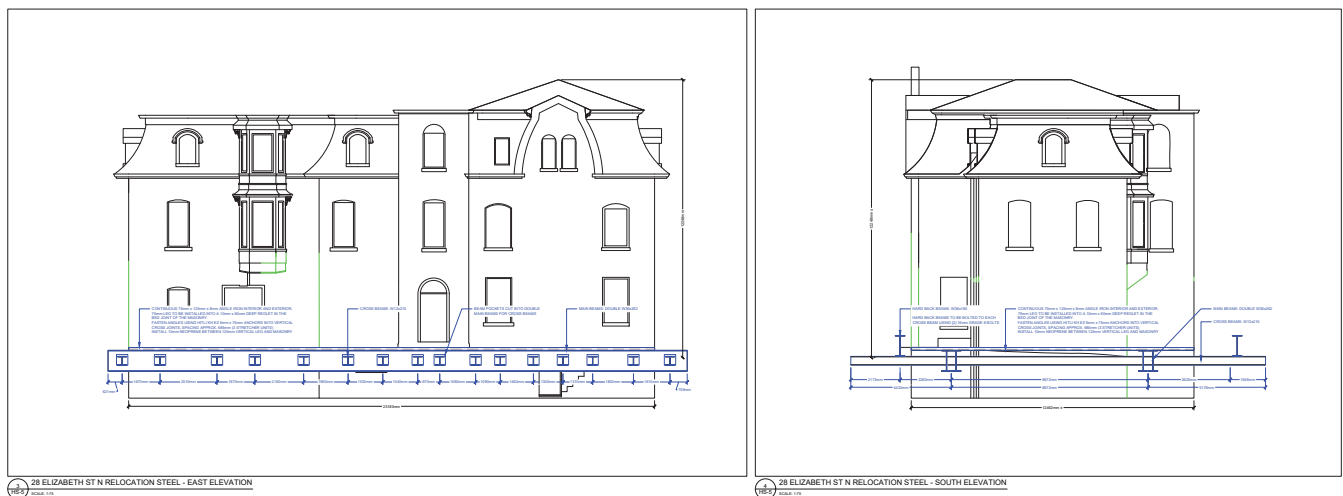
Fig. 3.8. An excerpt from the relocation plan, showing the structural support below the first floor.

Severance of the house from the existing foundations is to occur at the top of the building foundations. The relocation process is to be undertaken by an engineer and contractor experienced and specialized in this process. Details regarding the relocation can be found in Appendix G.

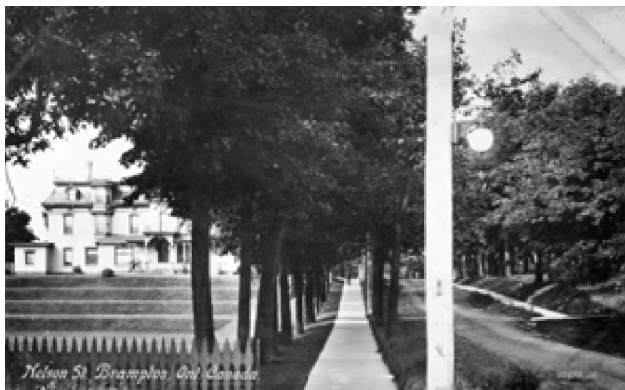
Fig. 6.2. An image of the historic landscape along Nelson Street West, circa 1925.

Historic photos of the site along Nelson Street West show a planted boulevard of high branching deciduous trees, believed to be Oak trees by the project landscape architect. A planting scheme resembling the original will be reinstated along the boulevard, with a similar species of tree. This will help to reintroduce the most public landscape element of the scheme, which will create a shaded, pleasing link from George Street, to the public square introduced in front of Haggertlea.

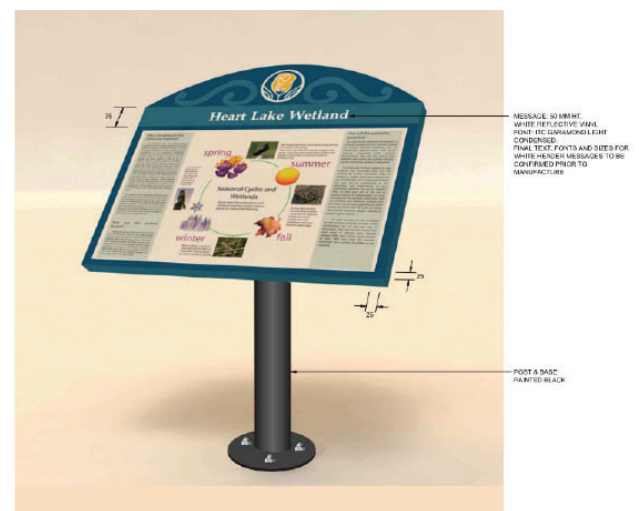
Fig. 6.5. An example of a pedestal plaque, as per the City of Brampton's Heritage Plaque Program.

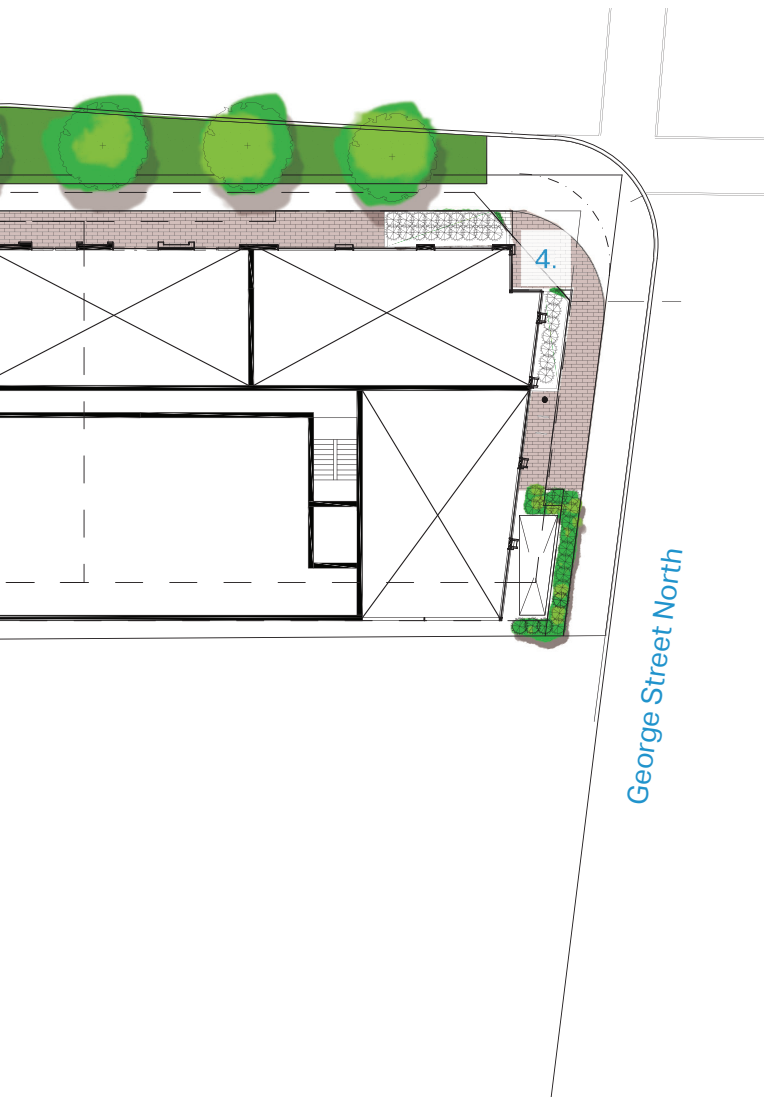
Fig. 6.6. Left, a schematic plan of the commemorative landscape, also showing the interpretive pedestal plaque locations.

- Dichromatic paving,
- A terraced lawn,
- The quatrefoil canopy and,
- Trees along Nelson Street West

In order to explain the scale and extent of the historic terraced lawn, at the front of the Haggertlea house, the scale of the terraces will be represented via dichromatic paving patterns, which will extend across the extent of the paved pedestrian area in the north-south direction of the site, sited between the east facade of

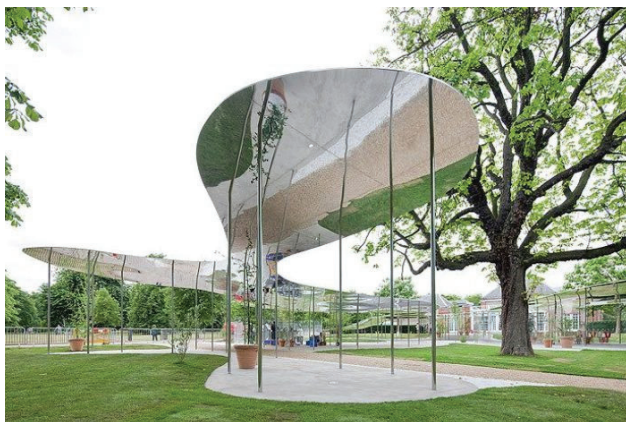
Fig. 6.7. A 2009 pavilion by Sanaa Architects, as a possible precedent for the quatrefoil canopy.

the house and the new retail spaces within the podium of the tower. The terraced lawn, previously only meant for the select few visitors invited to the grounds of the house, will be scaled down and transposed to the north-west corner of the site, north of the house, creating a new terraced landscape linking with the public plaza. Enclosing the volume of the terraced lawn will be a wall, which will be inscribed with interpretive elements. Finally, the plaza will further explain the layering of changes in this space with the creation of the quatrefoil canopy, interpreting a historic image of the house in which a quatrefoil-shaped conservatory is illustrated at the south end of the house. The proposed canopy would provide shading for new seating areas, and would emulate the shape of the former footprint in a contemporary manner, at the approximate scale and location of the conservatory. Refer to figure 6.7. for a precedent of a free-form shaped canopy by Sanaa Architects.

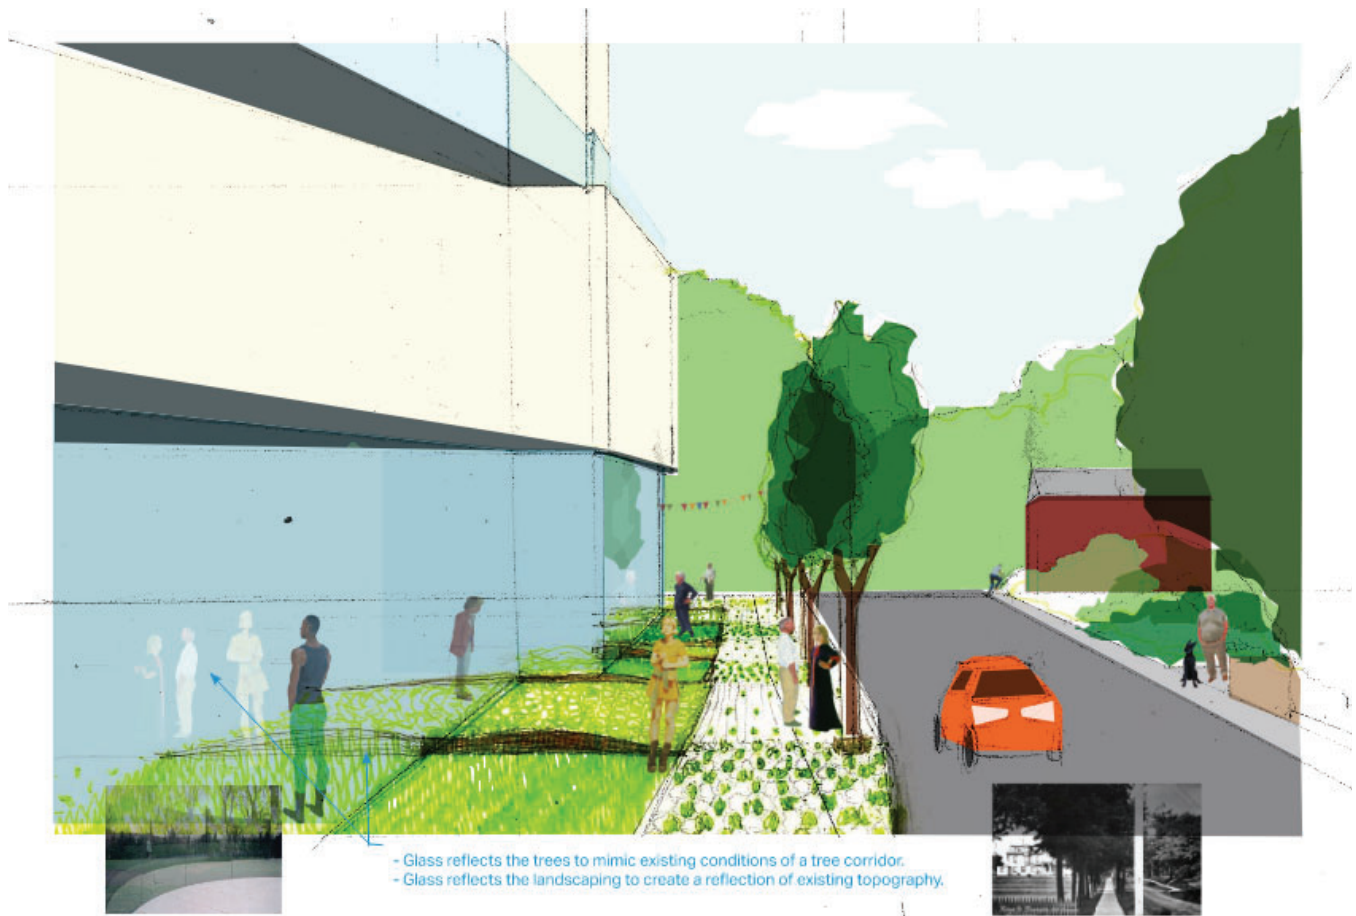
Fig. 6.9. An artistic interpretation of the former scheme, showing the reflection of the terraces

While elements of this concept carry into the current commemoration strategy, specifically the tree lined boulevard and the dichromatic paving representing the scale of the terraces, the physical terraces along Nelson Street West and the reflective surface along the building were eliminated. This was primarily due to proposed road widening, which left a reduced area to include physical terraces, and reduced the interaction and engagement between the building and the public realm along Nelson Street West. Furthermore, the terraces, which were previously available to access by visitors to the house, are proposed to be introduced as a public gathering element and a way to enhance visibility of Haggertlea in the current scheme.

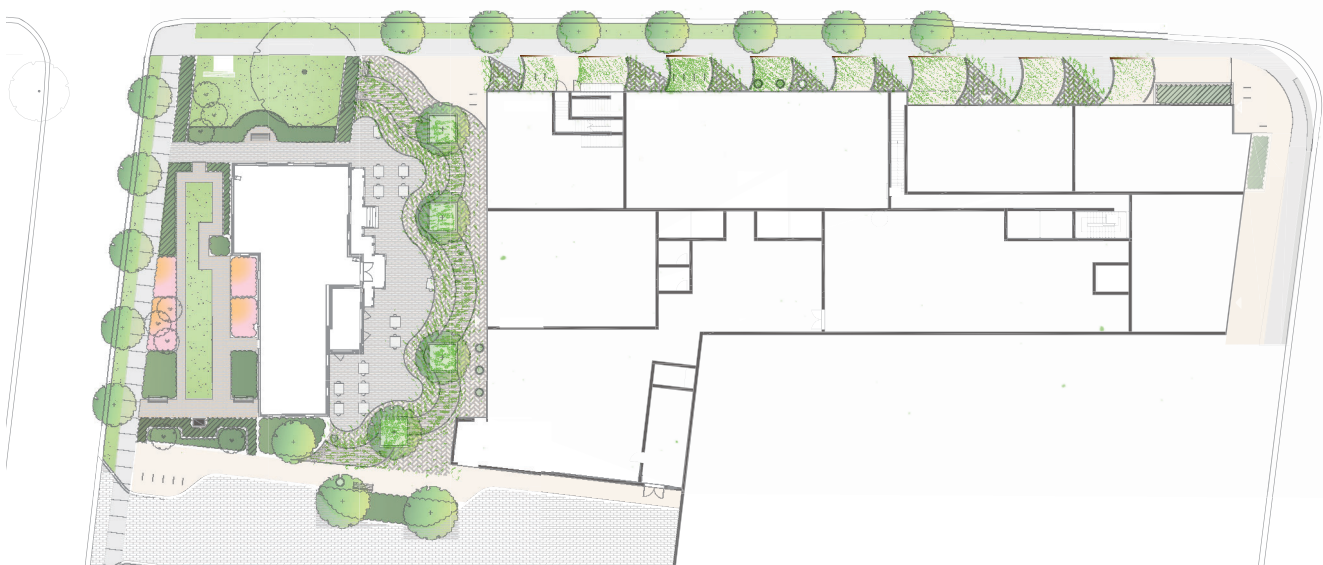
Fig. 6.8. Previously proposed site plan showing terraced landscape along Nelson Street

In front of Haggertlea, within the public space, the terraces were interpreted with different coloured paving, in the arrangement as rendered within the 1877 drawing of the house, seen in Figure 6.1.
