10020-10054 Mississauga Road &
2036 Bovaird Drive West

HERITAGE IMPACT ASSESSMENT

May 9, 2023

ERA Architects Inc.
#600-625 Church St
Toronto ON, M4Y 2G1
416-963-4497

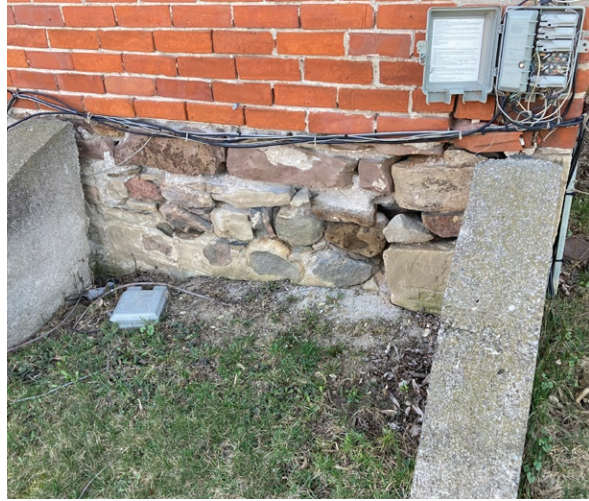
- Foundation stone appeared to have severe mortar loss at localized areas.
- Severe deterioration of pointing was observed at the foundation between two concrete half-walls. Localized brick deterioration and mortar recessing was also observed at this location.

Severe deterioration of foundation pointing (ERA, 2023).

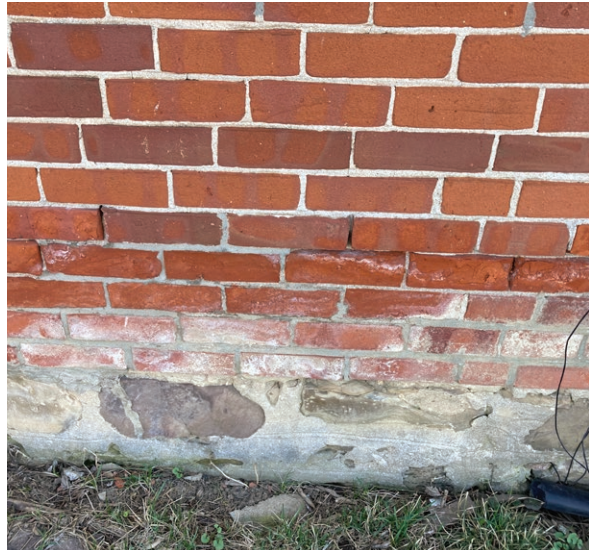
- Selective areas of spalling were observed.
- Efflorescence was observed at several locations.
- Recessed mortar joints were observed at localized areas in the brick.

Efflorescence and spalling (ERA, 2023).

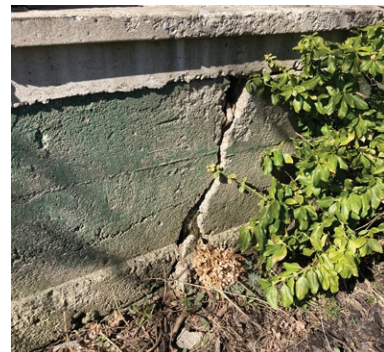
- Concrete on stone foundation at porch appears to be in poor condition with cracking in the parging. Selective areas of defective concrete were noticed.

Cracking on the porch's stone foundation (ERA, 2023).

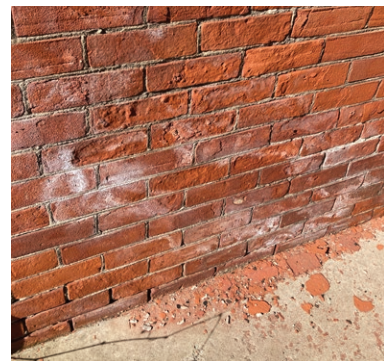
- Spalling of masonry in select locations was observed.
- Evidence of step cracking was visible below the north window sill. Cracking has been infilled with unsympathetic mortar.

Masonry spalling on the porch level (ERA, 2023).

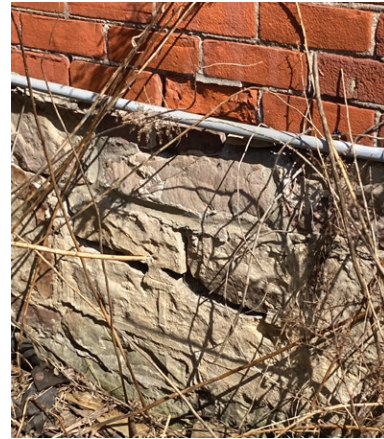
- Flashing on fascia of bay window is in poor condition and is only attached by one end.
- Recessed mortar joints are found throughout the façade, with localized areas of severe deterioration in the foundation stone.

Severe deterioration of the stone foundation (ERA, 2023).

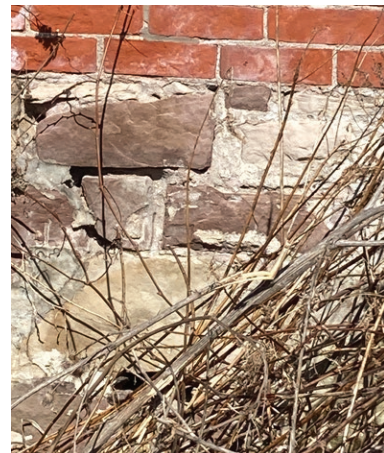
Severe deterioration of the stone foundation (ERA, 2023).

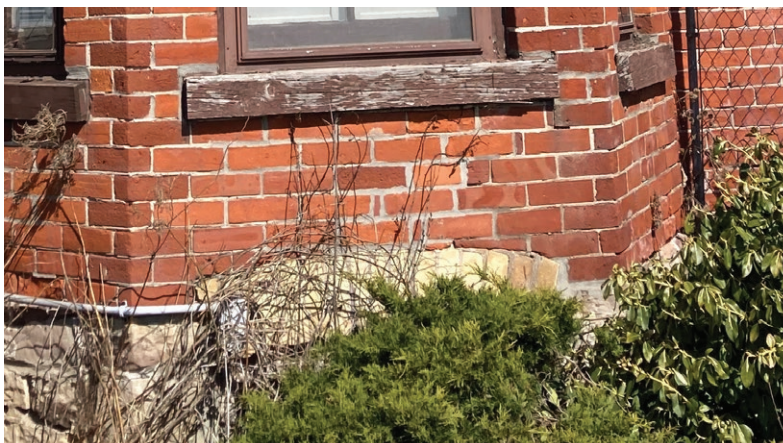
- Evidence of step cracking was visible below the bay window sill. Cracking has been infilled with unsympathetic mortar.
- Basement window appears to have severely deteriorated wood at frames.

Evidence of step cracking below the bay window sill, infilled with unsympathetic mortar (ERA, 2023).

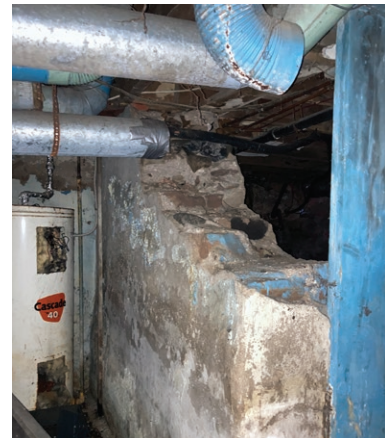
- Basement of original building appears to be rubble stone with parging.
- Pointing appears to be in fair condition with localized areas of poor and deteriorating mortar.
- Concrete floor appears to be in defective condition with water related deterioration. At some locations, it appeared that the bearing soil has been washed away.
- Flooding was observed in a large area of the basement.
- Efflorescence was visible on the rubble walls.
- Floor joists appear to be in fair condition.
- It was observed that part of the rubble foundation wall was removed to allow building services to pass through.
- Mold and water damage was visible on interior sheathing.

Damaged rubble foundation wall (ERA, 2023).

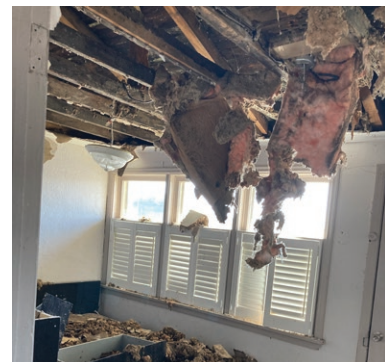
- Interior has localized areas of water damage. At these locations partial visibility of deterioration, beyond the sheathing material was visible.
- Water related deterioration was present at the ceiling of the south bay window.
- At the south addition, the ceiling has collapsed, exposing rafters.

Collapsed ceiling in first floor south addition (ERA, 2023).

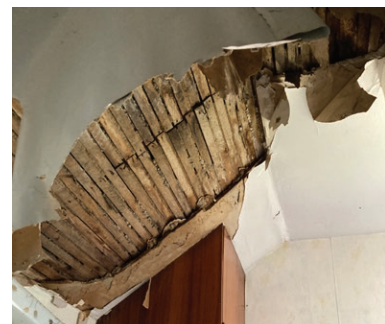
- Moisture damage was visible at several locations on the ceilings. Collapse of the ceiling was visible at 2 locations.
- Peeling paint was visible on the ceilings and walls.
- Mold was visible at areas of deterioration.
- Cracking of plaster finishes was visible.

Collapsed ceiling in the second floor bathroom (ERA, 2023).

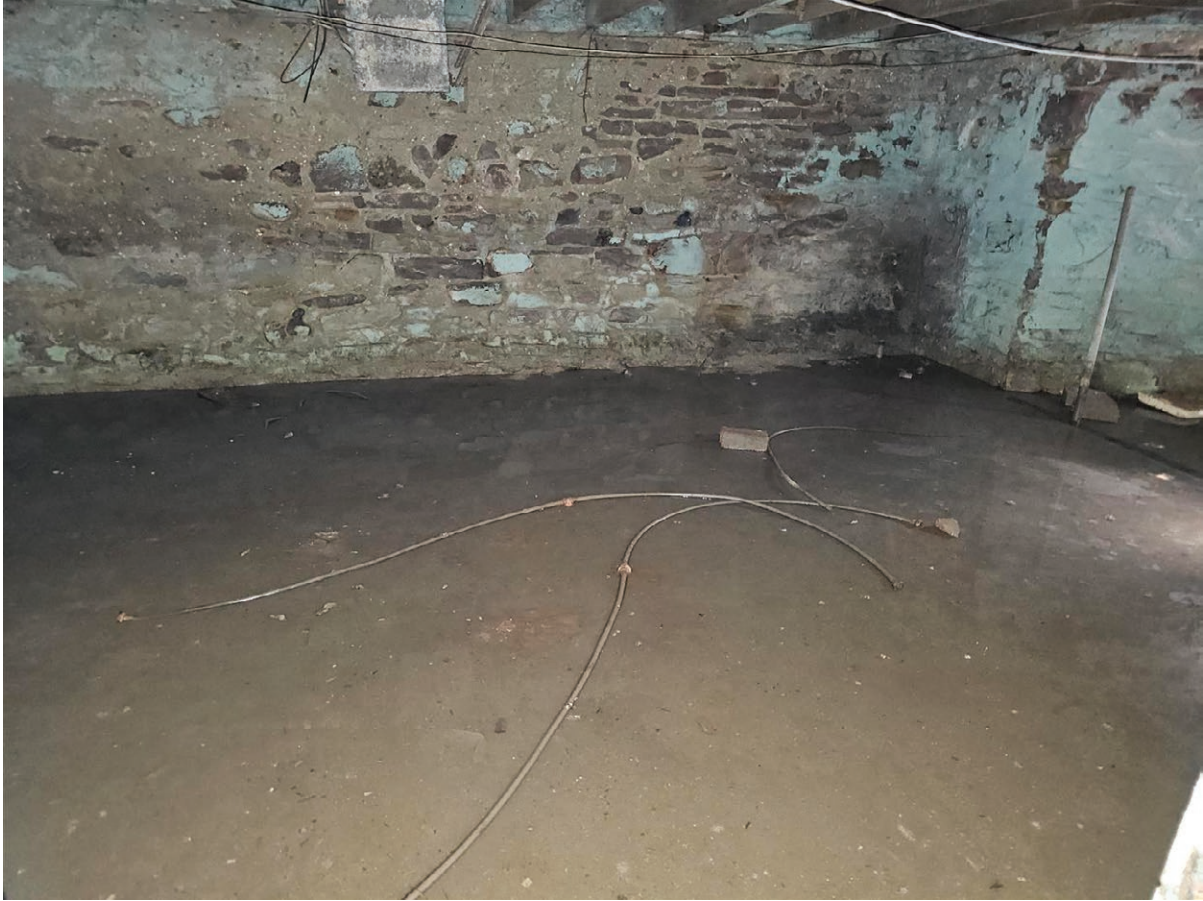
Flooding in basement (ERA, 2023).
