# **HISTORIC BOVAIRD HOUSE COMMUNITY MUSEUM**

## **FEASIBILITY REPORT**

CORPORATION OF THE CITY OF BRAMPTON / JUNE, 2023

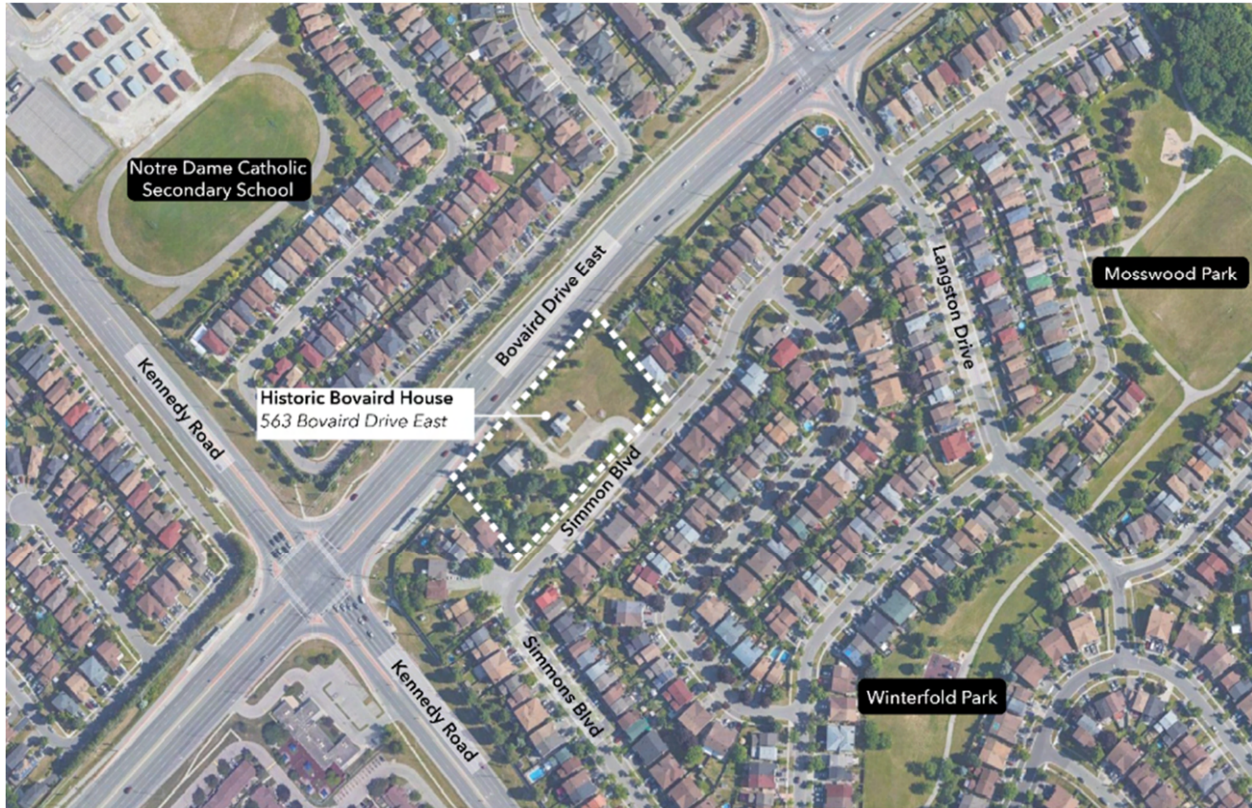
Figure 2: Site Context Plan

Historic Bovaird House is located at 563 Bovaird Drive East at the southeast corner of Kennedy Road and Bovaird Drive. The site is situated a 10-minute drive north of downtown Brampton and in close proximity to Highway 410. Situated in a predominantly residential neighbourhood, there are several nearby parks and public open spaces, including Etobicoke Creek.

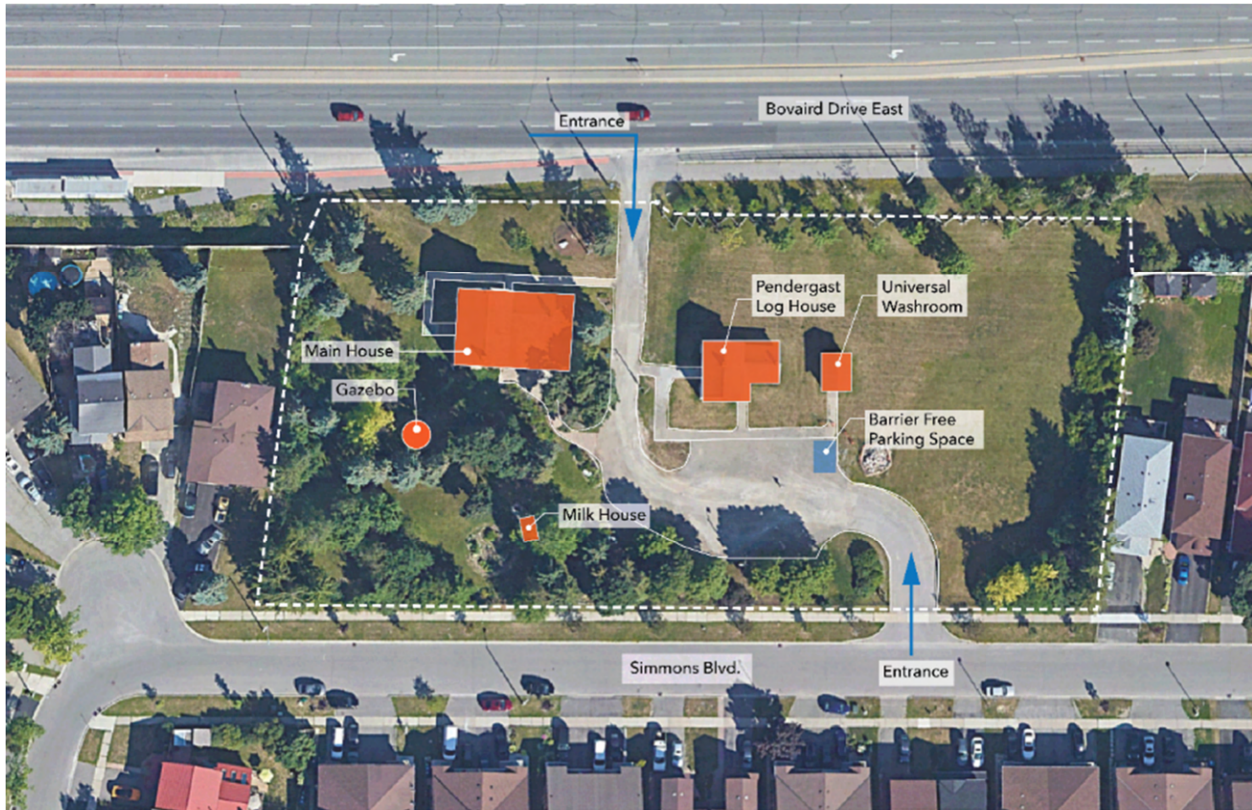
Figure 3: Site Layout Plan

Many years ago, the approach to the west facing main entrance of the house was via a driveway that ran west to the Town Line (now Kennedy Road). Today, visitors access the farmhouse by way of the 'side entrance' that is situated close to the parking lot. Vehicles can enter from the residential Simmon's Blvd. to the south or from the Eastbound Bovaird Drive East.

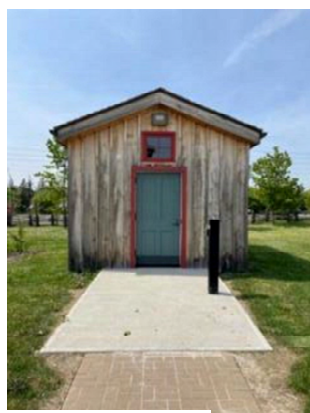
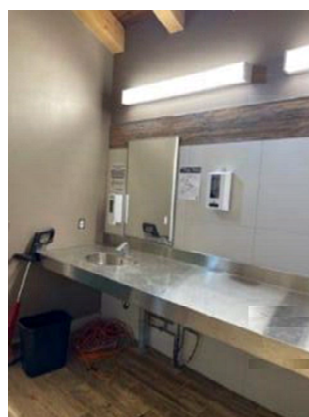
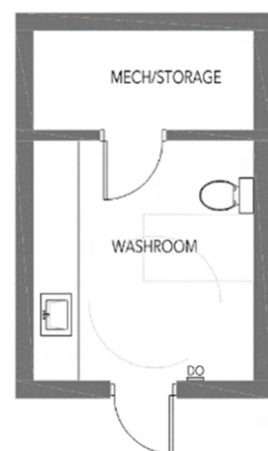
Figure 7: Universal Washroom

Located on the site, adjacent to the barrier free parking space is a recently added universal washroom. This was built at the same time as the Pendergast Log house. Constructed to be code compliant, it is also complete with its own mechanical and electrical systems including electric boiler, electrical panel and HVAC.

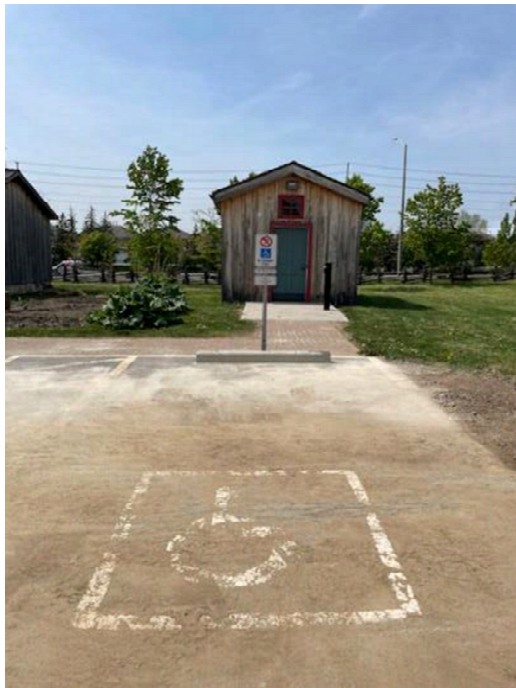
Figure 11: Barrier Free Parking Space

The City of Brampton Traffic By-law 93-93, Section 48 outlines requirements with respect to public parking areas and provides information regarding requirements for accessible parking spaces. For between 13-100 parking spaces provided, 4% must be barrier free. If between 13-25 parking spaces are provided, 1 Type A Van Accessible parking space is to be provided. The existing parking lot meets this requirement.

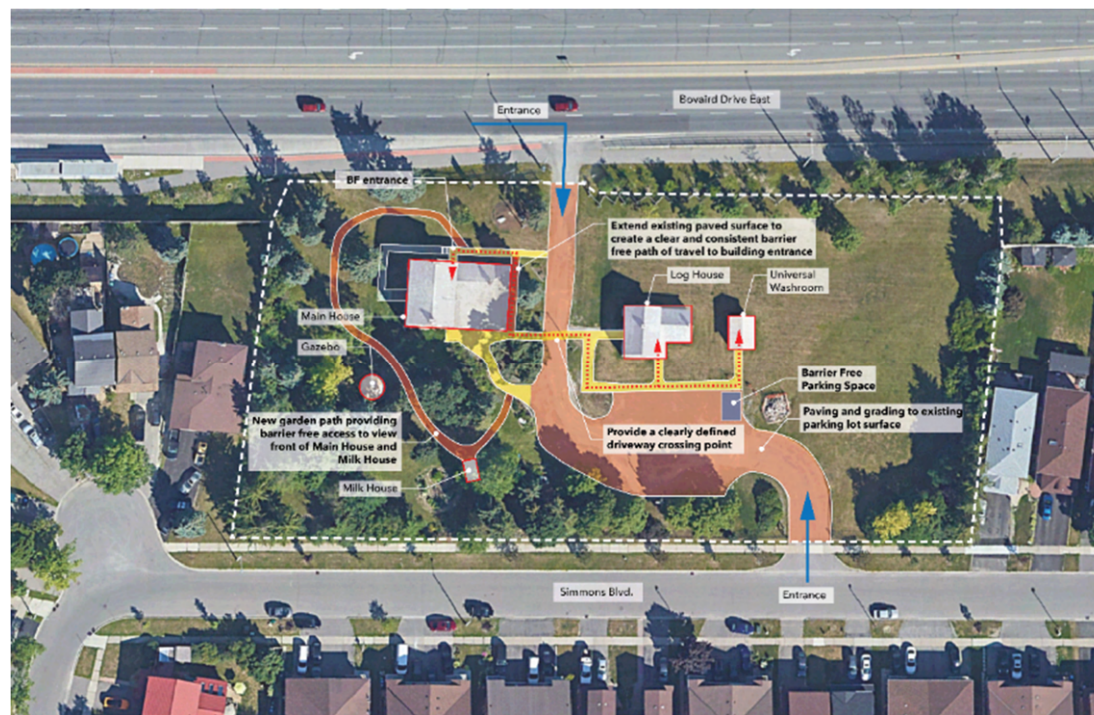
Figure 13: Proposed Site Accessibility

To comply with the accessibility requirements outlined in the Community, Human Resources, Exhibition and Physical Plant Standards as described in Section 2.2, it is recommended that the existing path is extended to provide a safe, accessible and continuous barrier free path of travel with a clearly identified driveway crossing point to the Main House. This extension to connect the existing barrier free paths of travel must comply with OBC 3.8.3.2(1)(h) which requires it to comprise a permanent, firm and slip-resistant surface with a minimum clear width of 1100mm and tactile attention indicators to identify where the vehicular driveway intersects the path. It is also recommended that the existing parking lot is graded and surface finished upgraded to level paving for ease of mobility around the site.

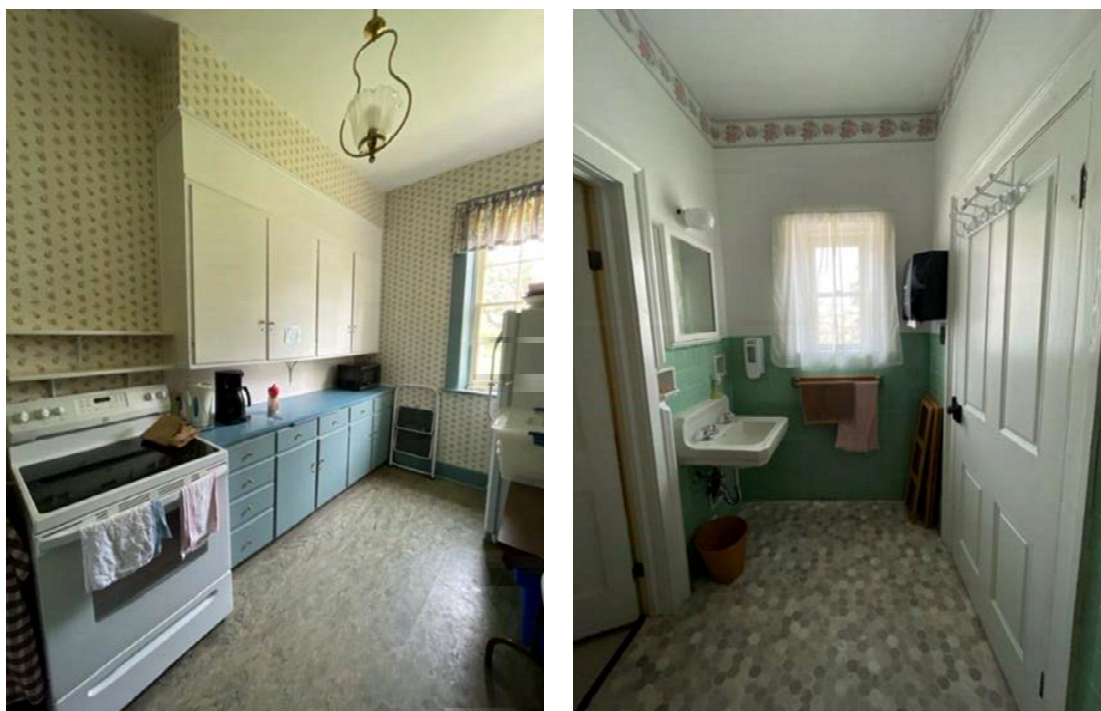
*Figure 25: Existing modern kitchen on ground floor and washroom on second floor where lift could potentially be located*

It is recommended that it is installed in a portion of the house where it will have the least impact on the existing heritage features and character of the building. A potentially suitable location is the modern kitchen on the ground floor, which has a modern washroom located directly above on the second floor.

The Brampton Accessibility Standards requires a minimum cab size of 1725mm by 1525 mm. However due to the sensitive existing building fabric and the restriction on providing a machine room or pit, a LULA (Limited Use/Limited Application) elevator is considered more appropriate in this instance. While the cab size is smaller than is required by the Brampton Accessibility Standards, it will provide barrier free access to the second floor for all visitors.

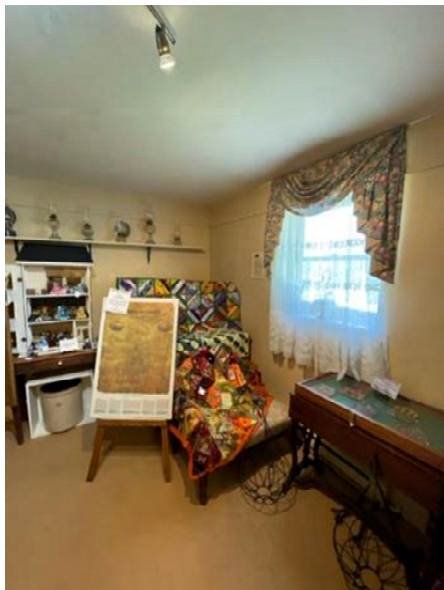
*Figure 28: North area of gift shop where Option 1 proposes an office space and Option 2 proposes a photo exhibit.*

To enhance the enjoyment of the museum for all visitors, a similar approach can be adopted at Bovaird House. A suitable, accessible area on the ground floor can be dedicated to an exhibit detailing the contents of the second-floor exhibits. This could occur in the north end of the gift shop as illustrated in figure 29.

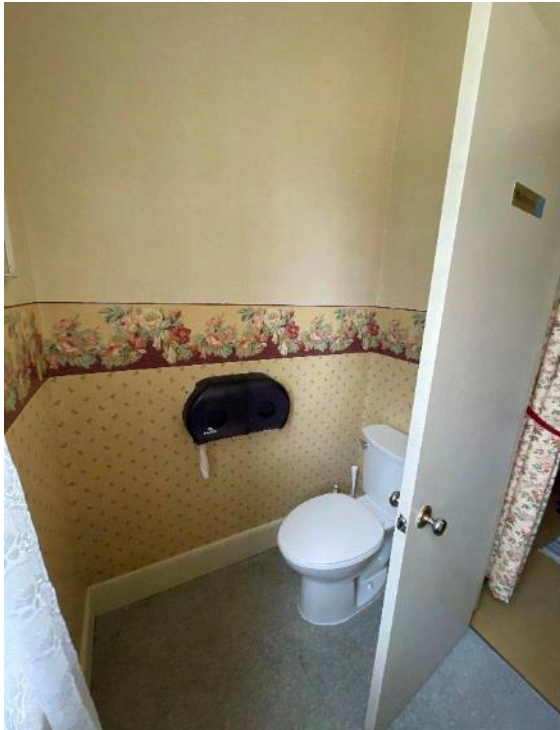
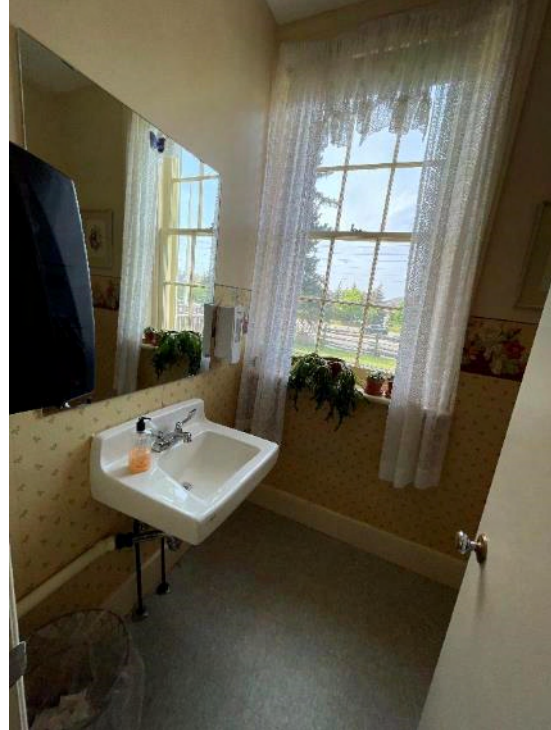
Figure 33: Main House - Existing Ground Floor Washroom

There are currently three washrooms on the property. There is one located on the ground floor of the Main House, one located on the second floor of the Main House, and a free-standing universal washroom adjacent to the carpark. Based on occupancy, a minimum of one water closet is required for males and two for females to comply with OBC 3.7.4.3. As there is an accessible universal washroom located at grade, the additional washroom in the main house is not required to be barrier free. It is recommended that some minor cosmetic changes are carried out, such as door hardware and washroom accessories, if it is to be used as a public facility.

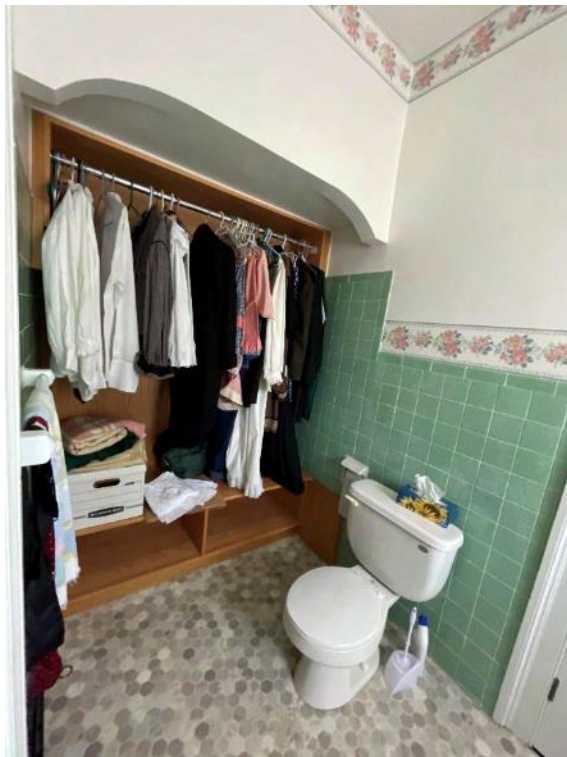
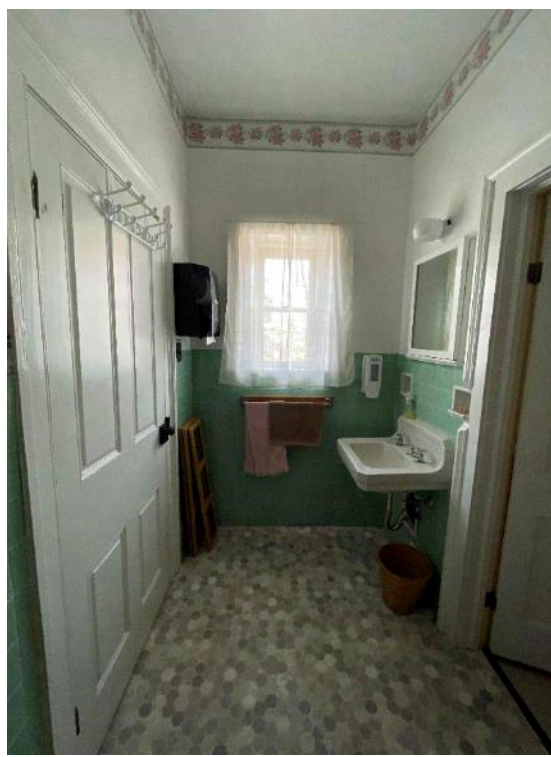
Figure 34: Main House - Existing Second Floor Washroom

If the washroom provided on the second floor is to remain, and is to be made available for visitor use, it will need to be upgraded as an ambulatory water closet compliant with OBC 3.8.3.8.(10). These requirements include provision for adequate clearance and grab bars in the washroom.

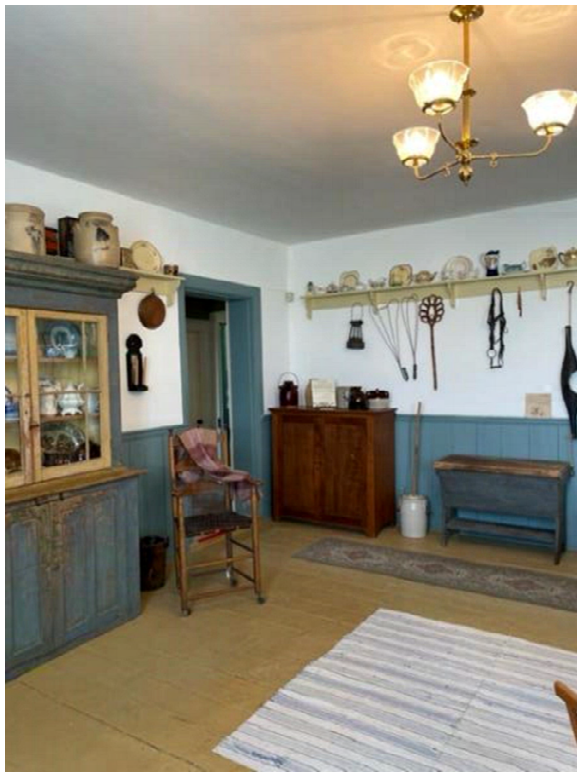
*Figure 40: Left: Main House Farm Kitchen - Education & Interpretation Space*

The Interpretation and Education Standard requires a community museum to provide sufficient space and a safe and secure environment for interpretation and education programs. There are two such existing spaces identified as being suitable for this purpose and currently used as such. In the Main House, the Farm Kitchen one of the largest spaces in the house and within the Pendergast Log House, there is a large kitchen/dining space on the east side. Both of these spaces are located on the ground floor and are accessible to all visitors. They also each contain artifacts and loose furniture which can be easily moved to accommodate larger gatherings of people in the space.

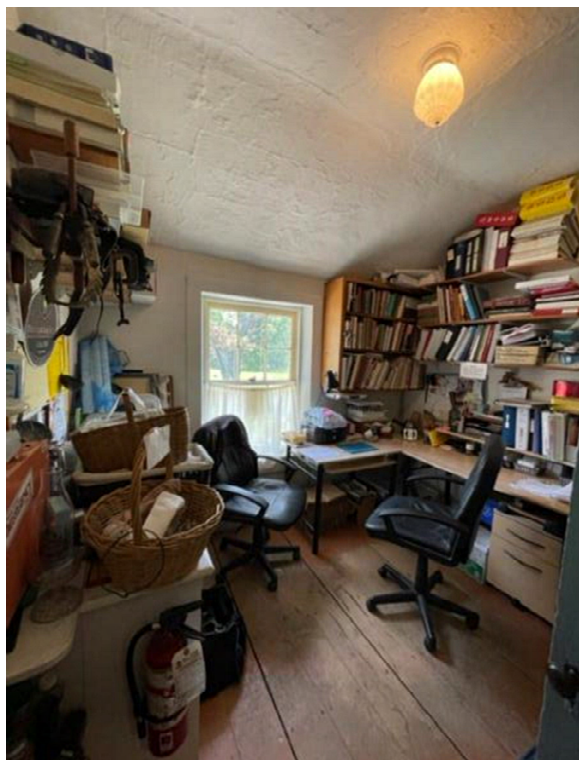
Figure 42: Left: Main House - Existing Office Space

The Research Standard requires that this space is clean, well lit, and separate from the rest of the museum. There is an existing small office space located on the south side of the Main House which is currently used by the volunteers who operate the museum. Due to the size and number of personnel who run the daily operations at Bovaird House, the size and location of the existing office appears appropriate. It has a window overlooking the garden which brings natural daylight into the room. For this space to be fully functional research facility, the provision of an adequate data and internet connection would need to be reviewed.

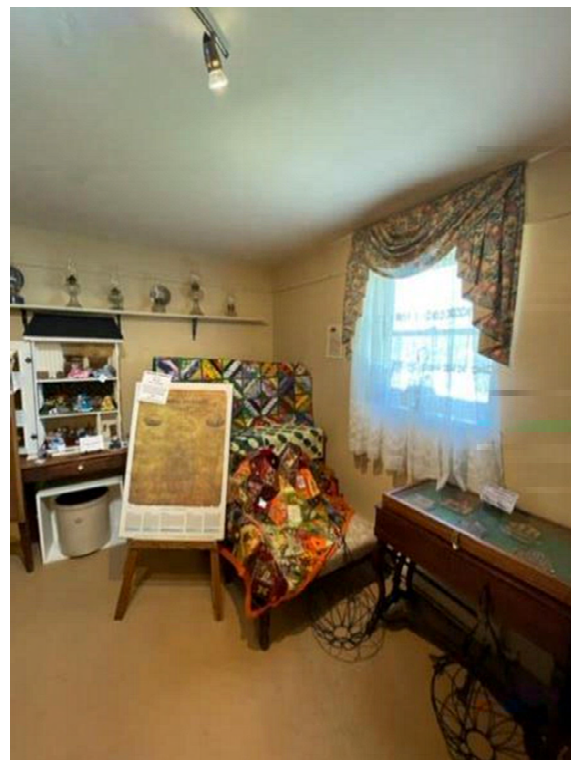
Figure 43: Right: Main House - Potential office/research space in north section of existing gift shop

If an elevator were to be installed as described in Option 1 within the accessibility recommendations outlined in Section 3.2, the accessible office space would need to be relocated to an alternate accessible location. The existing gift shop currently occupies the full length of the carriage house on the west side of the Main House. This is a proportionally large area of the overall floor plan and could be consolidated to occupy just the south portion of the carriage house, with the north portion being used as a research/office space. This would provide an office space similar in size to the existing one that is accessible and offers increased surveillance of the gift shop.

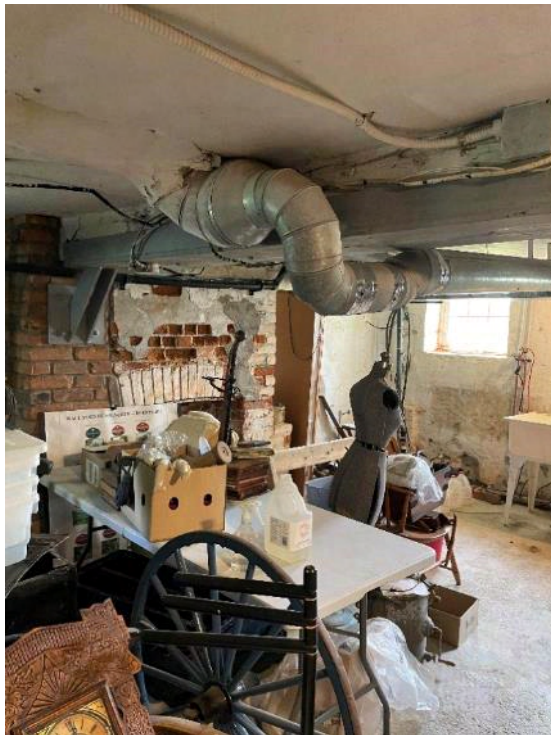
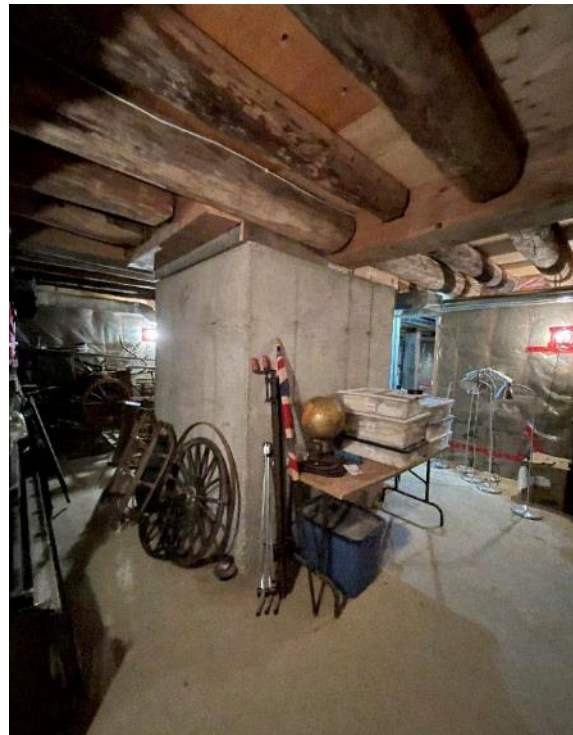
While the storage areas seem appropriately sized in relation to the size of the museum, they presently appear cluttered with a lack of organisation and record of the collections and artifacts stored there. Appropriate shelving, cabinets and supports should be installed to make more efficient use of the space and provide sufficient circulation to easily access items.

*Figure 44: Left: Main House - Existing Basement Storage*

*Figure 45: Right: Pendergast Log House - Existing Basement Storage*

As required by the Conservation Standard, access to the storage areas should be restricted to designated, appropriate staff only. While it is not feasible to add modern security measures such as card access readers, it is recommended that Bovaird House develops an artifact storage access policy to prevent unauthorized access to these areas, where keys are to be stored, and who has access to these keys.
