10020-10054 Mississauga Road &
2036 Bovaird Drive West

HERITAGE IMPACT ASSESSMENT

May 9, 2023

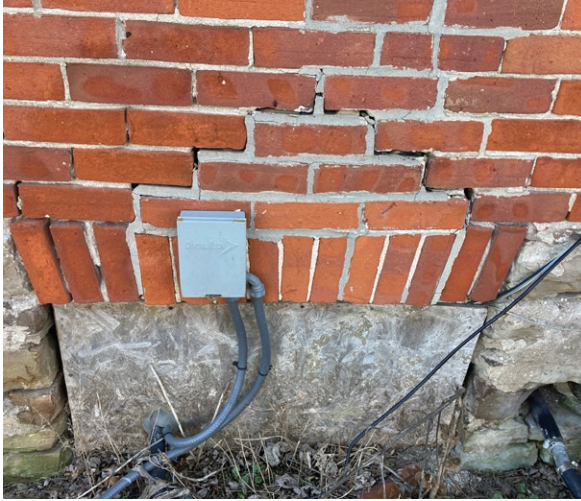
- Step cracking above a basement window lintel was observed. Area has been previously repaired, and has failed again. Recessing mortar and spalling masonry is also visible in adjacent areas.

Step crack above basement window (ERA, 2023).

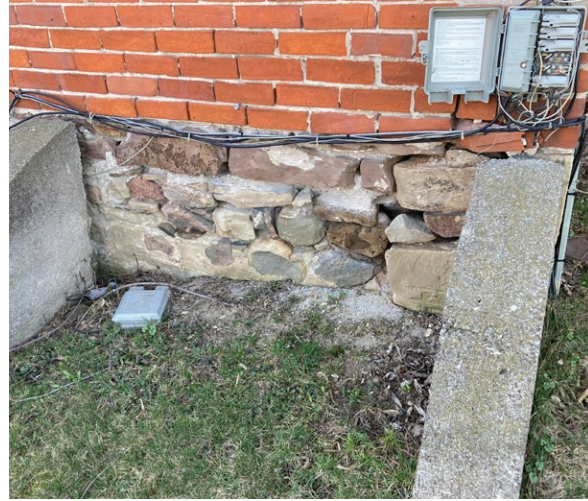
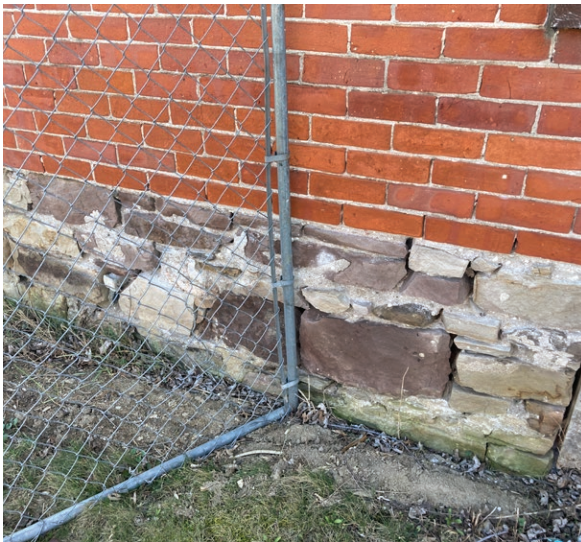
- Foundation stone appeared to have severe mortar loss at localized areas.
- Severe deterioration of pointing was observed at the foundation between two concrete half-walls. Localized brick deterioration and mortar recessing was also observed at this location.

Severe deterioration of foundation pointing (ERA, 2023).

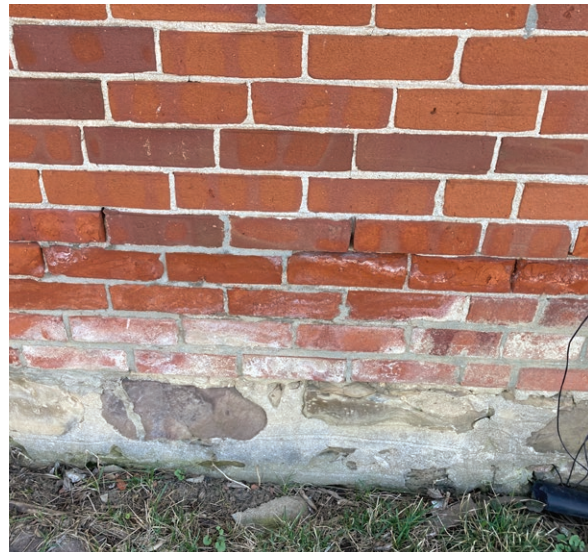
- Selective areas of spalling were observed.
- Efflorescence was observed at several locations.
- Recessed mortar joints were observed at localized areas in the brick.

Efflorescence and spalling (ERA, 2023).

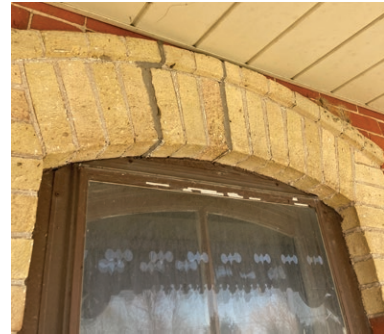
- Unsympathetic pointing was noted above the north porch window.
- Efflorescence was visible at the southeast corner of the masonry.
- Recessed mortar joints were noted above the porch landing. In some locations the mortar was completely deteriorated.

Unsympathetic pointing above the north porch window (ERA, 2023).

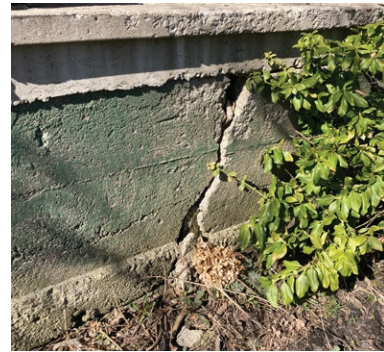
- Concrete on stone foundation at porch appears to be in poor condition with cracking in the parging. Selective areas of defective concrete were noticed.

Cracking on the porch's stone foundation (ERA, 2023).

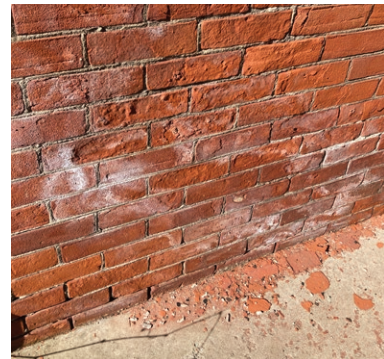
- Spalling of masonry in select locations was observed.
- Evidence of step cracking was visible below the north window sill. Cracking has been infilled with unsympathetic mortar.

Masonry spalling on the porch level (ERA, 2023).

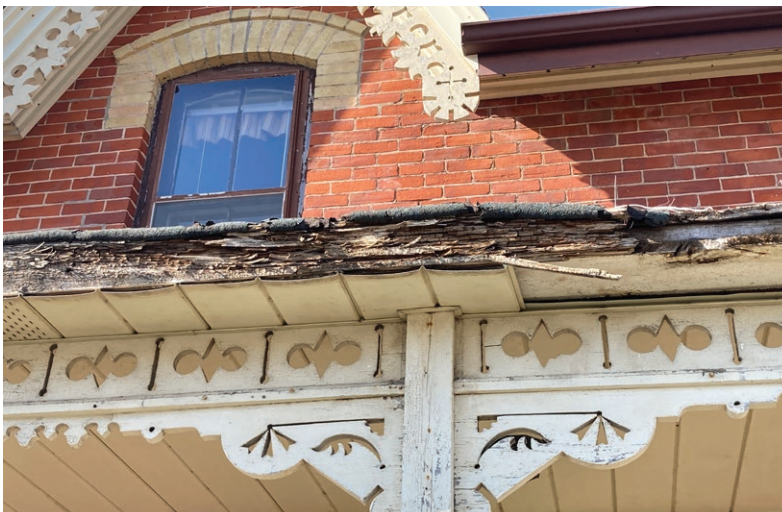
- The metal eavestrough and downspouts appear to be in fair condition.
- Fascia on porch has completely rotted and appears to be in defective condition.

Rotted porch fascia (ERA, 2023).

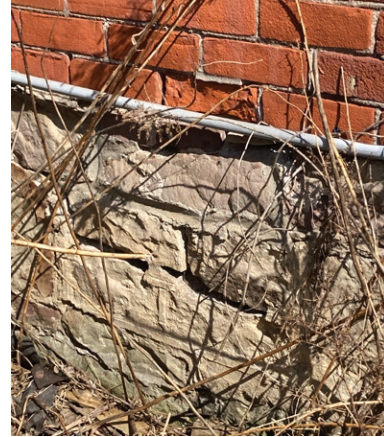
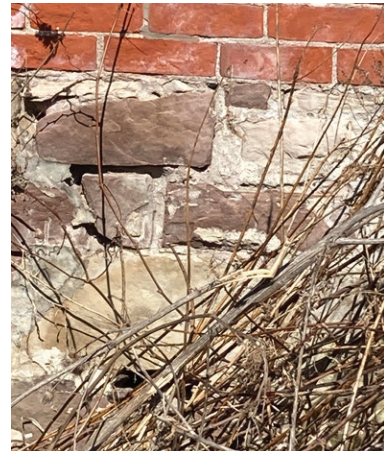
- Flashing on fascia of bay window is in poor condition and is only attached by one end.
- Recessed mortar joints are found throughout the façade, with localized areas of severe deterioration in the foundation stone.

Severe deterioration of the stone foundation (ERA, 2023).

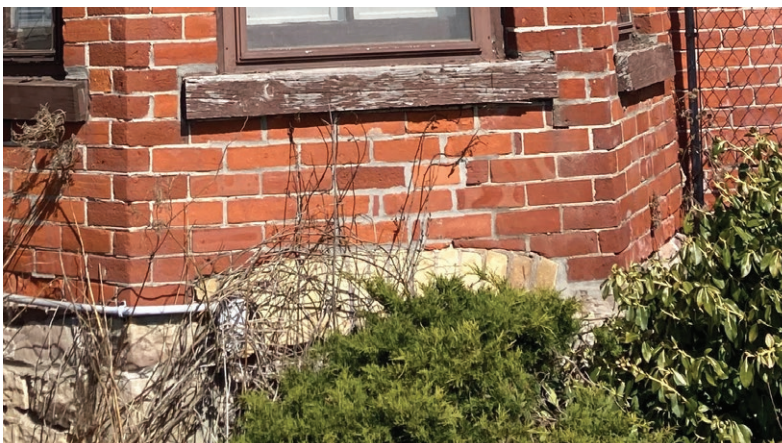
- Evidence of step cracking was visible below the bay window sill. Cracking has been infilled with unsympathetic mortar.
- Basement window appears to have severely deteriorated wood at frames.

Evidence of step cracking below the bay window sill, infilled with unsympathetic mortar (ERA, 2023).

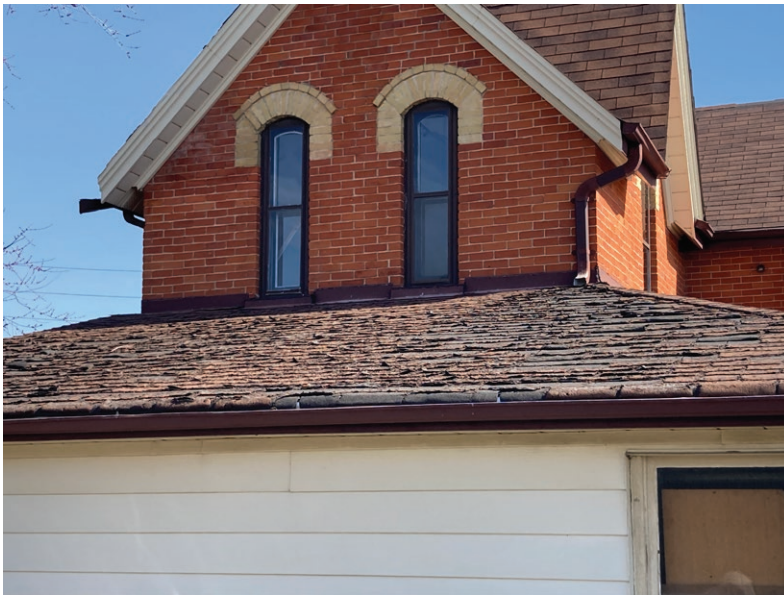
- Rear addition:
 - Stone veneer appears to be fair condition.
 - Roof appears to be in poor-to-defective condition with localized deterioration, missing and curled shingles.

Defective shingles on the rear addition (ERA, 2023).

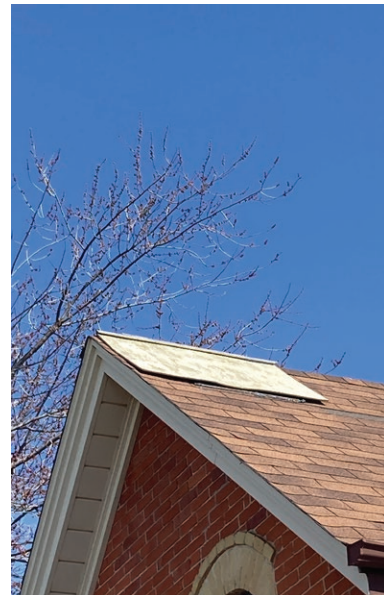
Former opening for chimney stack, with a temporary cover (ERA, 2023).

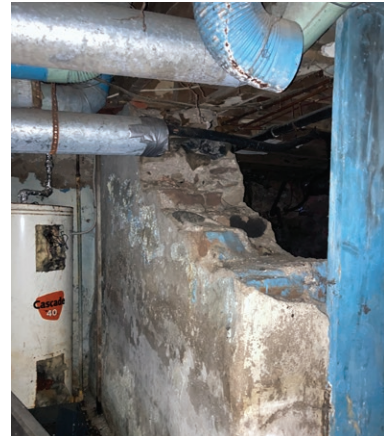
- Basement of original building appears to be rubble stone with parging.
- Pointing appears to be in fair condition with localized areas of poor and deteriorating mortar.
- Concrete floor appears to be in defective condition with water related deterioration. At some locations, it appeared that the bearing soil has been washed away.
- Flooding was observed in a large area of the basement.
- Efflorescence was visible on the rubble walls.
- Floor joists appear to be in fair condition.
- It was observed that part of the rubble foundation wall was removed to allow building services to pass through.
- Mold and water damage was visible on interior sheathing.

Damaged rubble foundation wall (ERA, 2023).

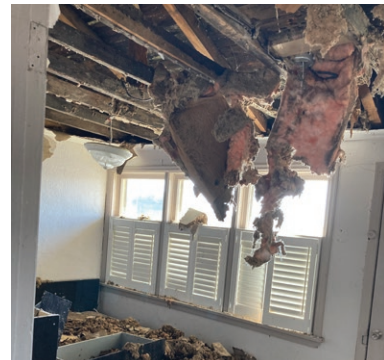
- Interior has localized areas of water damage. At these locations partial visibility of deterioration, beyond the sheathing material was visible.
- Water related deterioration was present at the ceiling of the south bay window.
- At the south addition, the ceiling has collapsed, exposing rafters.

Collapsed ceiling in first floor south addition (ERA, 2023).

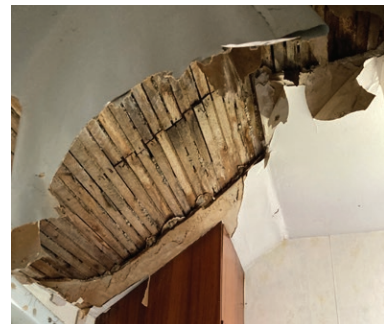
- Moisture damage was visible at several locations on the ceilings. Collapse of the ceiling was visible at 2 locations.
- Peeling paint was visible on the ceilings and walls.
- Mold was visible at areas of deterioration.
- Cracking of plaster finishes was visible.

Collapsed ceiling in the second floor bathroom (ERA, 2023).

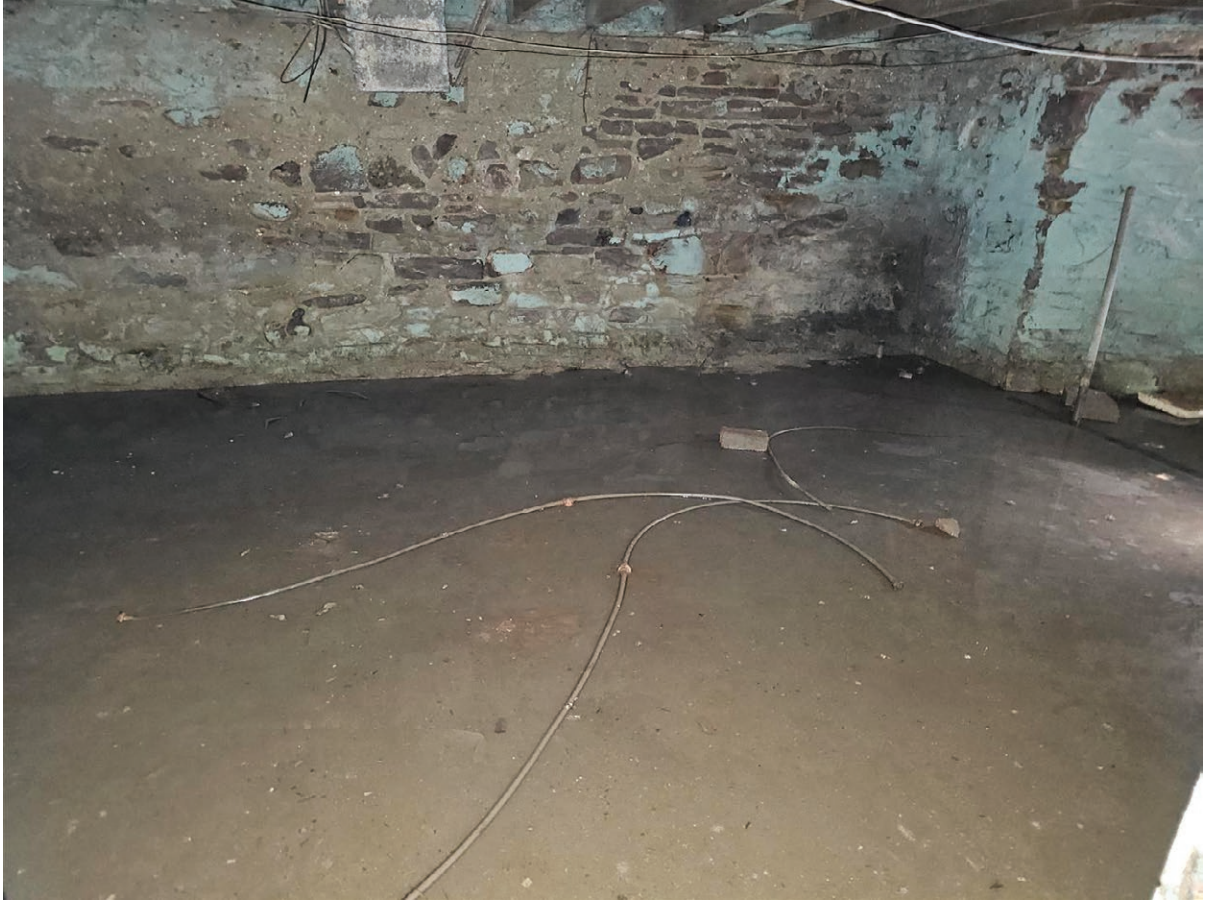
Flooding in basement (ERA, 2023).

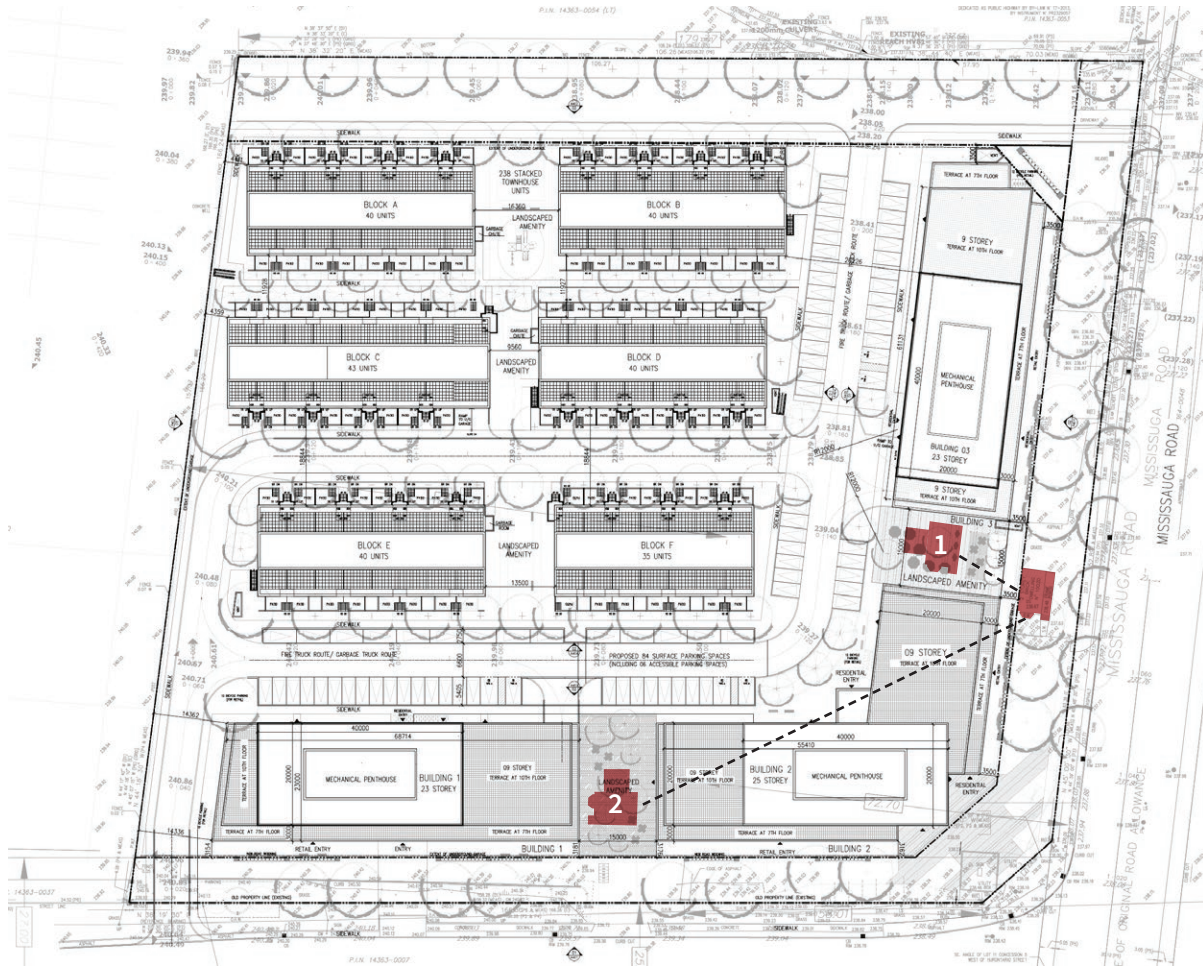
Site Plan showing the possible locations for relocation on Site (Architecture Unfolded, 2022; annotated by ERA).
