**TO:** Opal Valley Developments, c/o Tony Priori  
**FROM:** Chelsey Collins (Tyers), Cultural Heritage Specialist, WSP Canada Inc.  
Heidy Schopf, Cultural Heritage Lead, WSP Canada Inc.  
**SUBJECT:** 11185 Airport Road Heritage Impact Assessment Addendum  
**DATE:** August 8, 2024

# 11185 Airport Road Structural Condition Assessment

11185 Airport Road  
Brampton Ontario

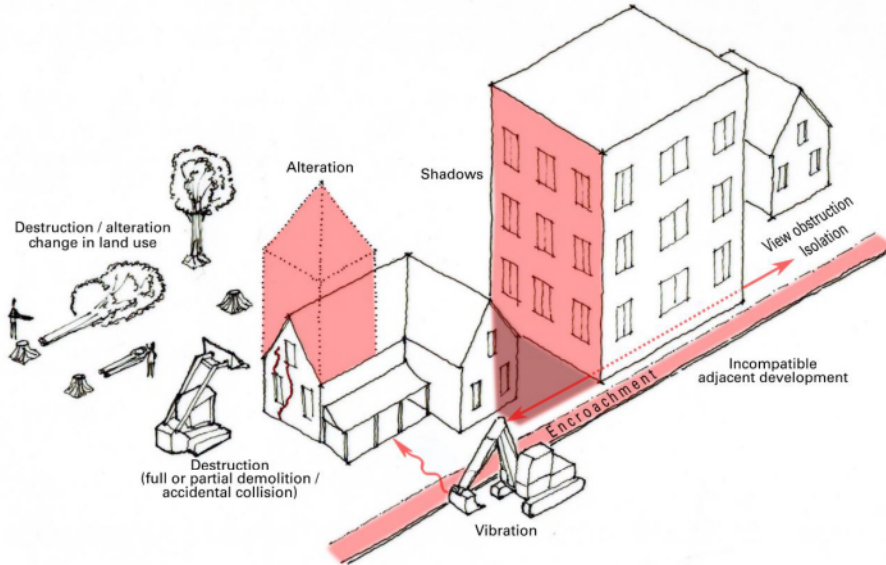
**Figure 1: Examples of negative impacts.**

Other potential impacts may also be considered such as encroachment or construction vibration (Figure 1). Historic structures, particularly those built in masonry, are susceptible to damage from vibration caused by pavement breakers, plate compactors, utility excavations, and increased heavy vehicle travel in the immediate vicinity. Like any structure, they are also threatened by collisions with heavy machinery, subsidence from utility line failures, or excessive dust (Randl 2001:3-6).

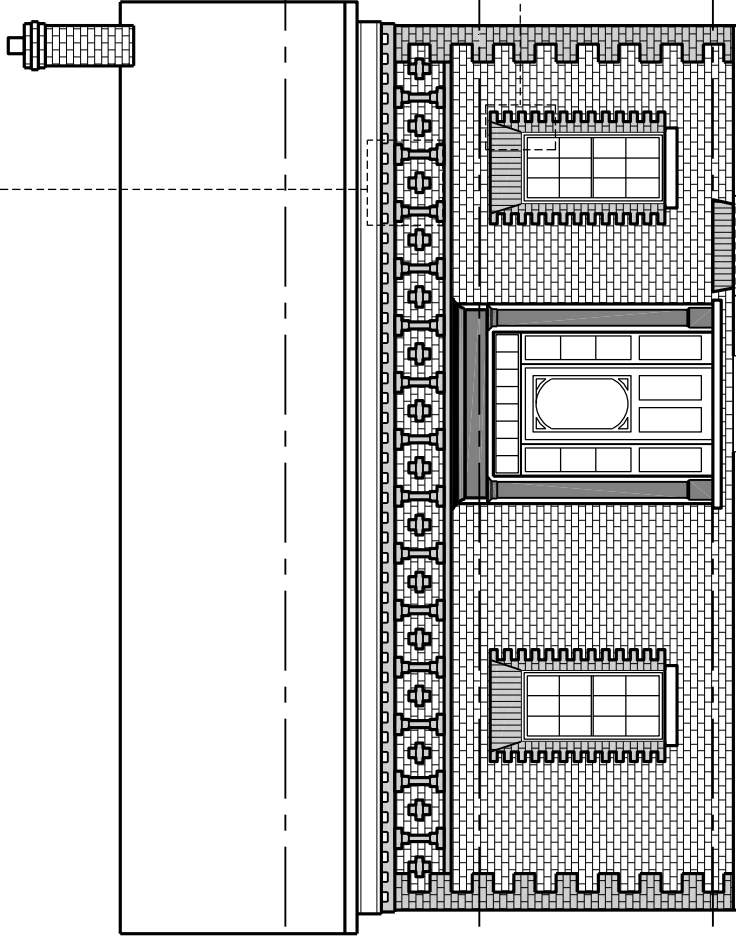
**EXISTING WEST ELEVATION**

NOTE: SHADED BRICKS SHOWN ARE THE BUFF COLOURED BRICKS. THE REST ARE THE RED BRICKS
