**Documentation and Salvage Report –
59 Elizabeth Street North and
Railroad Street Cultural Heritage
Landscape**

Final Report

April 23, 2025

Project Number:
160941102

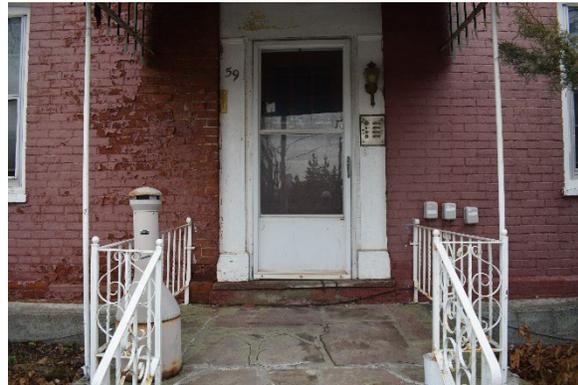
The east façade faces the intersection of Railroad Street and Elizabeth Street North. It has three metal sash windows with wood frames and sills on the second storey (Plate 1). It has a central front entrance with a metal awning, and a stone entrance porch. There is a replacement door situated in a wood frame, with wood surrounds and painted plywood covering the transom. A buzzer system is located to the side of the door (Plate 2). Two sash windows flank the entrance at either side, both metal in wood frames with wood sills. The two first storey windows have brick hood moulds. The bricks on the exterior façade are painted with localized areas of peeling.

Plate 2 Entrance to 59 Elizabeth Street North with stone porch

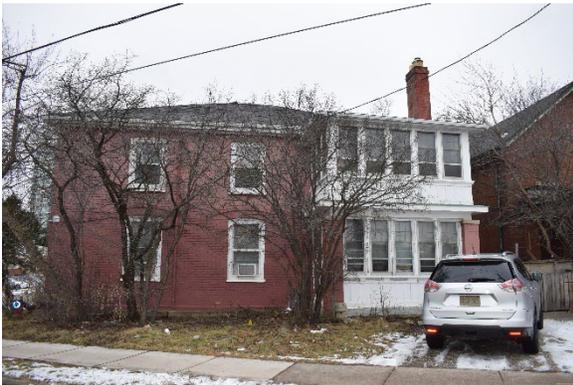
The north façade has an enclosed two storey wooden porch (Plate 3). The soffits at the roofline are vinyl. The second storey of the porch has five windows on its front (north) façade, and three windows on each side façade. The windows have metal storm windows covering wood six over one sash windows. There is a projecting eave between the second and first stories of the porch, with wood soffits. There are two brick piers on the front façade, both topped with stone caps. The first storey of the porch also has metal storm windows covering six over one wood sash windows. It also has five windows on the front façade, and three on the sides. To the east of the porch are four windows, two on the second storey and two on the first. They are all metal, with wood frames and sills. There are brick hood moulds above the first storey windows.

Plate 3 North façade of 59 Elizabeth Street North

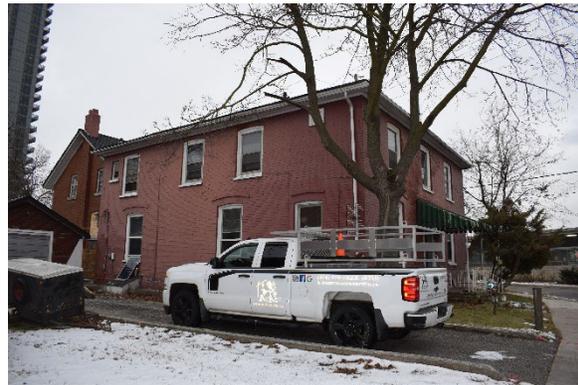
metal sash windows with wood frames and sills and one small window towards the west side of the façade (Plate 4). There are former coal shoots at the ground level that are covered with either plywood sheets or plexiglass covers (Plate 5).

Plate 4 South façade of 59 Elizabeth Street North

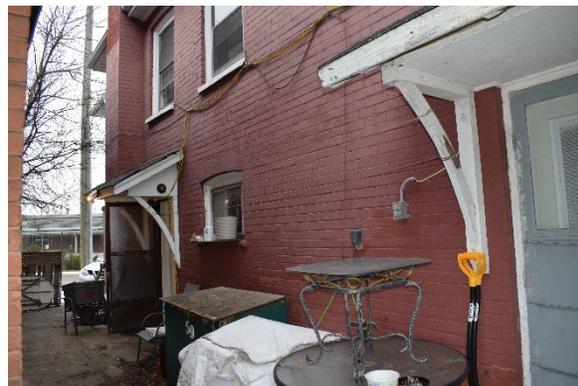
The west façade is the rear of the structure. On the first storey are two doorways, both with small wooden entrance porches (Plate 6). The doors are replacements. There is a small window beside the north entrance, with a metal window in a wood frame. There are two metal sash windows on the second storey, to the north side of the façade, both in wood frames with wood sills. The brick chimney runs from the ground to above the roofline on the north side of the façade (Plate 7). The brickwork in the south corner of the façade is spalling (Plate 8).

Plate 6 West façade showing wood entrance porch overhangs and windows

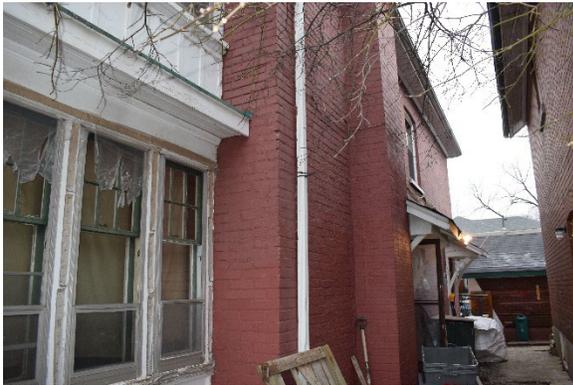
Plate 7 West façade showing brick chimney

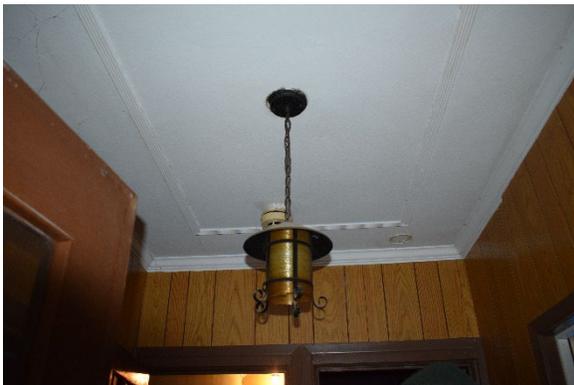
The interior of 59 Elizabeth Street North consists of two residential apartments on the second storey, two residential apartments on the first storey, and an unfinished basement. The second unit on the second storey could not be accessed. The first storey contains an entrance hall, accessed from the main door on the east façade. The entrance hall has been renovated with composite wall panels that resemble wood. The ceiling appears to be the original plaster, complete with decorative moulding and mid-20th century light fixture (Plate 9).

Plate 9 Entrance hall interior, showing decorative plaster moulding and light fixture

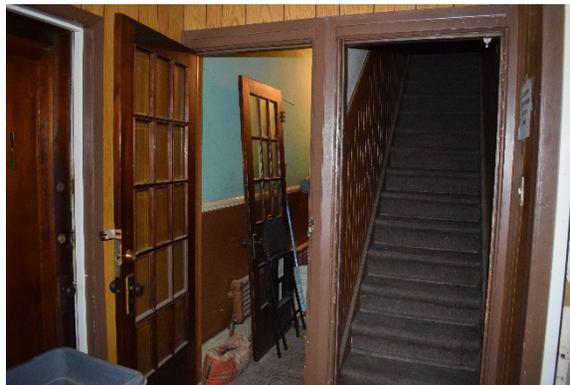
There are doors on the north and south sides of the hall that lead to the residential units on the first floor. There are two entryways facing the main entrance on the west side of the entrance hall (Plate 10). The west entryway leads to a steep narrow staircase that accesses the second storey. The left doorway has a multi-paned wood and glass door which leads to the narrow, short basement hallway that provides access to the basement through another door at the end of the hallway (Plate 11). The hallway has wood baseboards and crown moulding, as well as plaster walls and a chair rail moulding. All doors and door trim are modern replacements. The flooring is hardwood, and the hallway also contains a cast iron radiator.

Plate 10 Double doorway in the entrance hall, the left leads to the basement access hallway, the right to the second storey

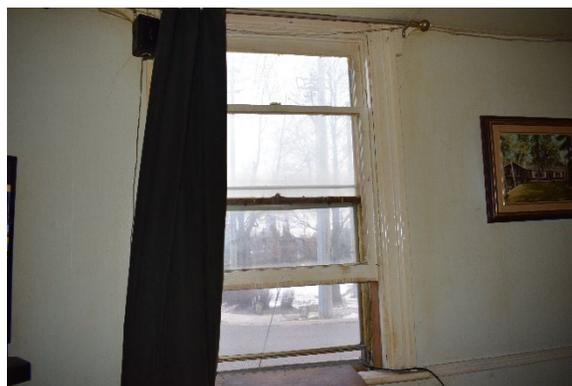
replacement door, with wood door trim. On the south wall is a window with wood trim, and a one over one wood sash window (Plate 15).

Plate 15 Apartment Two interior, showing historic window

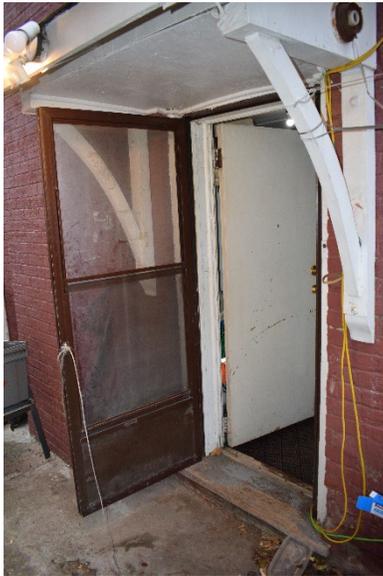
Across the entrance hall from Apartment One is Apartment Two. Apartment Two has plaster walls, wood sash windows with wood trim, and an exterior access door similar to apartment one (Plate 16). The bathroom had a tile floor, with a cast iron radiator, claw foot bathtub, and single pane frosted glass window with wood trim (Plate 17). The first storey of the double height enclosed porch is accessed through this unit, although it was not possible to see into it during fieldwork due to occupancy.

Plate 16 Apartment Two exterior access door

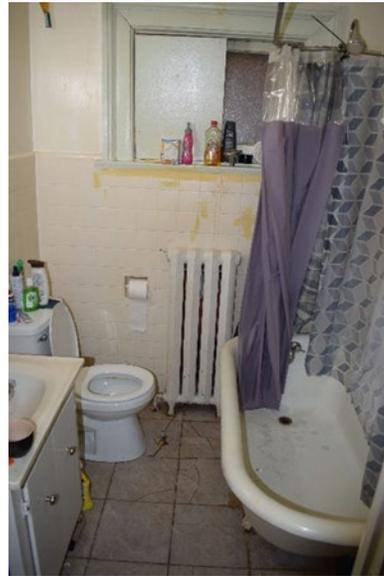
Plate 17 Apartment Two bathroom with clawfoot bathtub and cast iron radiator

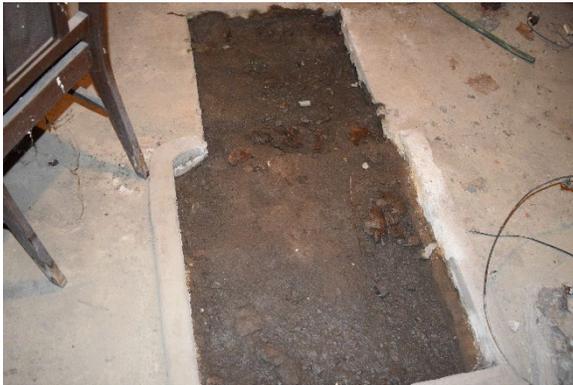
The basement is accessed through a doorway and down a short flight of wood steps (Plate 18). The basement is divided into several rooms. The brick and stone foundations of the building are visible throughout, as are the timber floor joints of the first storey (Plate 19 to Plate 20). Pipes and wiring run throughout the basement and some pipes are wrapped in newspapers, some which were observed to date to 1955. In the main basement room, timber support beams are visible and wood shelves have been built into the walls. A section of the wall houses modern electrical panels and fuse boxes. The foundations, floor joists, underside of the first storey flooring, and shelves have been whitewashed. In the south side room are the original coal chutes for the building, that have now been closed off. This room now holds the water heaters for the building and has a laminate floor with a drop ceiling (Plate 21). A stud and drywall wall separates this room from the one next to it, which also has old coal shoots on its south wall. In this room are two sinks: one is a large metal double sink, likely dating to the late 19th or early 20th century, and the other is a 20th century porcelain sink (Plate 22). The sink room has a poured concrete floor and a drop ceiling. The west room in the basement contains the modern furnace, as well as older, mid-20th century furnaces (Plate 23). The building foundation in this room has been parged with concrete, although sections of the foundation are still visible. The floor is poured concrete, with an empty spot where a previous heating source may have been located (Plate 24).

Plate 24 Basement interior, showing spot where previous heat source may have stood

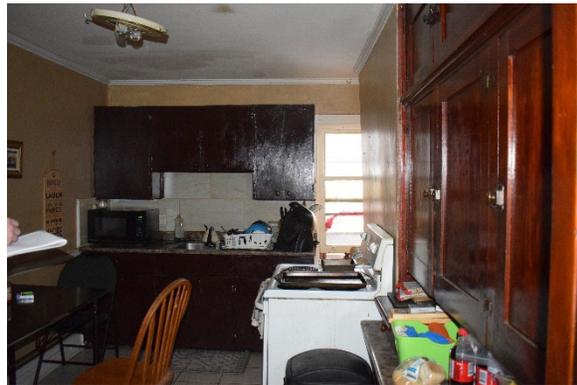
The kitchen has a tile floor, with plaster walls and a plaster ceiling with crown moulding (Plate 28). There is a one over one wood sash window on the south wall, with wood trim, and a cast iron radiator located next to it. A plaster wall, with the same crown moulding as the rest of the room, cuts abruptly into the window. It is unclear if this was the original interior layout of the room, or if the wall was added at a later date. This wall separates the kitchen from the hallway that connects to the bathroom, and also has the same built in cabinet.

Plate 28 Apartment Three interior, showing kitchen with crown moulding

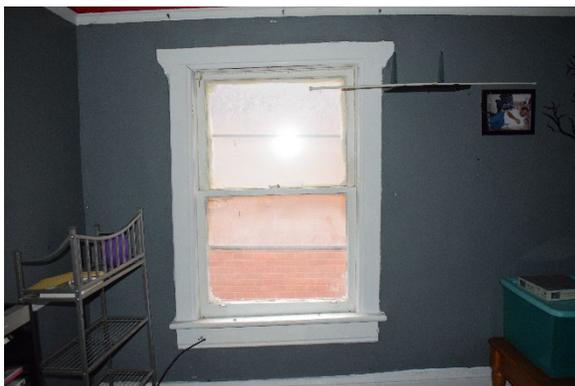
The living room has a hardwood floor with three plaster walls and a plaster ceiling. The north wall is stuccoed but has the same trim as the rest of the room. The west wall has a one over one wood sash window with wood trim (Plate 29). The baseboards, chair rails, and picture rails around the room are likely original. A doorway on the east wall leads to the bedroom (Plate 30). The door is a replacement, but the door trim is likely original. The north wall has a wood and glass pane door that provides access to the second storey of the enclosed porch (Plate 31). The porch is constructed of wood, including a wooden ceiling, all of which is likely original (Plate 32).

Plate 29 Apartment Three living area with wood window and trim
