23 Centre St. S, Brampton, Ontario

Kilpatrick-Young House

Issued: August 2019

HERITAGE IMPACT ASSESSMENT

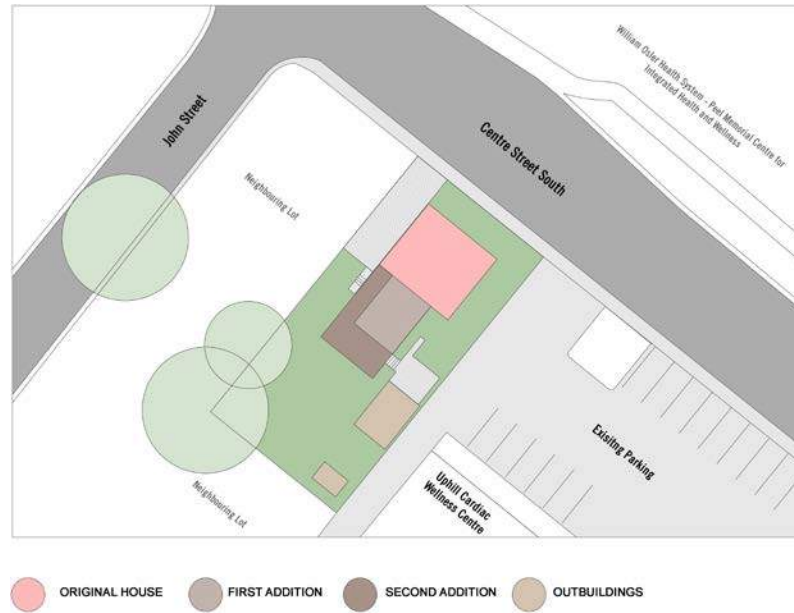
Figure 35 – Additions & Alterations to the original house, AREA

The rear extension was constructed as a series of additions. The building portions on the property are illustrated in a site plan diagram (Figure 35), which indicates the sequence of the house's construction. The stucco façade represents the "First Addition" in this diagram but, in comparing it to the 1924 map (Figure 42), it appears to have been made up of two portions. So, this First

footprint at the front and subsequently a series of additions at the rear (Figure 35). The construction sequence would suggest that the kitchen could have been relocated from being contained in the front portion, as shown in the St. Marys example (Figure 34), to the First Addition whenever it was built, which could have been as little as a few years or as much as a few decades after the Original House component.

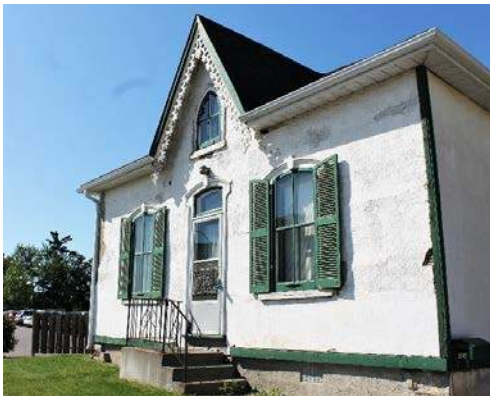
- a metal screen door which obscures the original paneled main door (Figure 36);
- a concrete front porch with metal railings (Figures 33 & 36);
- enclosed porches installed on both the north elevation and the rear that are clad with metal siding (Figures 37, 38, 39, 40 & 41);
- metal flashing that covers the fascia and soffits (Figure 33, 36, 38, 39); and
- a concrete block chimney on the rear south side of the main house (Figure 41).

Figure 36 - Street Facing East Elevation showing eaves with metal

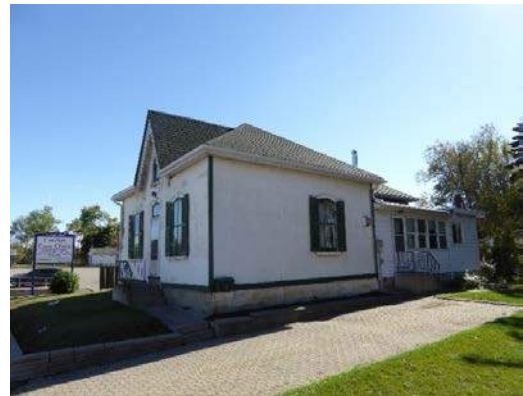
Figure 37 - North & East Facades

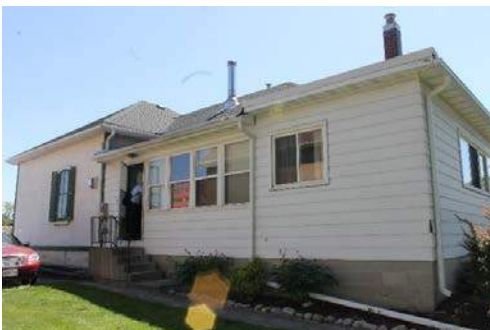
The rear one-storey "ell" extension is presumed to have been constructed after the original house due to the difference in material and construction style. The exact construction date of the ell is unknown however the earliest fire insurance plan found in the Peel Archives dates to 1924 in which the addition can be seen (Figure 42). The "summer kitchen" portion appears to be a later (than 1870) addition probably from the late nineteenth century or early twentieth century, but is older than the accreted extensions wrapping around it, which are post-WWII, and primarily from the 1970's. Metal siding is used for the exterior wall cladding on the remainder of the exterior walls of the rear addition which is post-war in construction (Figures 38, 40 & 41).

Figure 38 - "EII" Addition as seen on North Elevation clad in metal siding

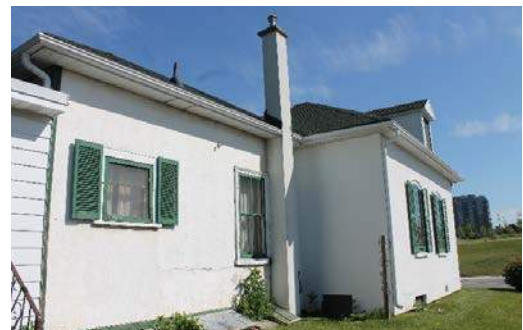
The south wall of this ell is clad in stucco for about two-thirds of its length (Figure 39). This stucco portion of the ell comprises approximately 25% of the perimeter wall of the addition which is the only remaining exterior portion of the earlier portion of the rear wing. This portion of the addition appears to be the first to be constructed on the original front house component.

Figure 39 - South Elevation showing the later "EII" addition

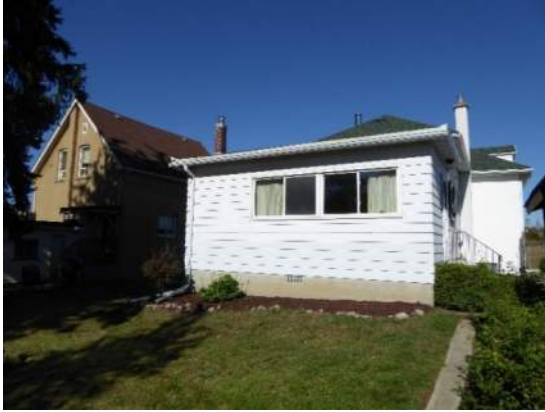
Figure 40 - West Elevation showing enclosed porch clad in metal siding

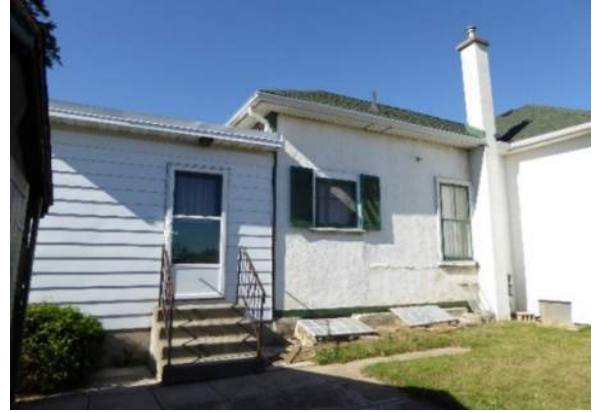
Figure 41 - South Elevation showing "Ell" Addition with metal siding & concrete block chimney

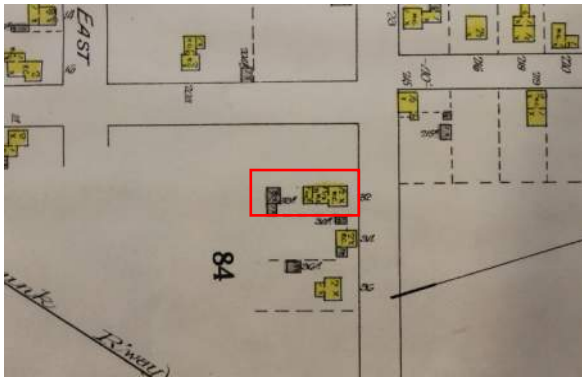
Figure 42 - Fire Insurance Plan, 1924 (Lot line annotated by AREA to show the subject property)

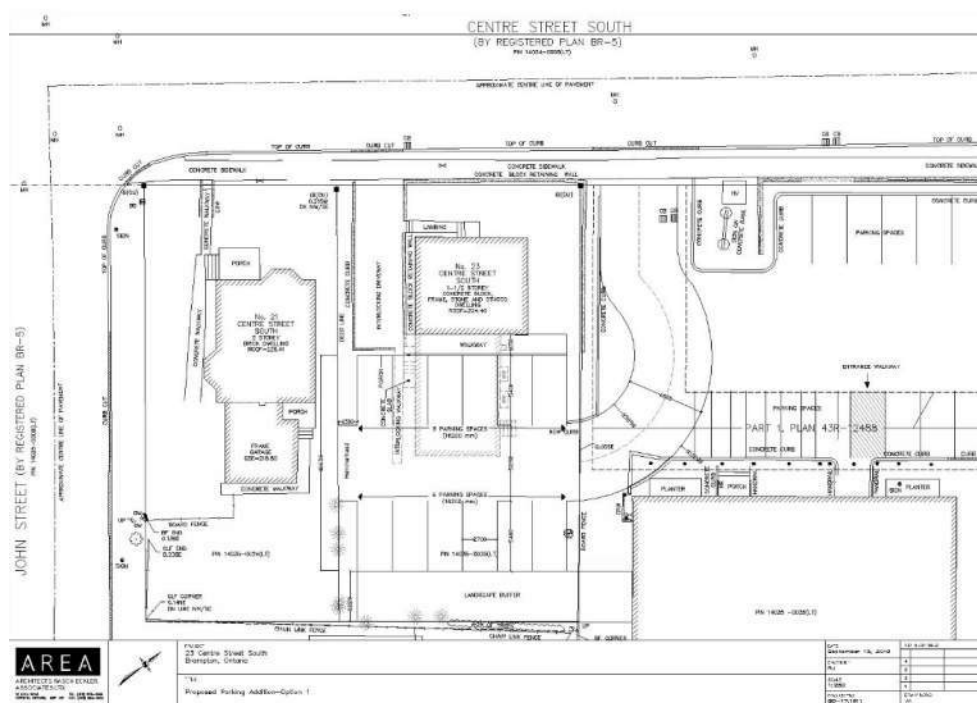
Figure 47 - Option 1: Site Plan Drawing with proposed demolition of rear wing and additional parking

To allow for additional parking space, it is proposed that the rear one-storey section of the house be demolished. By demolishing the rear-west section, it would allow for an additional 12 parking spaces that can be used by patients and employees of the Cardio-Pulmonary Services facility. A site plan drawing (Figure 47) has been prepared showing the proposed demolition of the rear wing and the additional parking spaces that replace it.

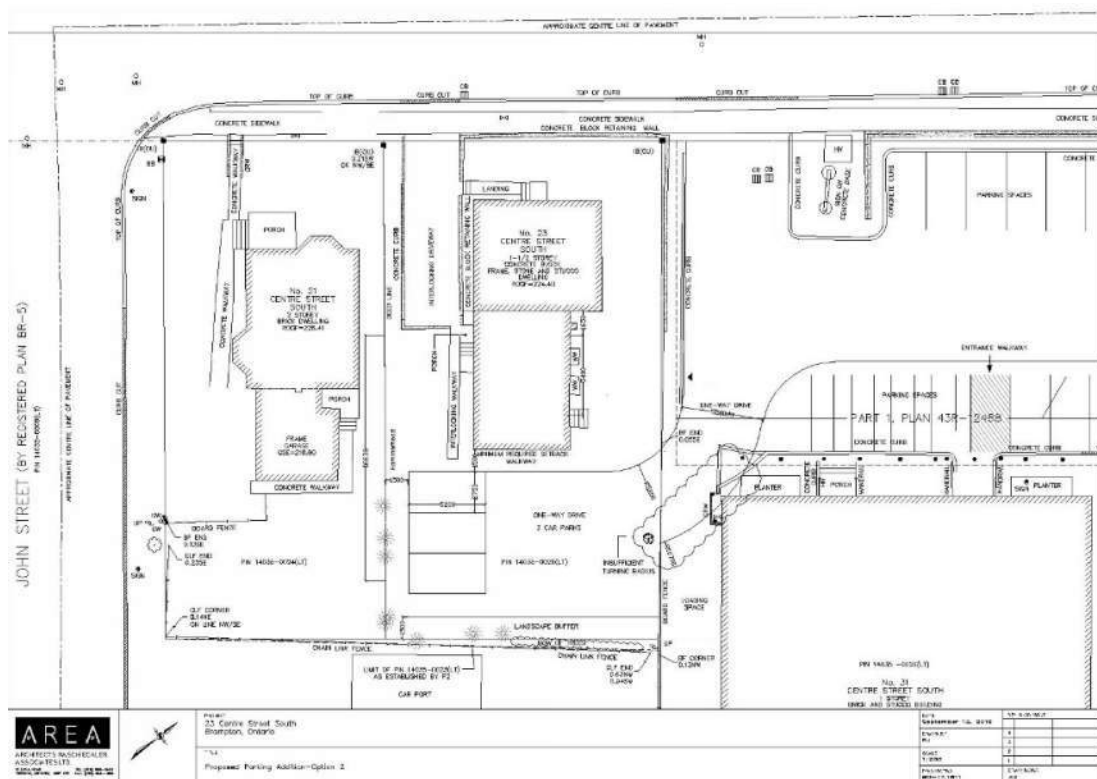
Figure 48 - Option 2: Site Plan Drawing showing proposed additional parking direct-access retaining the rear wing
3 car parking

This alternative development option proposes the development of a parking lot at the rear (west) end of the lot (Figure 48), while retaining the rear wing of the CHR. Conforming to the development guidelines for parking lots of commercial spaces, this arrangement allows for only 3 car parking spaces, which don't provide sufficient parking for the Brampton Cardio Pulmonary Services.

A variation of this option would entail the retention the stucco-clad section of the rear addition which was reviewed (but not illustrated here). In the case of partial demolition of the rear addition, the number of parking spaces potentially increases from three to four that still does not fulfil the medical facility's parking needs.

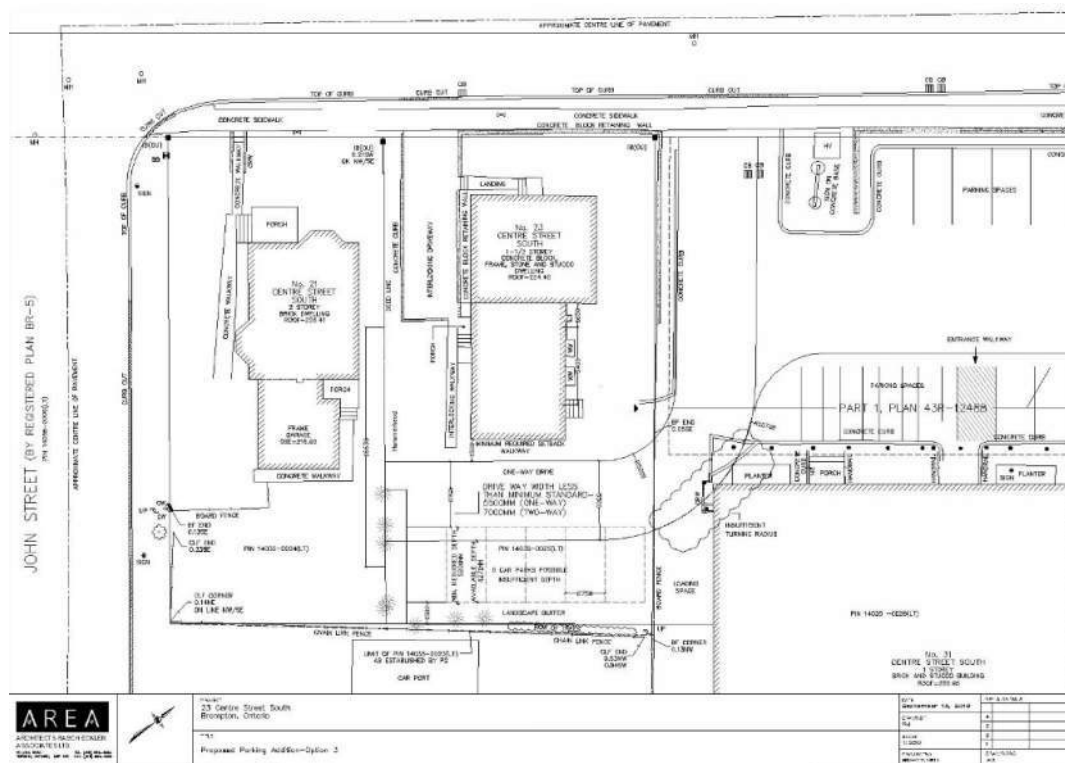
Figure 49 - Option 3: Site Plan Drawing showing proposed additional parking side-access retaining the rear wing

This development alternative proposes single row perpendicular parking at the rear (west) end of the lot (Figure 49) while retaining the rear wing of the CHR. This design uses a one-way drive aisle but does not meet the minimum parking design standards due to both insufficient depth and vehicle turning radius and hence cannot be implemented.

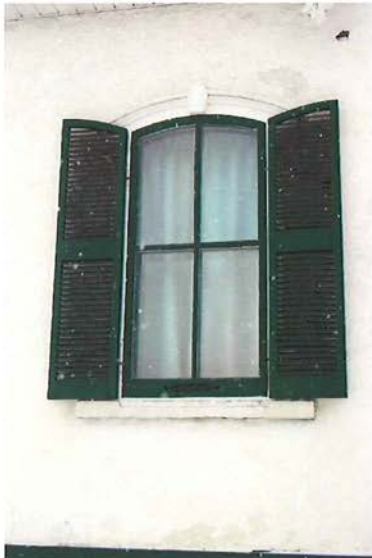
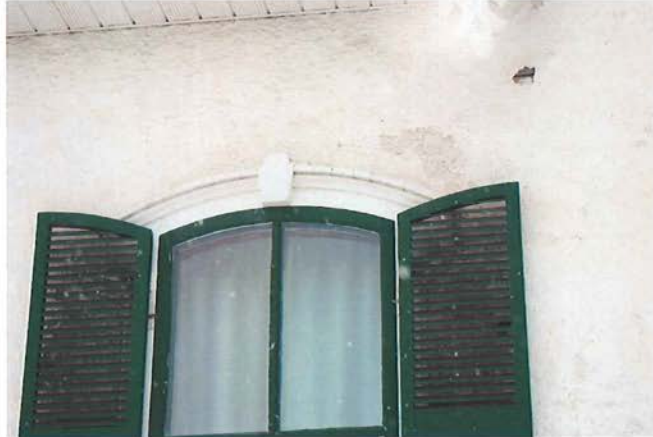
Figures 5 and 6: Details of south side showing moulded window surround, segmented arch over window, storm and wood shutters
