HERITAGE IMPACT ASSESSMENT

Snelgrove Baptist Church

12061 Hurontario St.
Brampton, ON L6Z 4P8

Reissue Date: 16 March 2022

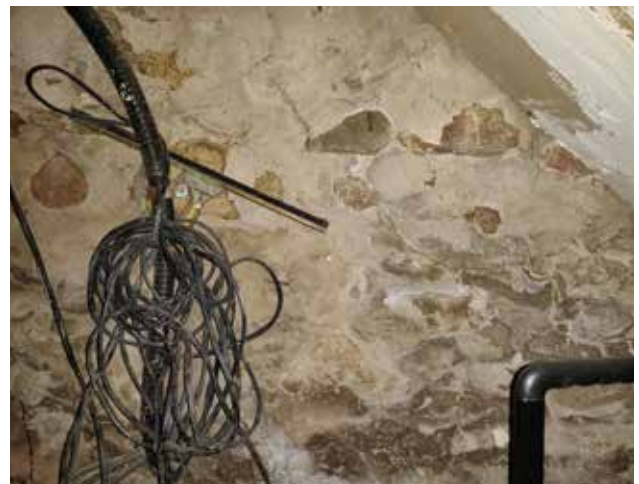
Fig. 5.6. Foundation walls interior face visible in the basement.

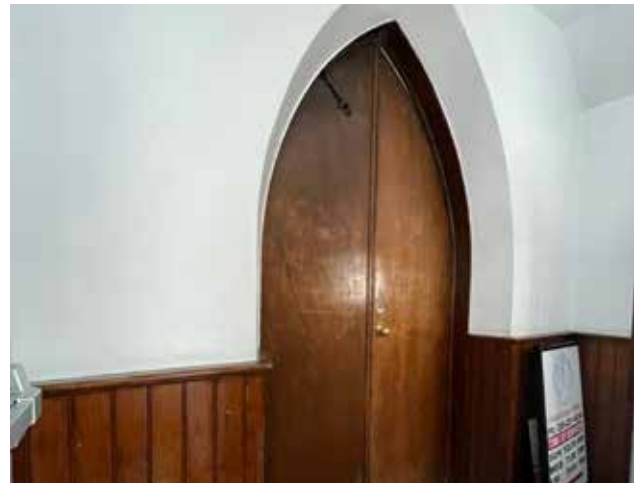
The original wood window frames are in fair condition, the windows have been replaced with incompatible aluminum or vinyl windows. The main entrance door appears to be original and in good condition. The side entrance door has been replaced and in fair condition.

Fig. 5.25. Main entrance door appears to be original, displaying Gothic-Revival style influences.

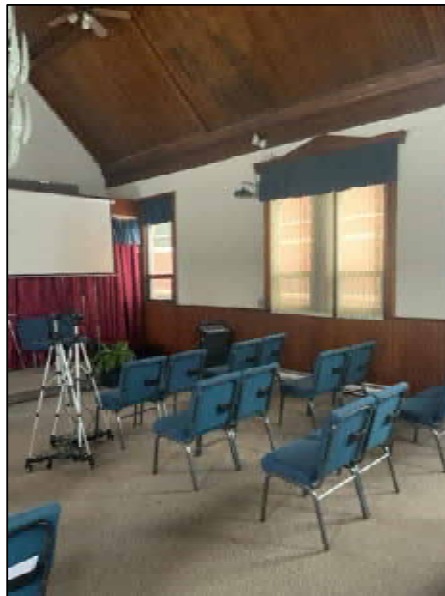
Photograph 1: Ground floor assembly space

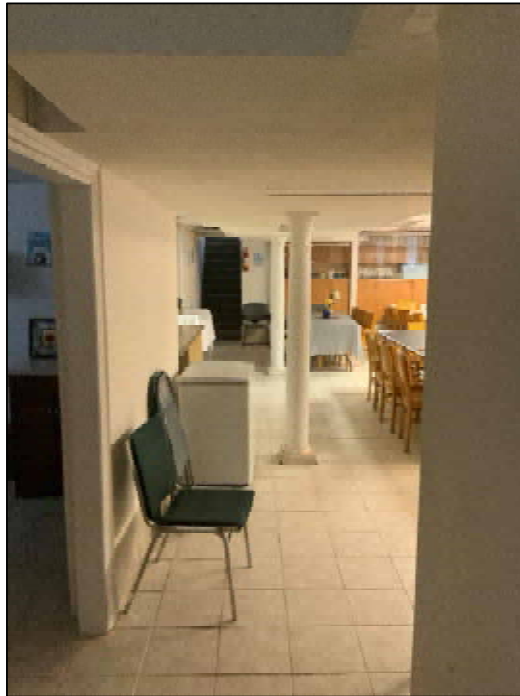
The ground floor is visible behind a combination of drop ceiling panels and drywall and is composed of 2" by 10" wood joists spaced at 16" on centre, pocketed into the brick at the exterior and supported on a heavy-timber wood beam on a series of cast-iron columns along the centreline of the building.

Photograph 3: Basement common space

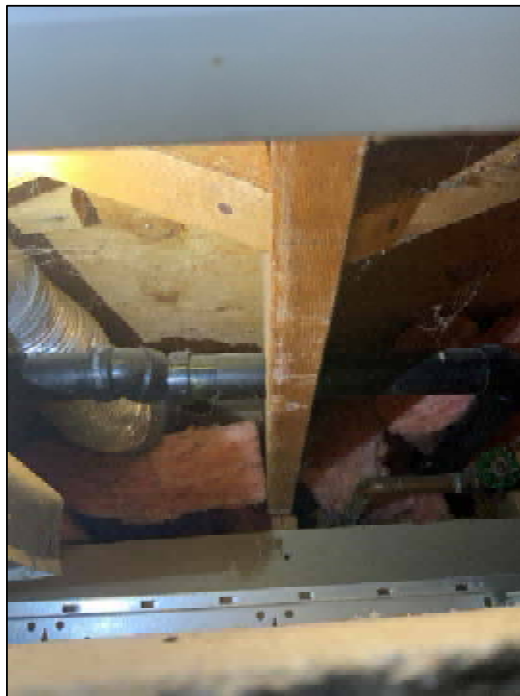
A change in floor framing was noted between the front and rear of the building above the men's washroom ceiling. New plywood and nominal wood framing can be seen towards the rear of the building and are likely related to the infill of space above the original basement stair opening.

Photograph 4: Modern floor framing above men's washroom

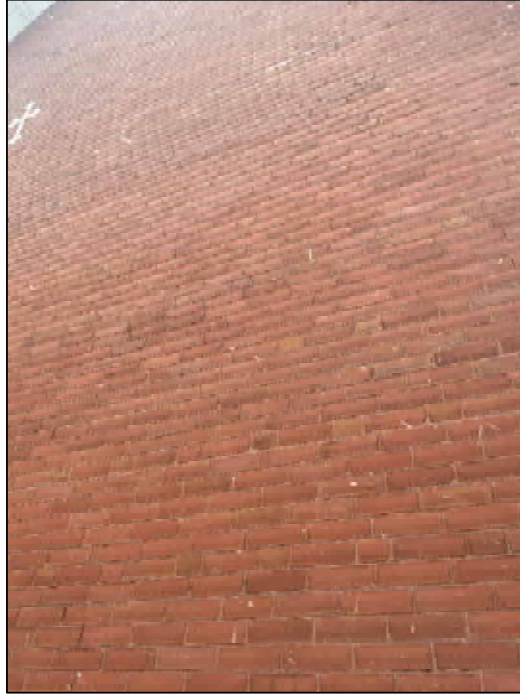
The exterior is constructed with multi-wythe brick masonry, constructed with a modified American Flemish bond (alternating rotated bricks every seven (7) vertical courses).

Photograph 6: Typical modified American Flemish bond

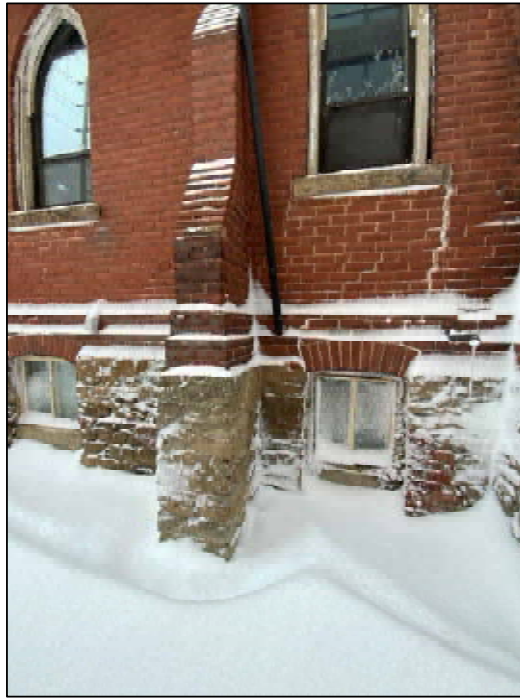
A total of thirteen (13) brick buttresses are constructed around the exterior perimeter, plus a brick chimney on the northwest elevation. Of particular interest are the plinth stretcher and header units, which are fabricated with a fired sloped face to match the slope of the buttress.

Photograph 7: Typical buttress
