Cultural Heritage Impact Assessment Report *Revised*

8265 Churchville Road,
Brampton, Ontario

Date:
August 2022

Prepared by:
**MacNaughton Hermesen Britton
Clarkson Planning Limited (MHBC)**

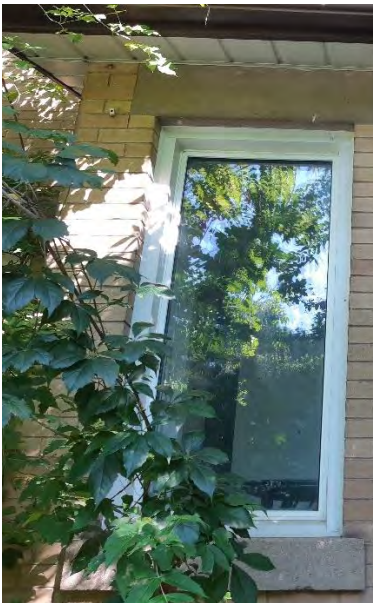
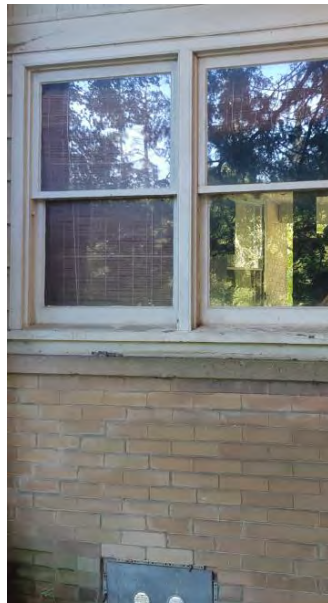
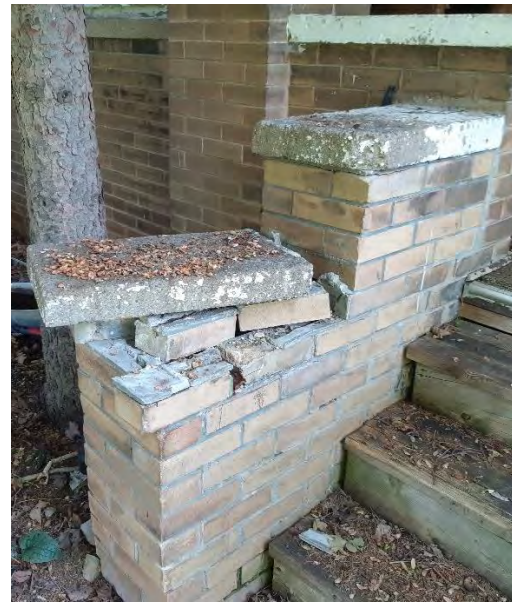
Figures 16, 17, & 18: (left) Detail view of contemporary windows at the south elevation, (centre) Detail of 20th century windows located within the enclosed verandah, north elevation (right) Detail of brick staircase at the west elevation of the verandah. (Source: MHBC, 2021)

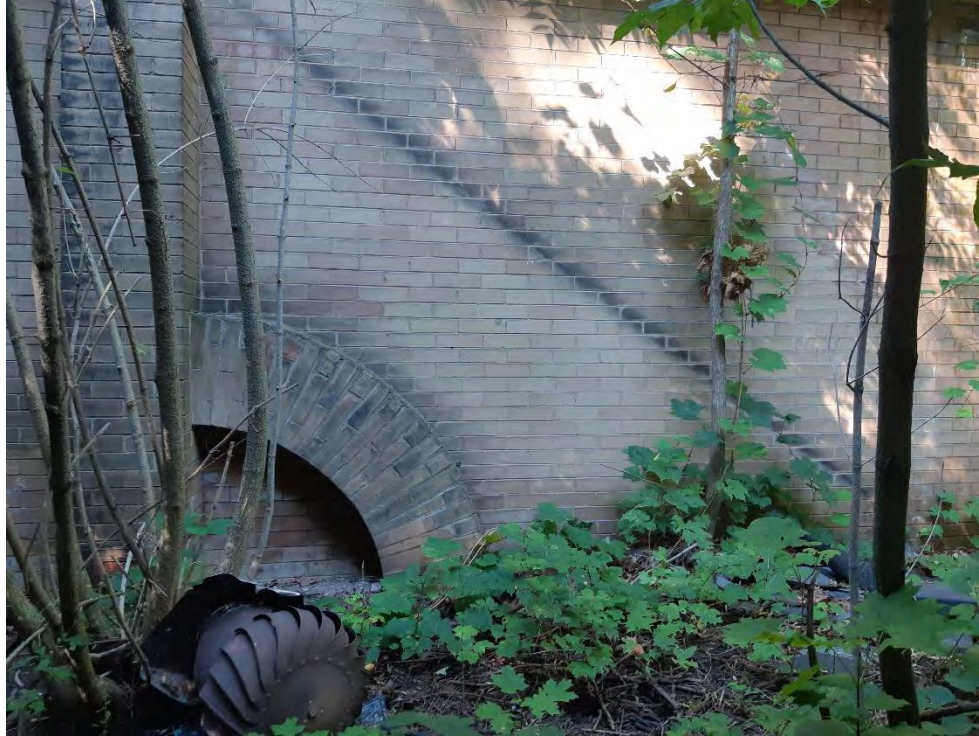
Figure 21: View of rear (east) elevation, looking north towards quarter-round chimney and evidence of former lean-to structure (Source: MHBC, 2021)

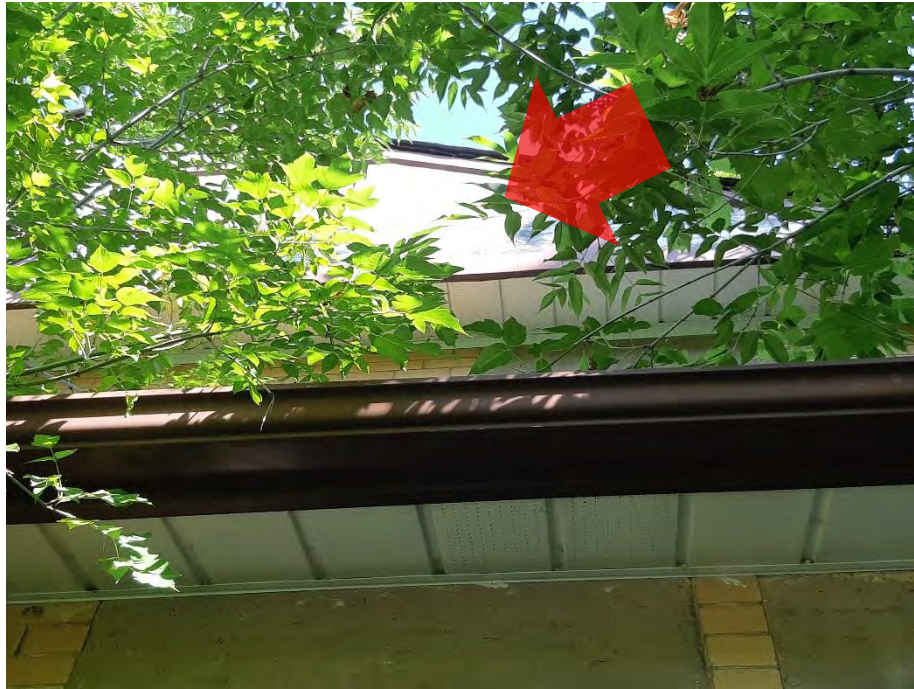
The south elevation includes a secondary door opening and a bay window with shed dormers. All windows at the south elevation have been replaced with contemporary windows. The window openings are various sizes and are primarily rectangular in shape. The gable end of the gambrel roof includes half-timbers and stucco. The cobblestones within the gable ends have been removed.

Figure 24: Detail view of side gable with half-timbering where cobblestones have been removed (Source: MHBC, 2021)

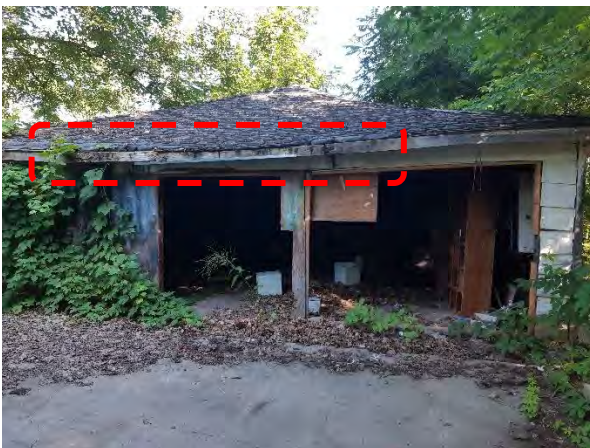
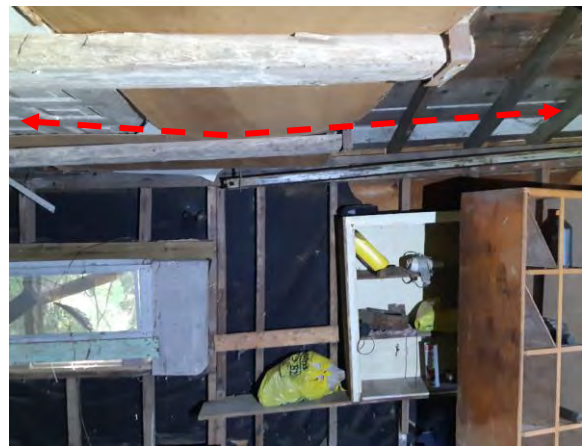
The exterior of the garage showed visible signs of potential structural instability, including bowed framing and a collapsing roof.

Figures 44 & 45: (left) View of south elevation noting bowed framing of roof, (right) Detail view of interior noting roof joints which are bowed and disconnected. (Source: MHBC, 2021).

to active water infiltration. Additionally, the detached garage is in poor condition. The roof is sagging and the walls are bowing outwards.

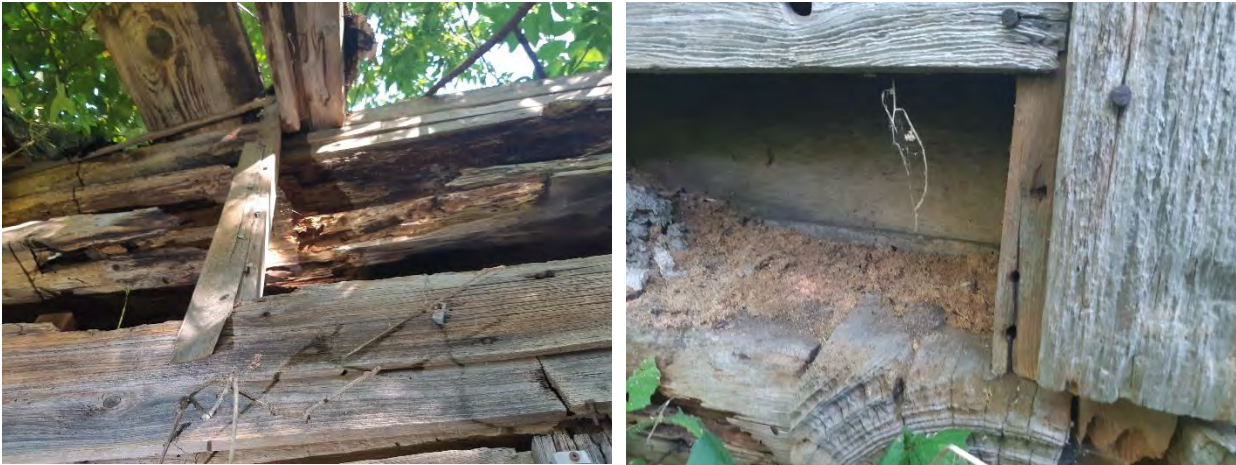
The 19th century outbuilding is partially collapsed and shows evidence of structural issues as a result of exposure to the elements and discontinued use.

Figures 46 & 47: (left) View of rotted wood framing, (right) Evidence of wood framing and beams rotted by termites or other insects (Source: MHBC, 2021)

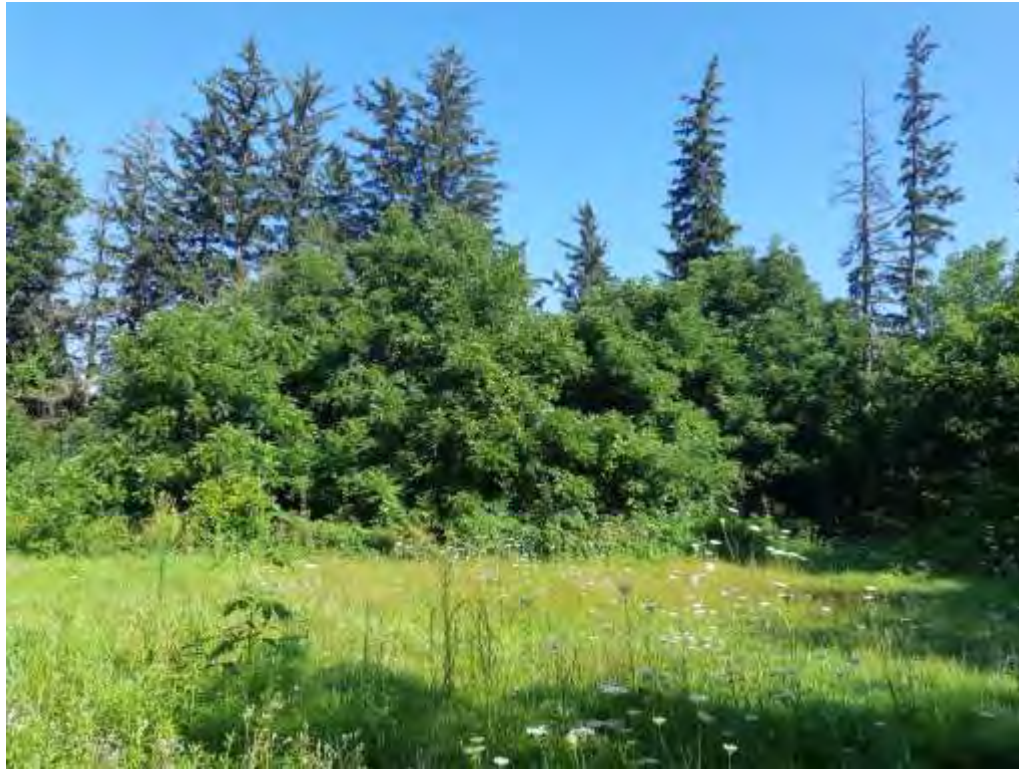
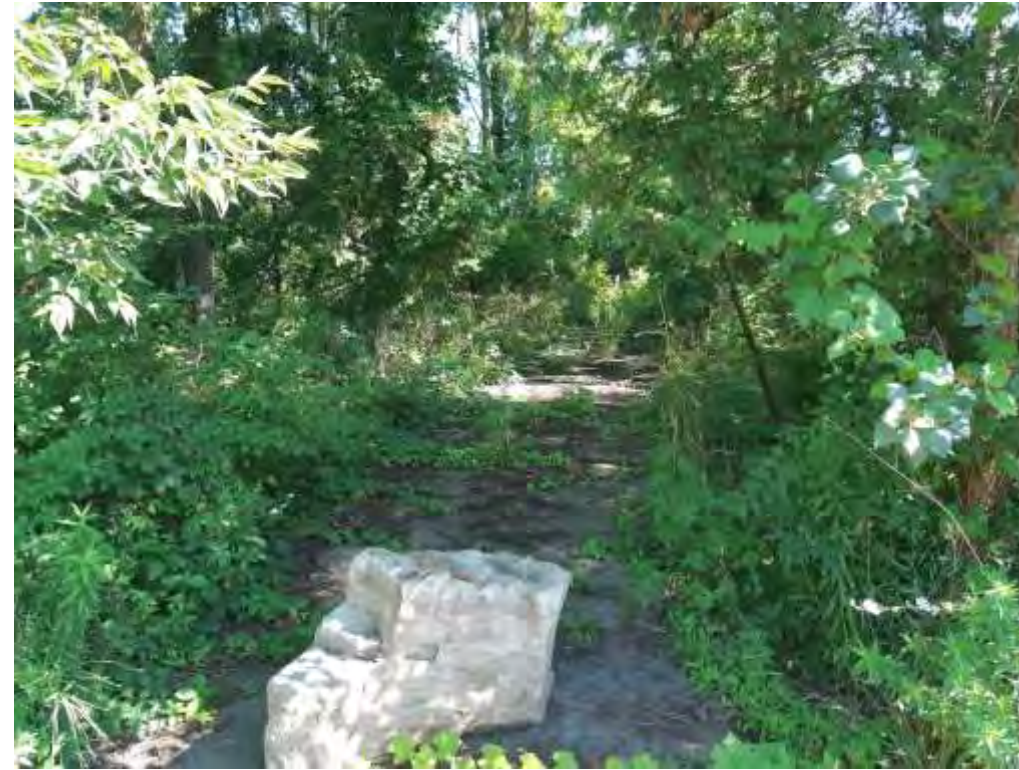
Plate 15 & 16: (left) View of open yard north of the dwelling, looking north (right) View of west entrance to driveway from Churchville Road, looking north-east, (Source: MHBC, 2019)

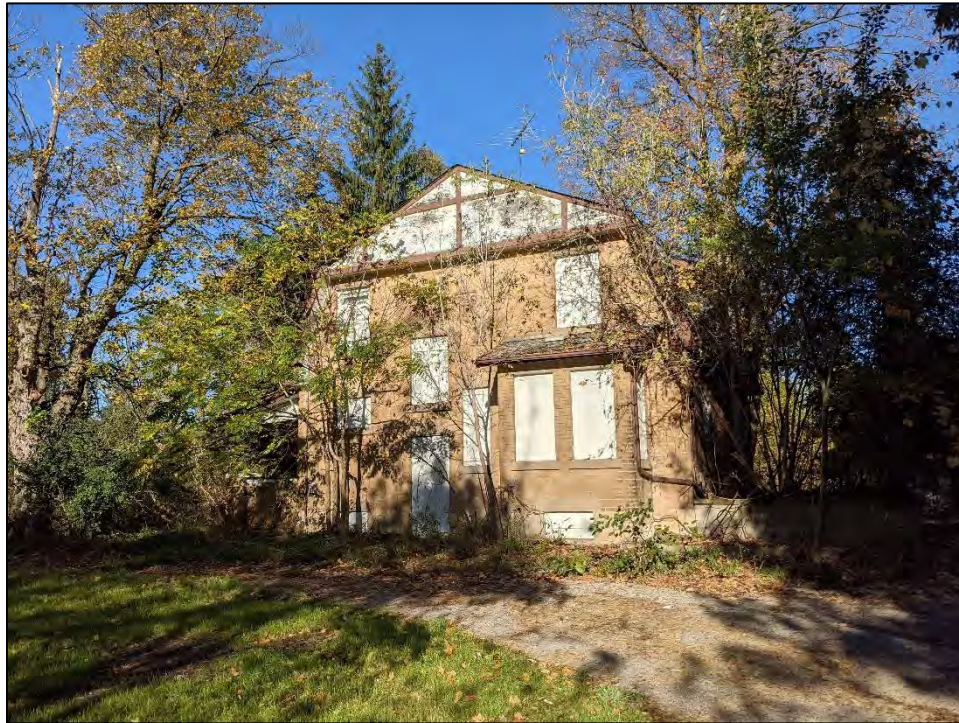
1. Wide cracking in the brick masonry walls was observed at the perimeter of the structure. Cracking was most severe at the two chimneys. Refer to Photo 1, Photo 2, Photo 7, and Photo 8.

Photo 1 – Front view of boarded-up building

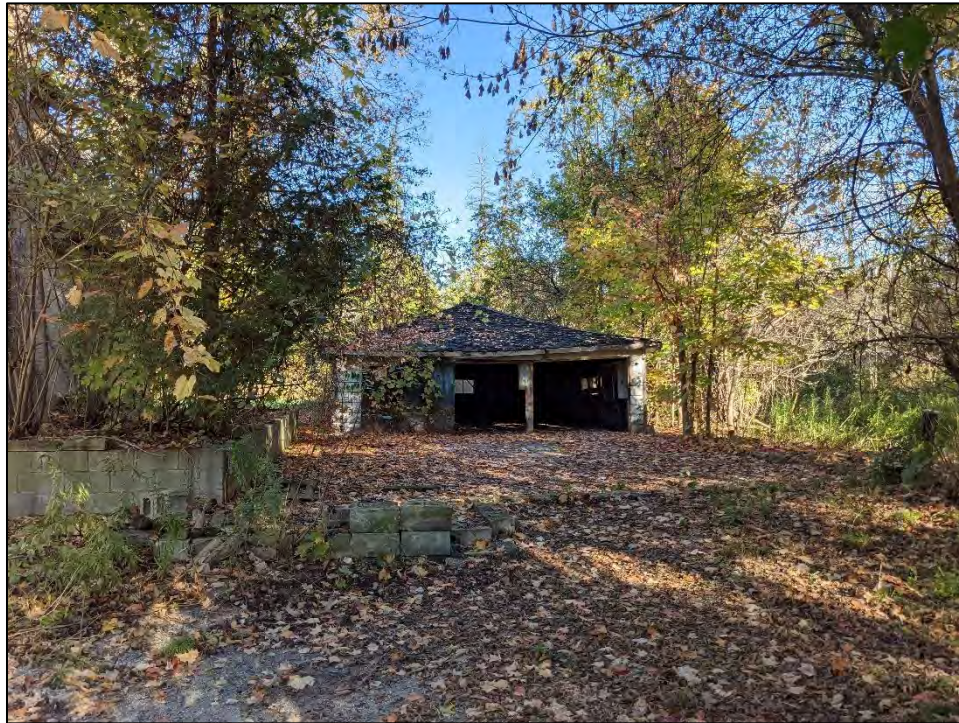
3. The drive-shed was in poor condition. The roof had significant vertical deformation (sagging) under its own weight. The exterior walls were bowing outward. The foundation had experienced differential settlement of more than 6". Refer to Photos 3 and 4.

Photo 3 – Front view of drive-shed

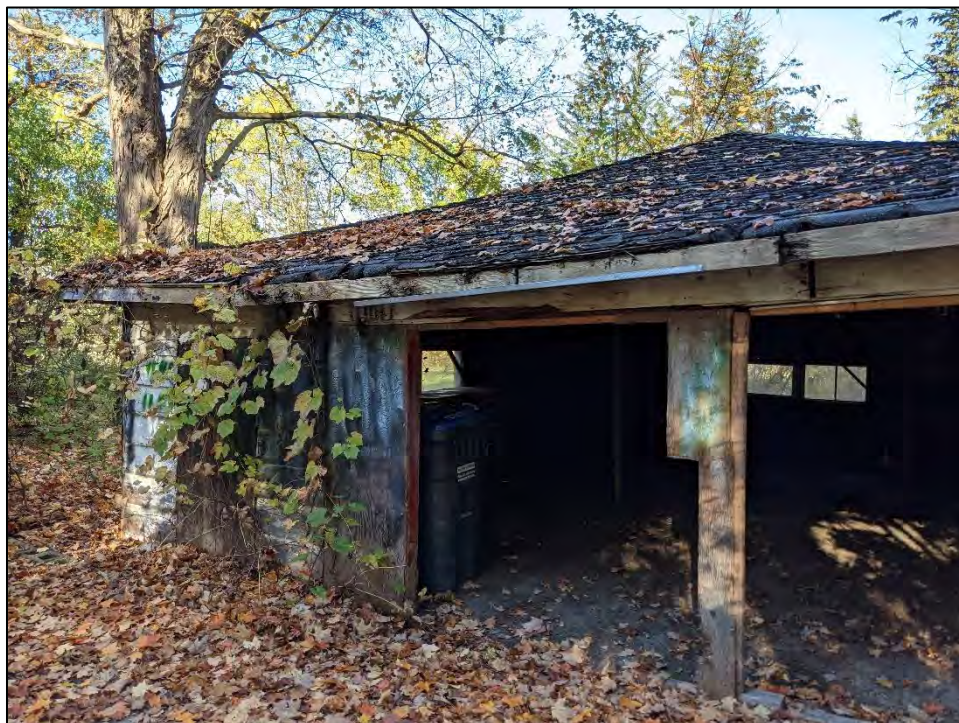
Photo 4 – Close-up of drive-shed exterior roof (significant vertical deformation)
