**St Andrews Presbyterian Church**  
**Heritage Permit Application**  
**Eaves Repairs**

**Re: 44 Church St East (St. Andrews Presbyterian Church), Brampton, ON**  
**Exterior Eavestroughs/Gutters and Attic Condition Review**  
**Letter Report**

## Condition Review Report

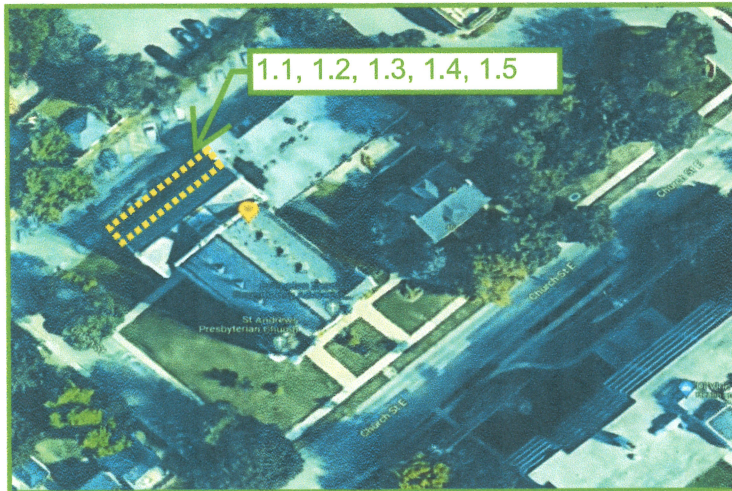
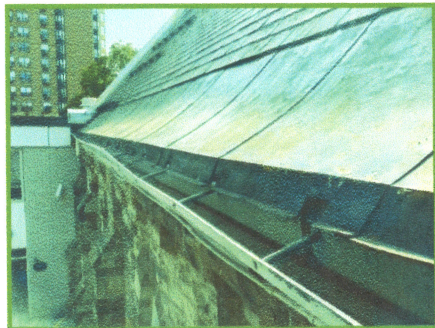
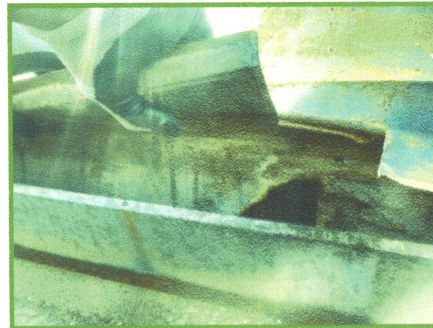
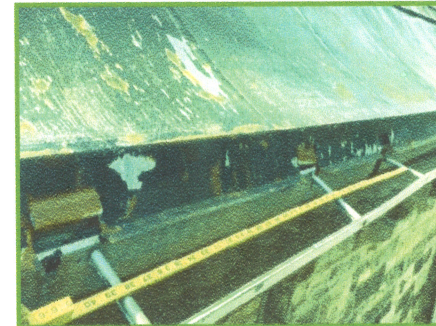
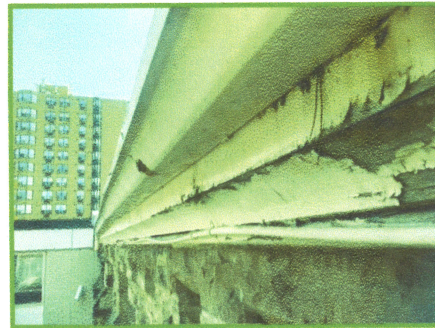
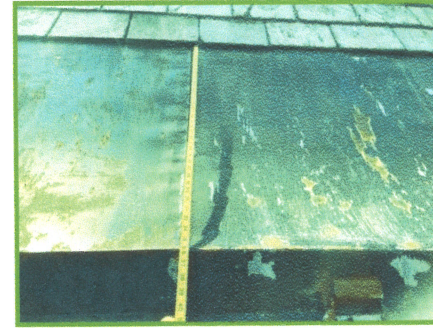
SK-01	AS NOTED	2023-06-07
-------	----------	------------

TruGrp Construction Ltd. was retained to assist with an articulated zoom boom for a close review of the gutters and exploratory openings. Refer to Appendix drawings and photographs on SK-01, SK-02 and SK-03 for locations of deteriorated gutters.

1. The eavestrough (gutters) consist of a 150mm (6") wide galvanized gutter attached to the edge of the roof with galvanized steel spike nails approximately 254mm (10") long and 406mm (16") spacing. Localized corrosion to the base of the gutter and general warping was observed to the majority of the north and west ends.
2. The slate roof above the eavestrough had a metal flashing approximately 900mm (36") edge metal flashing which appeared to be painted black galvanized metal flashing with drip edge, draining into the

gutter. Notched ends of the flashing around the gutter spikes were observed with general gaps/openings which are direct entry paths for water to enter below the fasteners and behind the gutter down the exterior wall.

3. Below the eavestrough is a wood crown moulding trim and fascia board, general weathering and wood rot was observed. At the north end, signs of pest/rodent damage was also observed.
4. The rafter ends where exposed at the north/west ends, contain areas of weathered ends with cracked/split ends which are generally not suitable for gutter faster re-attachment.
5. Generally warping to eavestroughs, tilted and rotated, indicative of sliding snow impact damage was noted on the north and west ends. The east elevation had 3 full rows of snow guards with limited damage to the eavestroughs where as the north and west and partial snow guards. The west side has 4 dormers where the sliding snow appears to collect which coincides with the gutter damage.

1. **Immediate: North end block off the parking area below. The gutter has shown some movement, do not park below the area for safety reasons until a repair is carried out.**

2. **Priority Gutter and Fascia Board Repair (North, East, West) ..... Est. \$120K to \$160K + HST**

- a. Remove and replace existing gutter with a prefinished aluminum gutter at north, east and west ends.
- b. Further review and reinforce exposed/damaged rafter ends to support new gutter (Est. 25% rafter end locations).
- c. Replace the rafter end fascia board with a new sealed and painted board.
- d. Install new crown moulding
  - i. Option 1: Wood crown moulding painted
  - ii. Option 2: Aluminum crown moulding prepainted (low maintenance option)
- e. Roof edge repair – salvage roof edge metal flashing. Cut back and modify with a new drip edge and sealant.

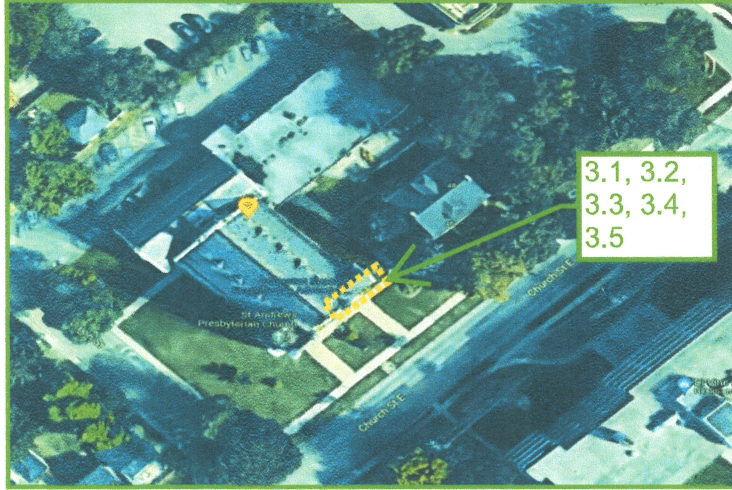
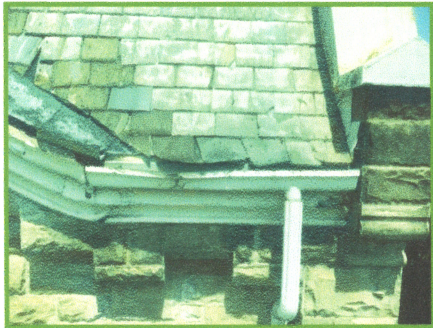
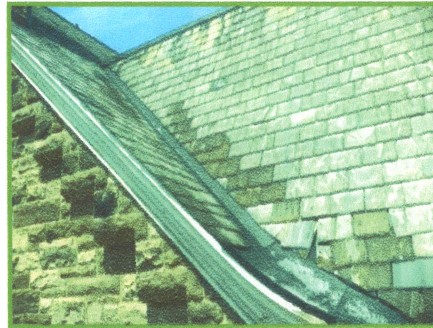
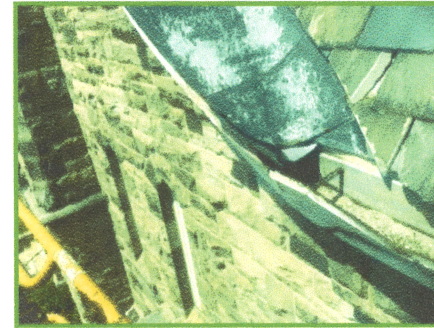
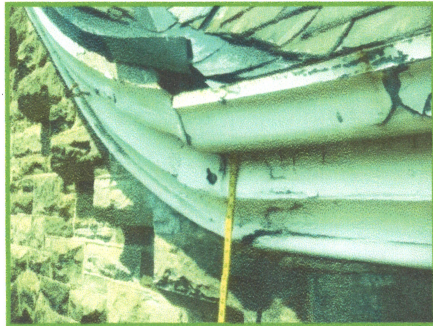
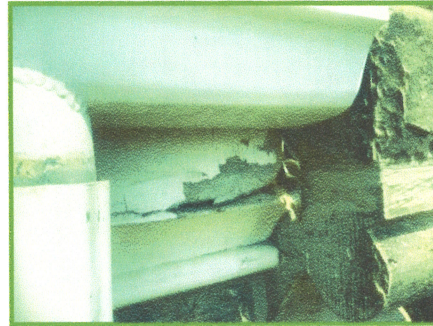
SK-03  
AS NOTED  
2023-06-07

Localized review at the south corner were reviewed with the zoom boom – Refer to SK-03. The area is generally performing, signs of peeling paint and wood rot was observed to the wood crown moulding and gutter. Previous repairs to the roof edge flashing and slate shingles was observed (Refer to Photo 3 and 4 below). Signs of warped/damaged gutter was observed which appears to be from snow damage.
