**8331 HERITAGE  
ROAD, BRAMPTON,  
ONTARIO  
MCCLURE  
FARMHOUSE**

**HERITAGE IMPACT  
ASSESSMENT**

FINAL REPORT - AUGUST 2023

PREPARED BY:  
ATA Architects Inc.

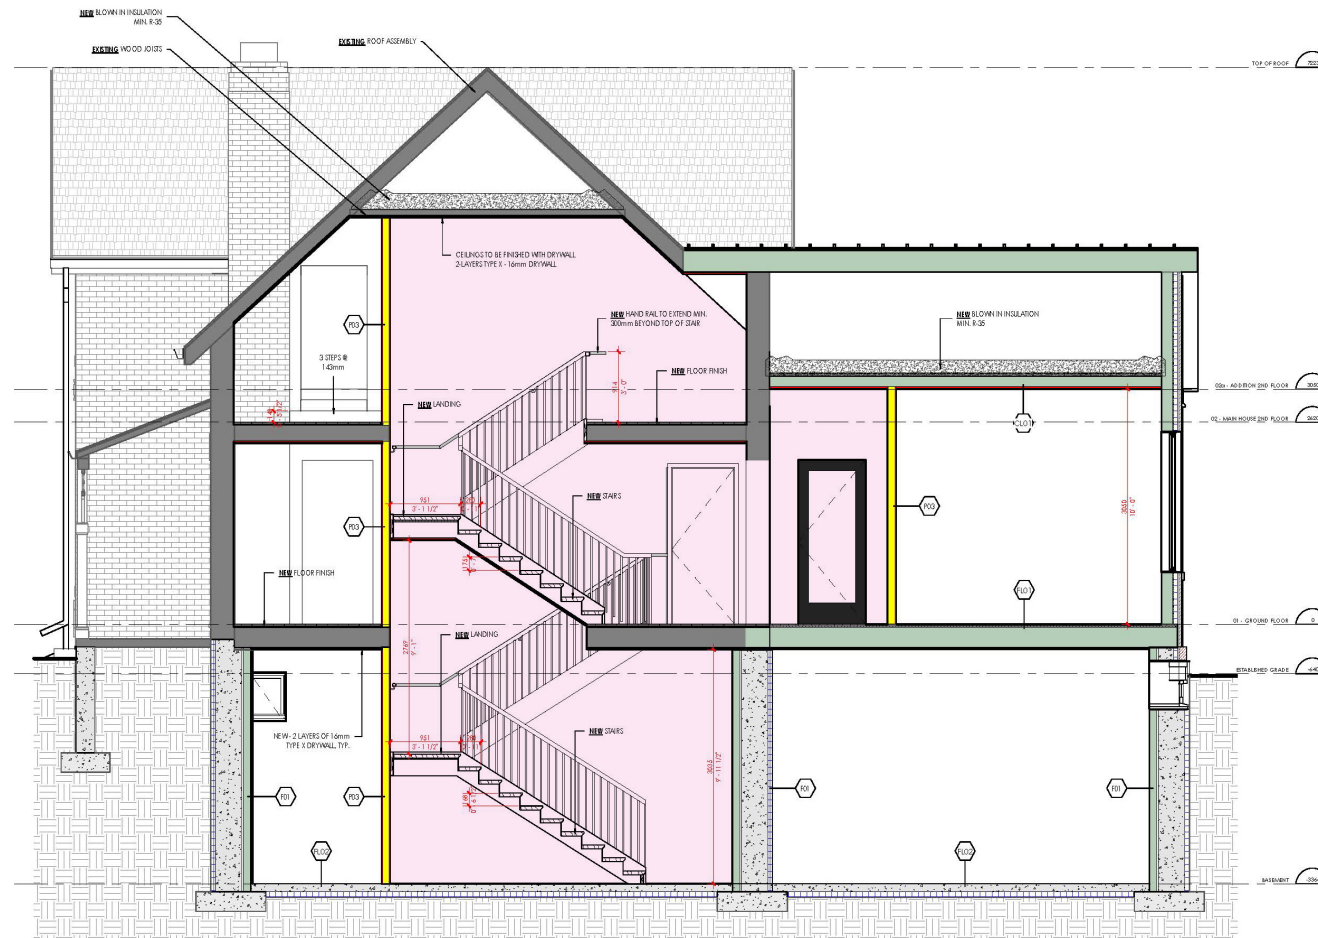
Figure 23  
Stair Section and Exit  
Source ATA Architects Inc.

When the two storey addition was added to the farmhouse, a step was created at the second. This step cannot be removed without major restructuring of the house. The step is not code compliant and affects the functional layout of the second-floor space.
