FINAL REPORT:

Scoped Heritage Impact Assessment

8990 McLaughlin Road South, City of Brampton,
Ontario

Project # LHC0443

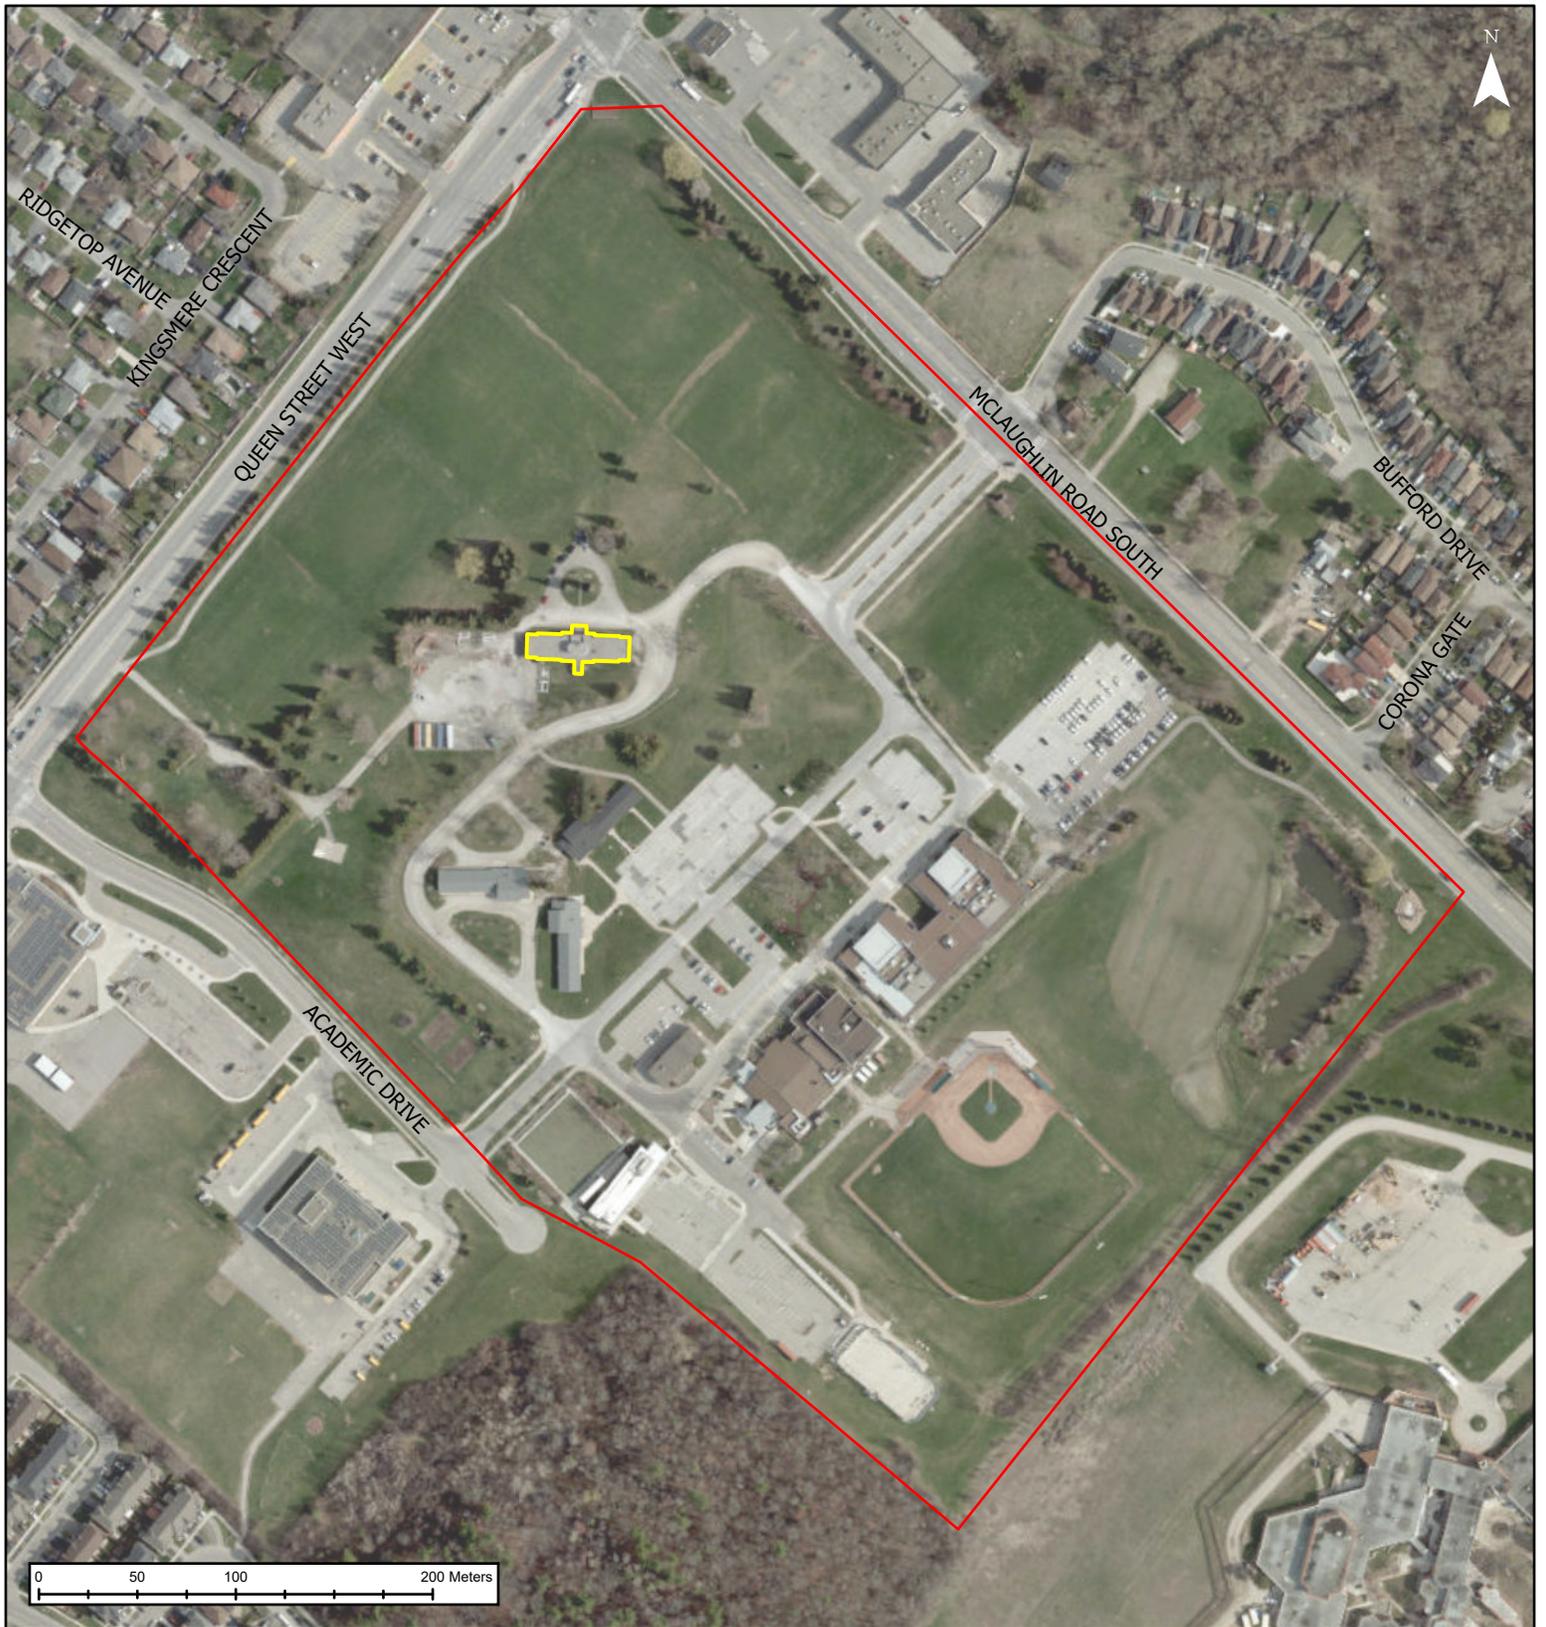
TITLE
Current Conditions of the Property

The Property is located to the south of the intersection of McLaughlin Road North/McLaughlin Road South and Queen Street West (Figure 1 and Figure 2). The Property is legally described as Part of Lots 4 and 5, Concession 2 WHS, designated as Parts 1,2,3 and 4 on Plan 43R-23285.

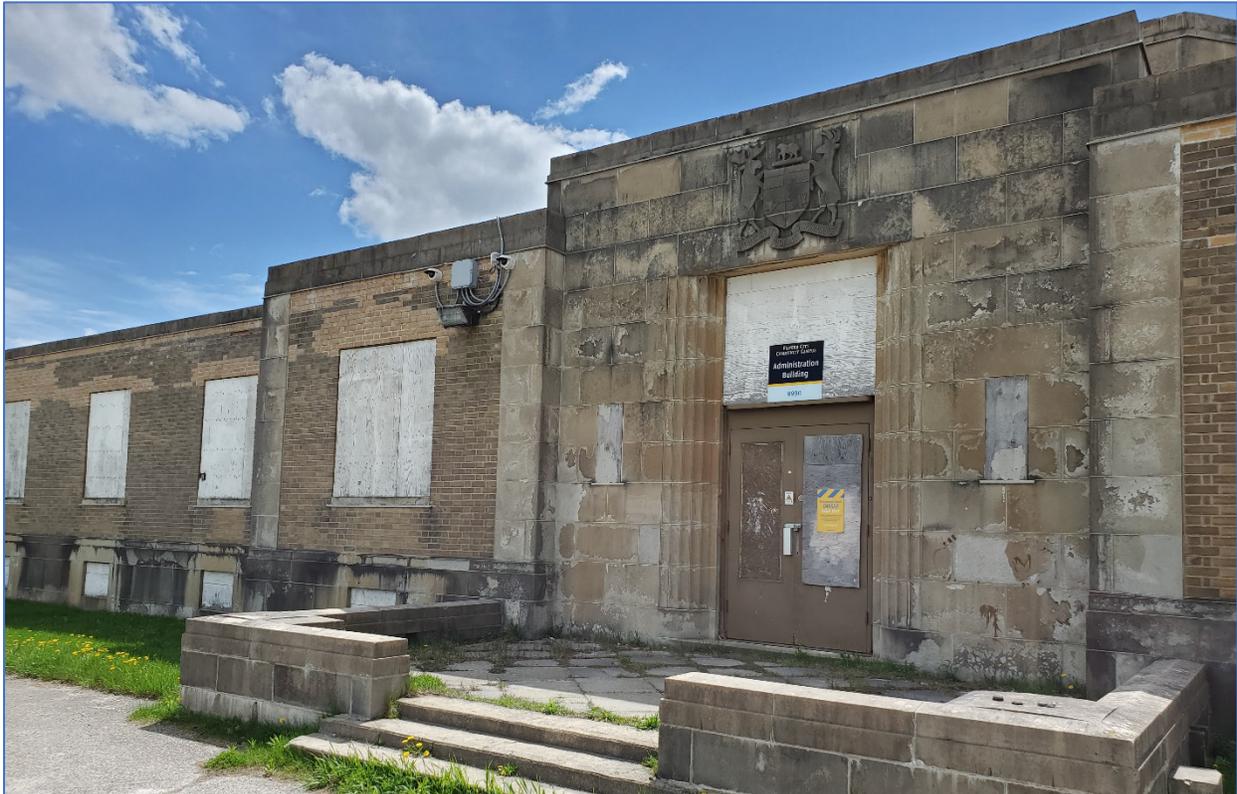
Photo 1: View southeast showing part of the building's primary, north elevation

The former Ontario Provincial Police Administration Building on the Property is a single detached, one-storey rectangular building with a full below grade basement. The building's primary, north elevation has a symmetrical, stepped back massing divided into eleven bays (Photo 1). The main exterior wall is composed of coursed Rama limestone and buff brick set in Flemish bond (Photo 2). Decorative elements on the building's north elevation include a Coat of Arms for the Province of Ontario rendered in cast concrete is situated above the building's primary entrance and a datestone reading '1937' located on the north elevation to the east of the main entrance (Photo 3 and Photo 4). The building has a flat roof with a stone parapet. An octagonal rotunda composed of stone is centrally located on the building's roof. The rotunda is composed of stone, has a flat roof with stone parapet, and has glass block windows in each of its eight sides. A large, buff brick chimney is centrally located on the building's south elevation. Only the base of the chimney remains.

First storey and rotunda windows have a flatheaded opening and plain stone slip sill. Basement windows are set into flatheaded opening and have no trim (Photo 1 and Photo 2).

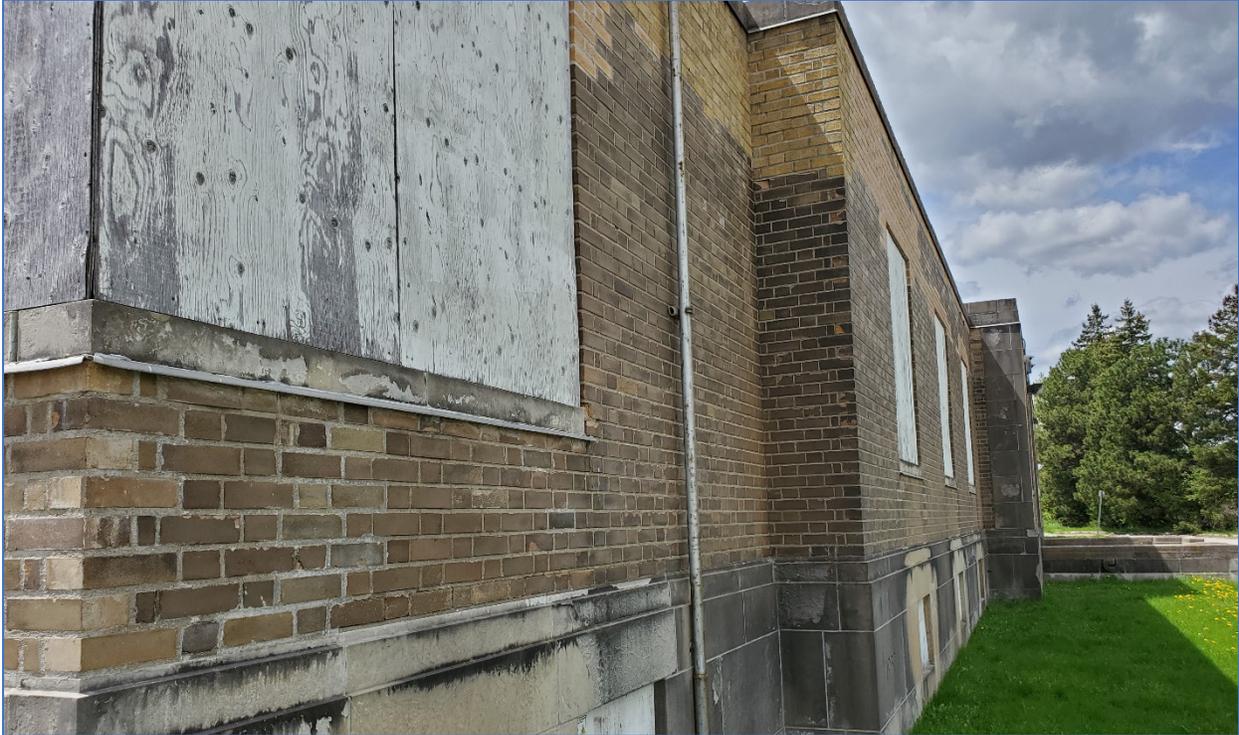
Photo 2: View southwest showing the building's external materials

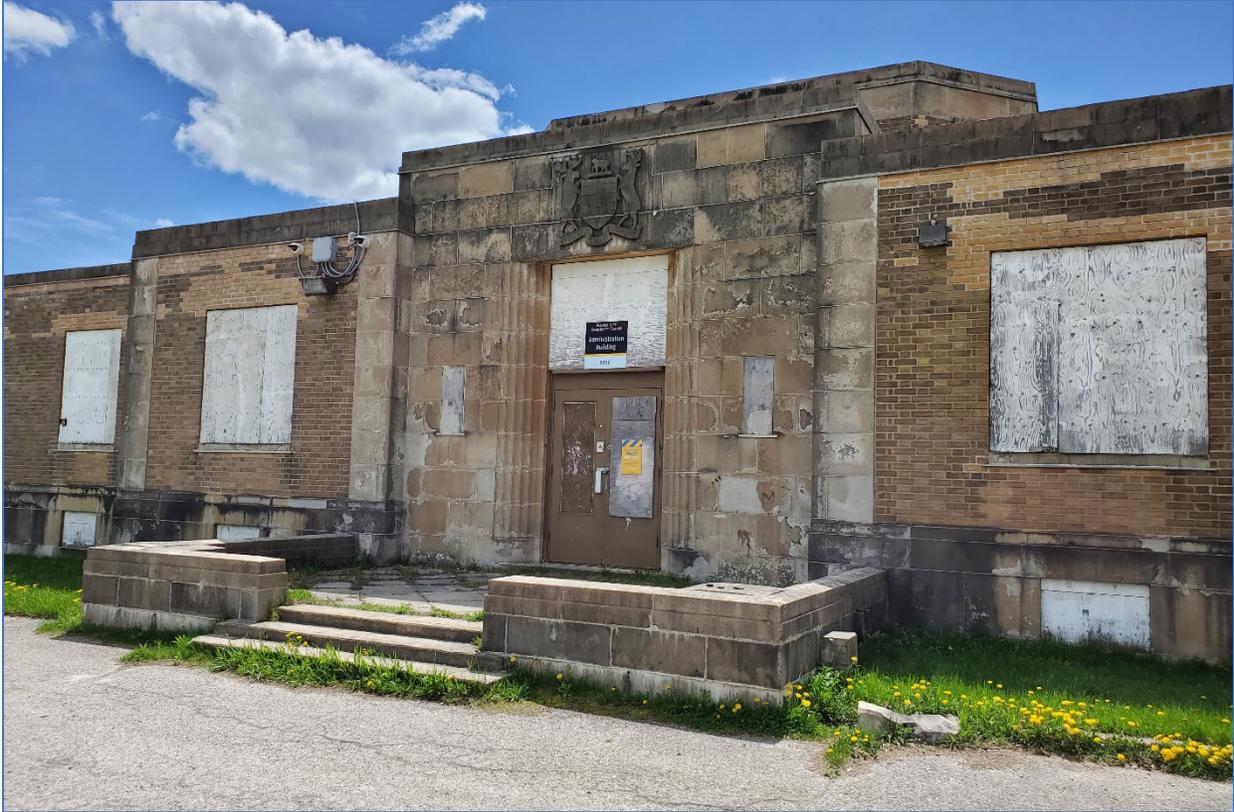
Photo 5: View southeast showing the building's main entrance and pavilion

The building's main entrance is centrally located on its north elevation. The doorway is narrowly recessed from the façade, has a flatheaded opening, a flatheaded transom, and abstracted fluted pilasters on both sides. The doorway has a solid two-leaf, metal door. The main entrance is accessed from a pavilion. The pavilion has a cut stone knee wall and stone deck (Photo 5).

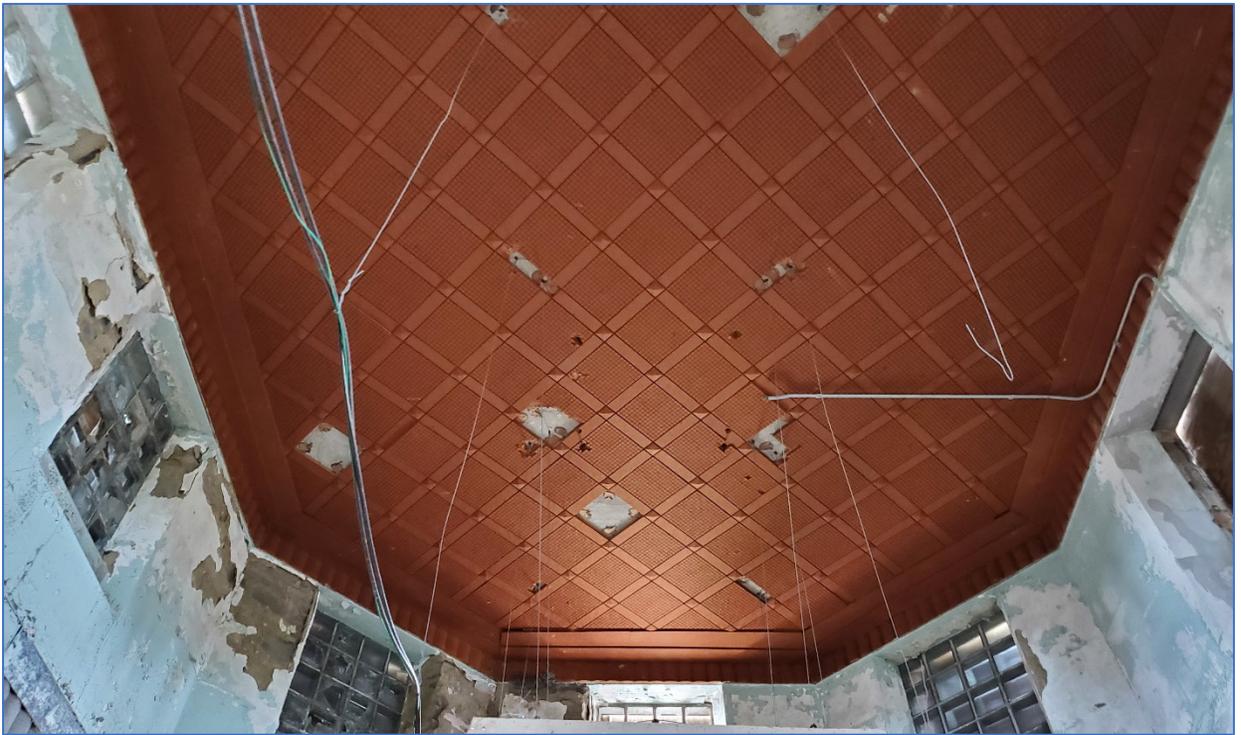
Photo 11: View of the ceiling in the rotunda

The building's primary entrance provides access to a vestibule and staircase that leads to the lobby. The vestibule and staircase have a terrazzo floor, painted walls with speckled beige terrazzo wainscotting, and a smooth painted ceiling. The interior side of the main entrance has an emerald green and burgundy red terrazzo surround. The lobby is accessed from a door at the top of the vestibule's stairs. The doorway has a flatheaded opening, a flatheaded transom, and emerald green and burgundy red terrazzo surround. The doorway has a two-leaf, metal door with central lights and chrome door pulls. The building's lobby is octagonal in shape and directly aligns with rotunda (Photo 6). It has a terrazzo floor rendered in emerald green, burgundy red, and speckled beige (Photo 7) and burgundy red terrazzo baseboard. Walls typically have speckled beige terrazzo wainscotting and smooth paint. One area on the south wall is clad in beige tile (Photo 8). Four metal grates are located on the north wall (Photo 9). The interior walls of the rotunda have a scalloped stone frieze band and walls painted sea foam green (Photo 10). The lobby's ceiling has acoustical tiles in repeating geometric motif of diamond lozenges and squares (Photo 11).

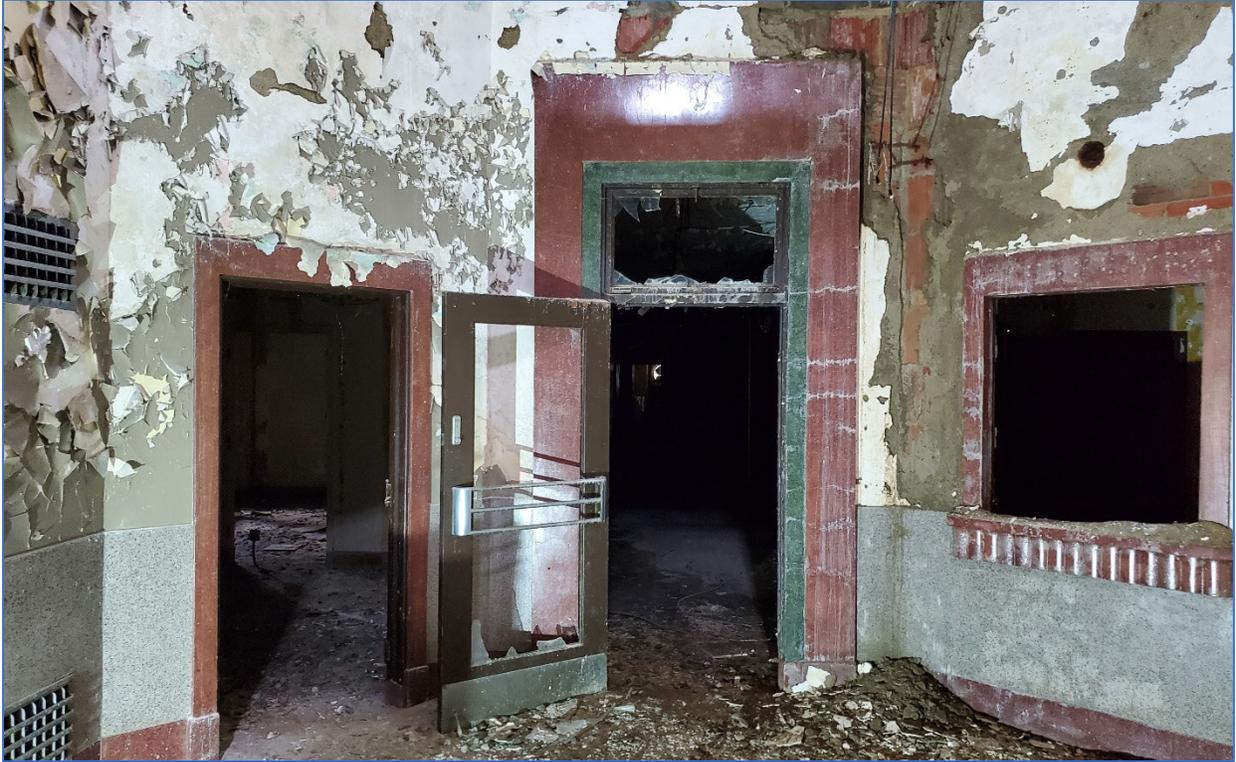
Photo 12: View east showing openings on the lobby's northeast (left; nondescript room), east (centre; hallway), and southeast (right; wicket) walls

hallways that extend the length of the building. Each of these four openings have a door with an emerald green and burgundy red terrazzo surround and a single leaf door with central light and chrome door pulls (Photo 12). The northeast and northwest walls have doorways that lead to nondescript rooms. These opening have a door with a burgundy red terrazzo surround and a single leaf door with central light and chrome door pulls (Photo 12). The southeast and southwest walls have wickets with burgundy red terrazzo surrounds (Photo 12).

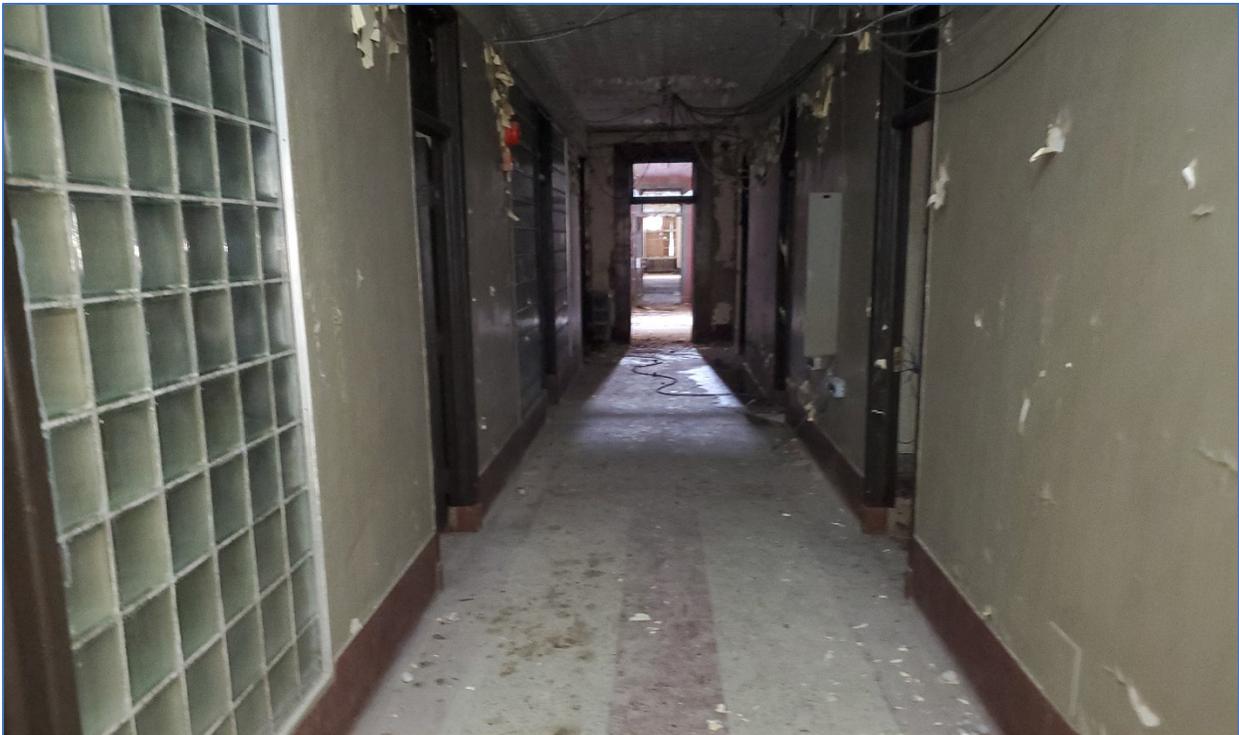
Photo 13: View west showing the east hallway

The east and west hallways share the same general configuration. They have a terrazzo floor rendered in emerald green, burgundy red, and speckled beige; burgundy red terrazzo baseboard; and painted wall and ceiling. Select wall sections on the south wall are composed of glass blocks (Photo 13). Nondescript rooms are located on both sides of the hallways. Rooms typically have concrete floor, painted concrete baseboards, painted walls, and concrete ceiling clad in acoustic paneling (Photo 14).

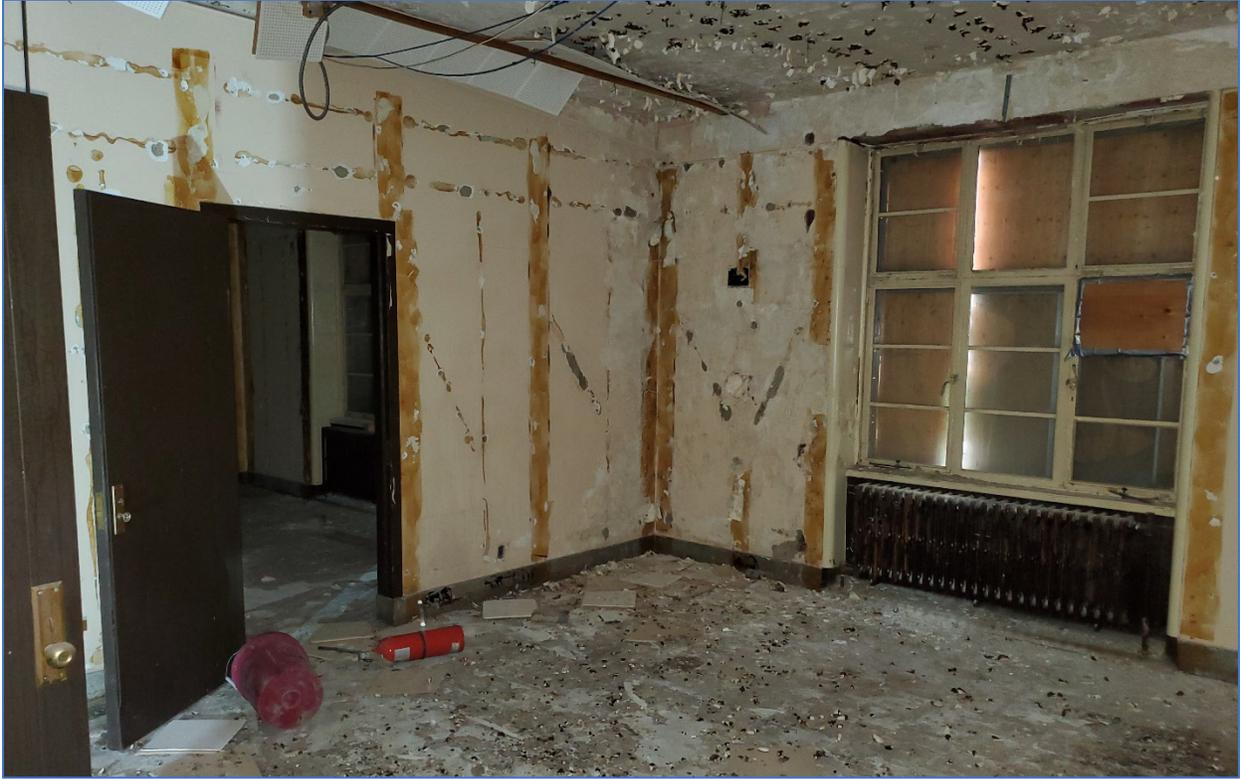
Photo 14: View northwest of a typical first storey room

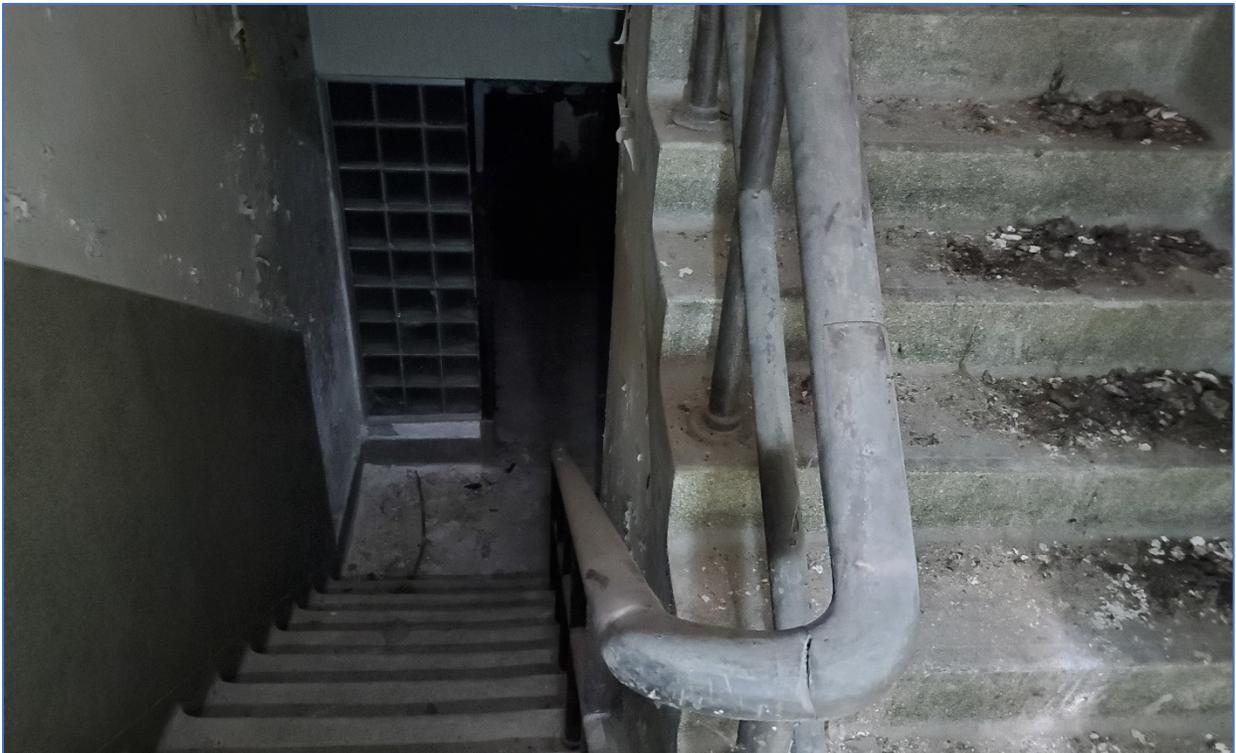
Photo 15: View north showing the basement stairway

The building's basement is accessed from a stairway near the terminus of the west hallway on its south side. The stairway is "U" shaped and is composed of concrete. It has tiled walls with speckled beige terrazzo wainscotting, and a smooth painted ceiling (Photo 15). The stairway leads to a central hallway in the basement. The hallway has a concrete floor and painted concrete baseboards, walls, and ceiling (Photo 16). The basement's ceiling is unfinished, and mechanical and electrical equipment is visible in several locations. The basement is typically composed of large, open rooms with nondescript uses. Basement rooms share the same material configuration as the basement hallway (Photo 17). The building's mechanical room is centrally located on the south wall of the basement. Mechanical and electrical equipment is located in this room including a furnace and water heaters (Photo 18). The walls in the centre of the basement are octagonal in shape and align with the building's lobby and rotunda (Photo 19).

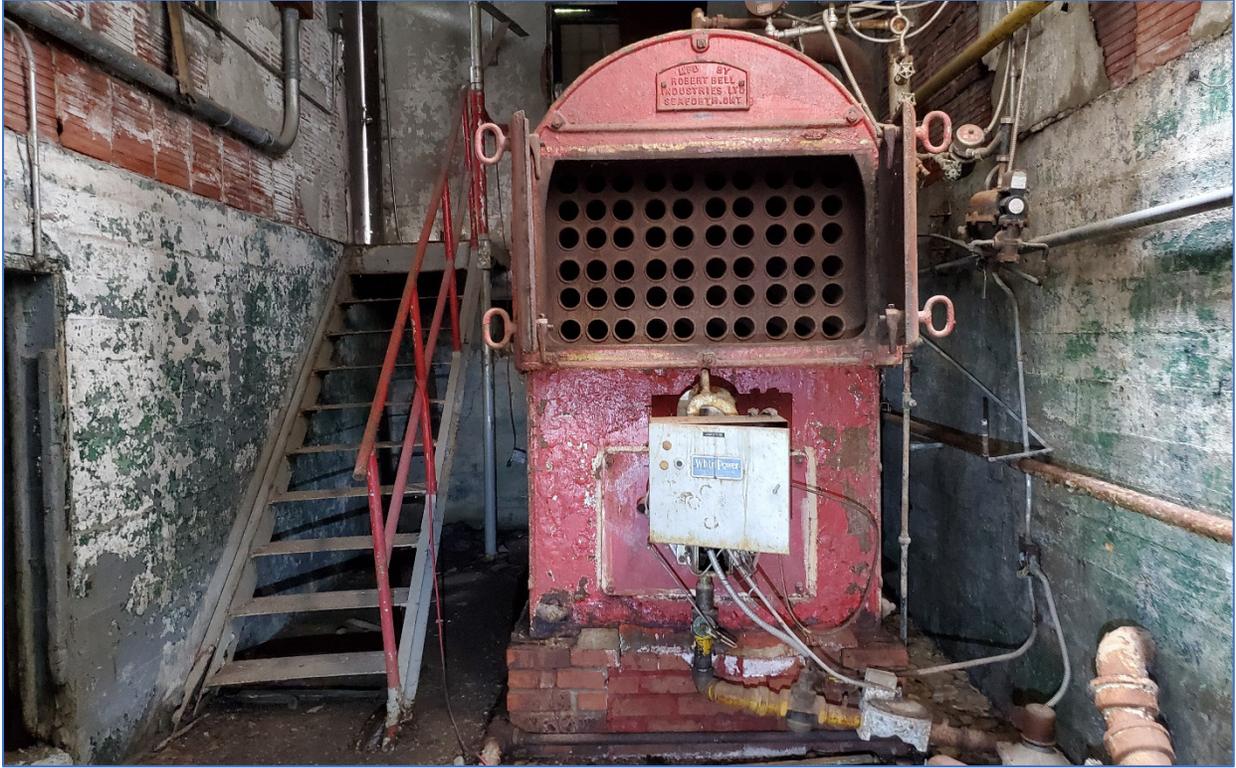
Photo 18: View south showing the furnace in the building's basement

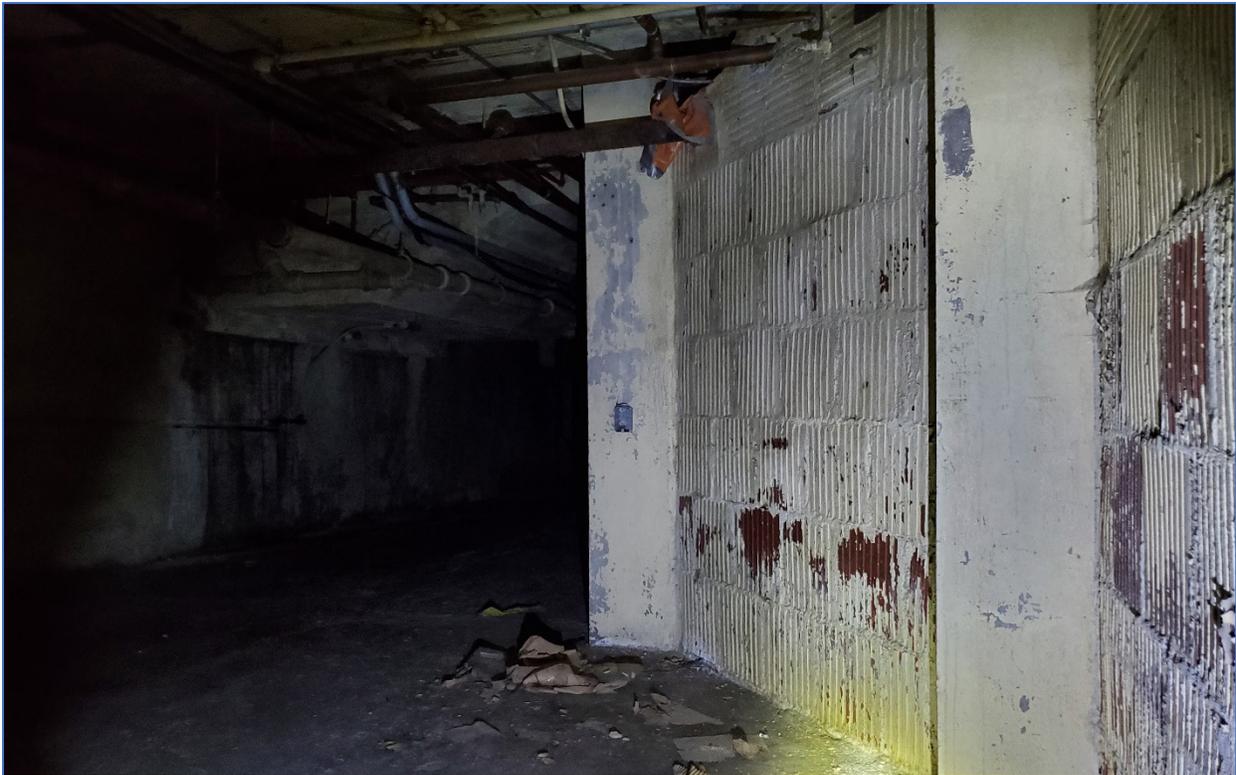
Photo 19: View east showing an angled wall section that aligns with the lobby and rotunda

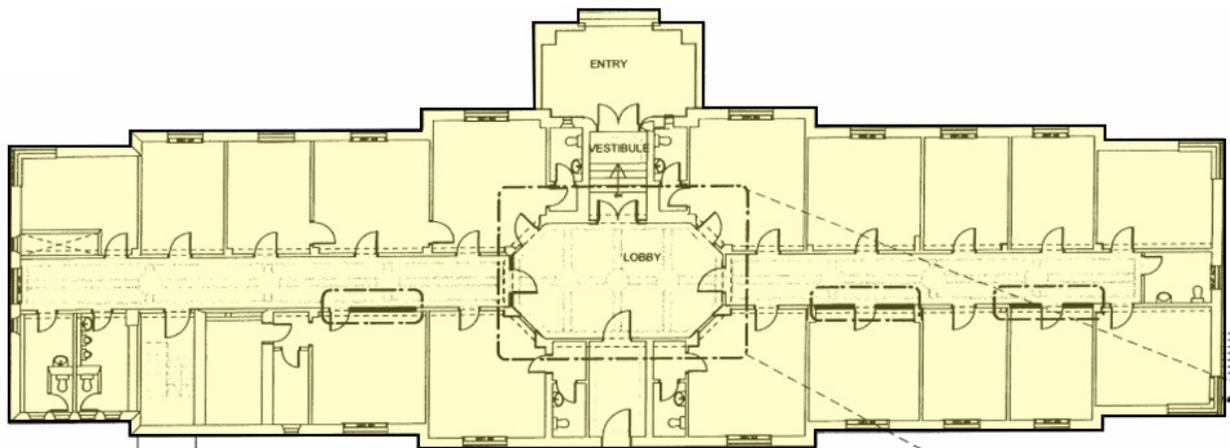
Figure 3: Diagram showing retained sections of the building for Option 1 'retention *in situ* and reuse'

Table 3 identifies the advantages and disadvantages of each option, identifies which heritage attributes would be retained with each option, and provides a brief description of the condition and presence of designated substances for retained heritage attributes for each of the options. The proposed options are identified in order of preference, from a purely heritage conservation perspective. To supplement Table 3, Figure 3 through Figure 8 visually display sections of the building that would be retained in four of the proposed options. Each diagram shows section to be retained in yellow and sections to be demolished in red.

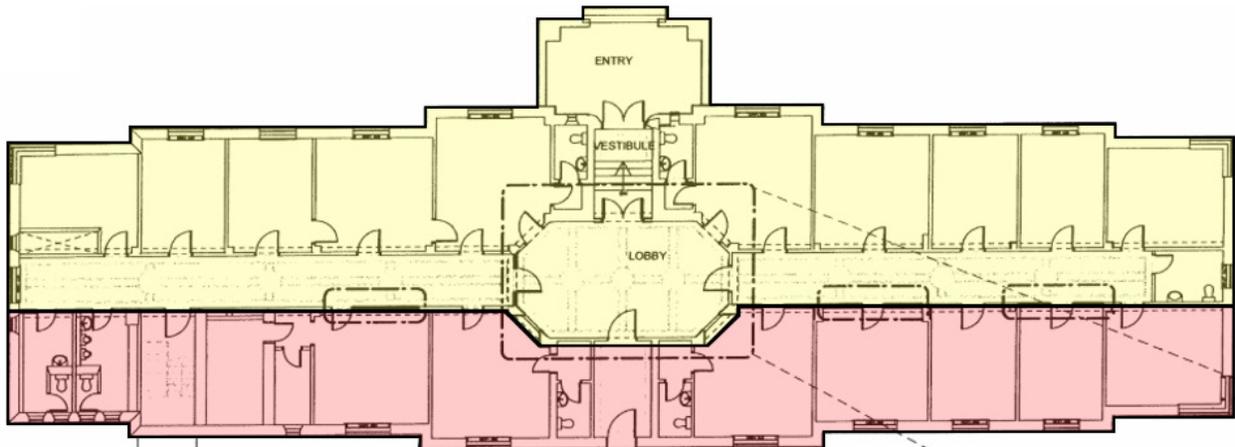
Figure 4: Diagram showing retained sections of the building for Option 2 'retention of north façade, lobby, rotunda, hallways, and rooms along the building's north façade'

The preferred option from a heritage conservation perspective is Option 2, retention of north façade, lobby, rotunda, hallways, and rooms along the building's north façade. This option is preferred because it allows for the retention of the highest number of heritage attributes and presents an opportunity for the salvage and reuse of materials from other areas of the building for selected repair/replacement. Since this option retains many of the building on the Property's heritage attributes, direction for refurbishing, maintaining, repairing, and replacing materials is provided in Table 4 of this report. This table identifies recommendations from ERA

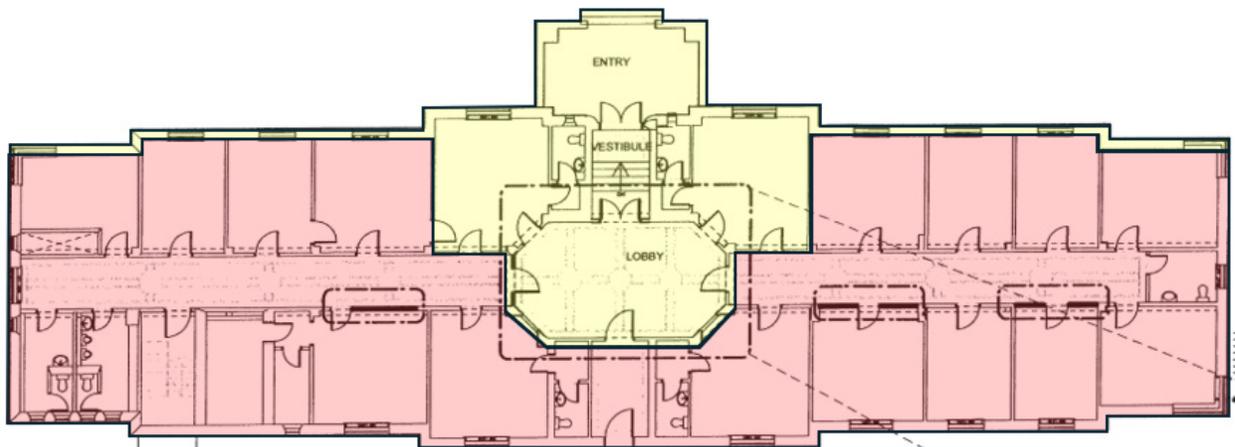
Figure 5: Diagram showing retained sections of the building for Option 3 'retention of north façade, lobby, rotunda, and rooms to accessed from the north wall of the lobby'

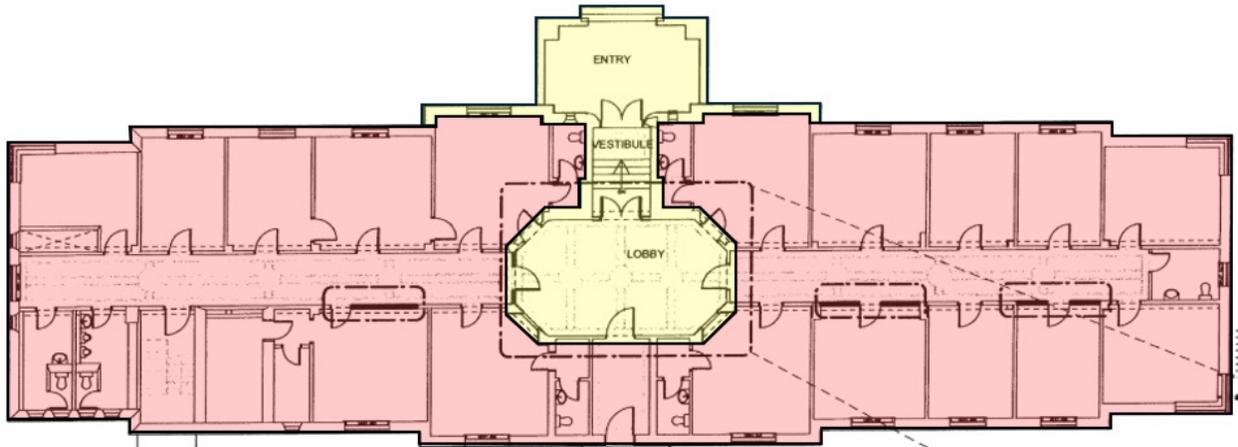
Figure 6: Diagram showing retained sections of the building for Option 4 'retention of central section of north façade, lobby and rotunda'

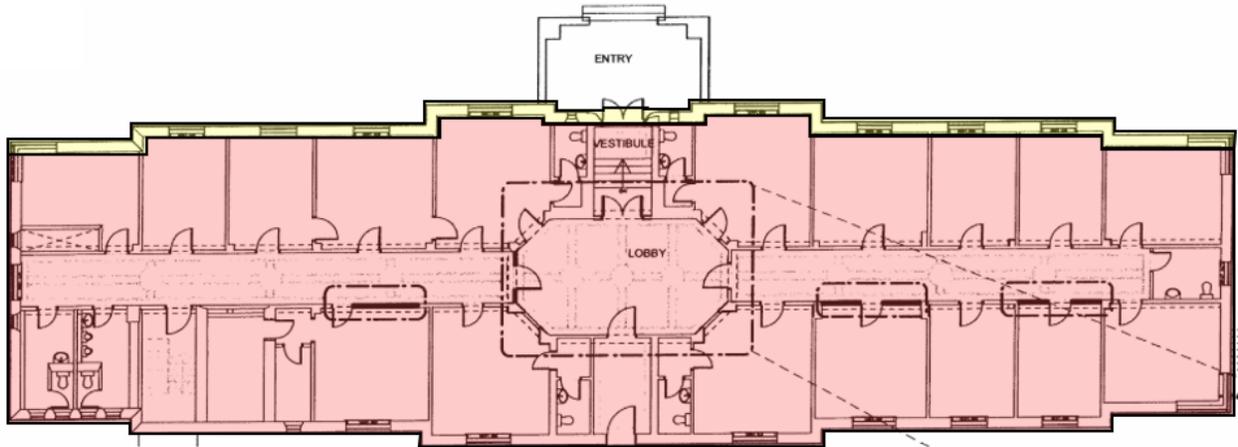
Figure 7: Diagram showing retained sections of the building for Option 5 'façade retention of only the building's primary, north elevation'

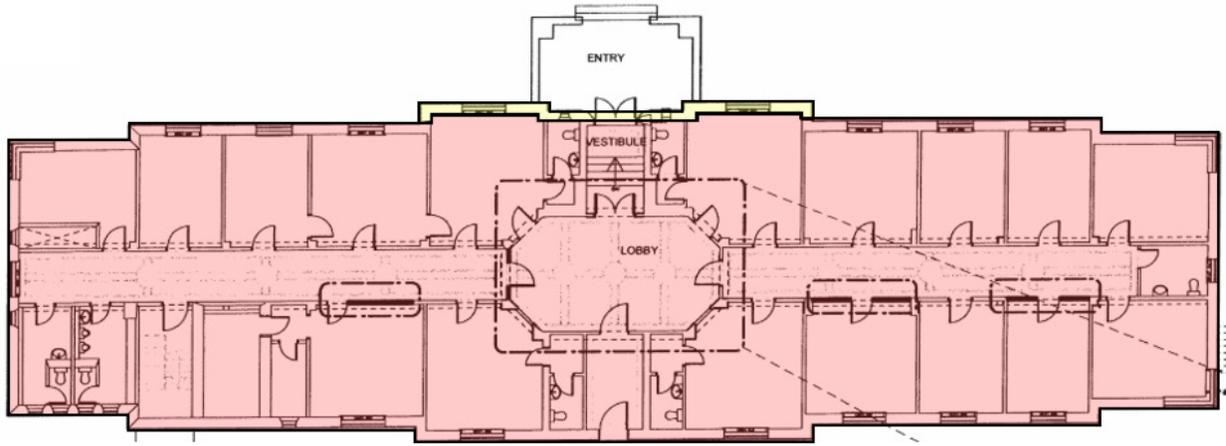
Figure 8: Diagram showing retained sections of the building for Option 6 'façade retention of only part of the building's primary, north elevation'

<p>6. Façade retention of only part of the building’s primary, north elevation (see Figure 8)</p>	<p>Allows for the retention of the heritage attributes located in the central section of the building’s north façade. Allows for some of the existing building to be retained and incorporated into the forthcoming development on the property. Eliminates the presence of designated substances on the Property.</p>	<p>Only heritage attributes located in the central section of the building’s north façade would be retained. All internal attributes and attributes on the building’s east, west, and south elevations would be removed. Attributes on the north elevation that are not in its central section would be removed. The building’s rotunda would be removed.</p>	<p>All attributes included in the central section of the building’s north façade would be retained.</p>	<p>Extensive repair and/or replacement of stone would be required. Extensive repair and/or replacement of the building’s primary entrance would be required.</p>	<p>This option is not preferred unless Option 5 is determined to be impractical or unfeasible.</p>

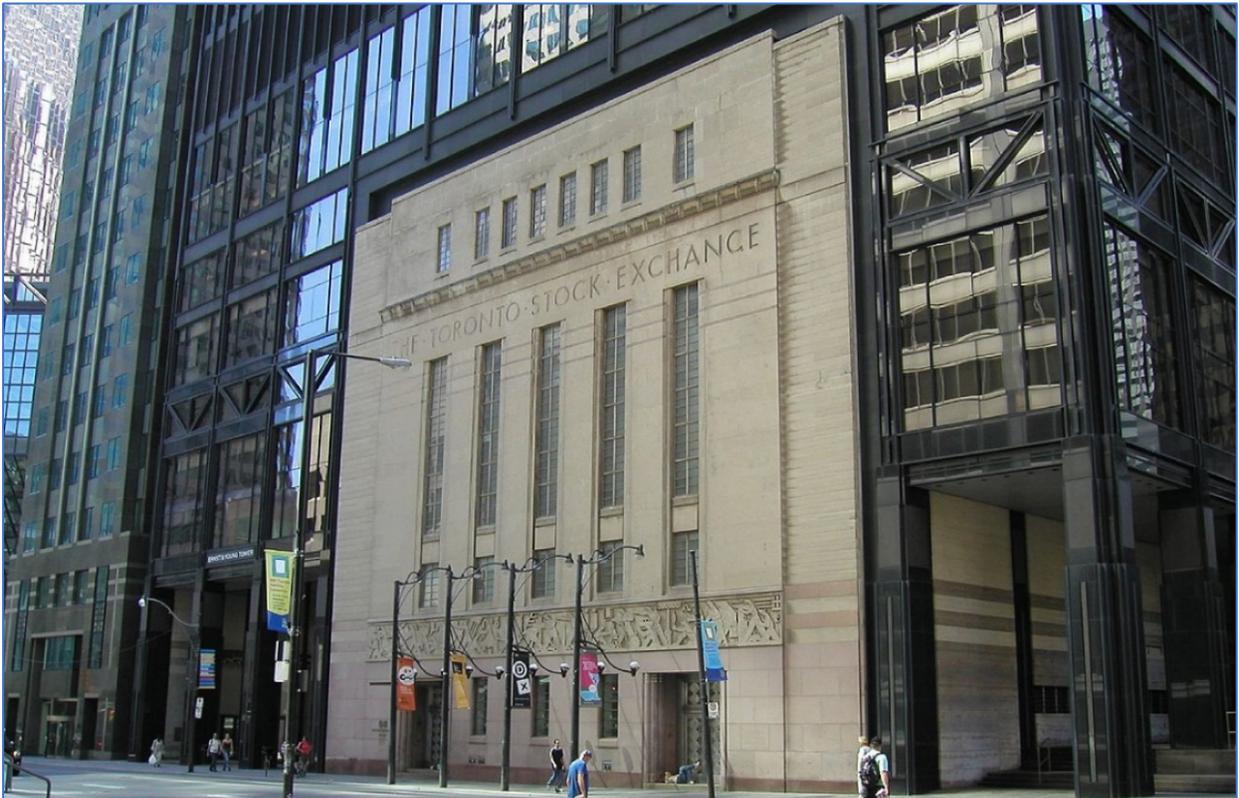
Figure 10: Photograph showing the integration of the former Toronto Stock Exchange building into a new development.²⁷

The building on the property was retained *in situ* and its primary elevation was retained as a prominent characteristic of the redeveloped property. Its side elevations and interior were also kept through the property’s redevelopment (Figure 10). This approach retained the buildings external and internal heritage attributes.

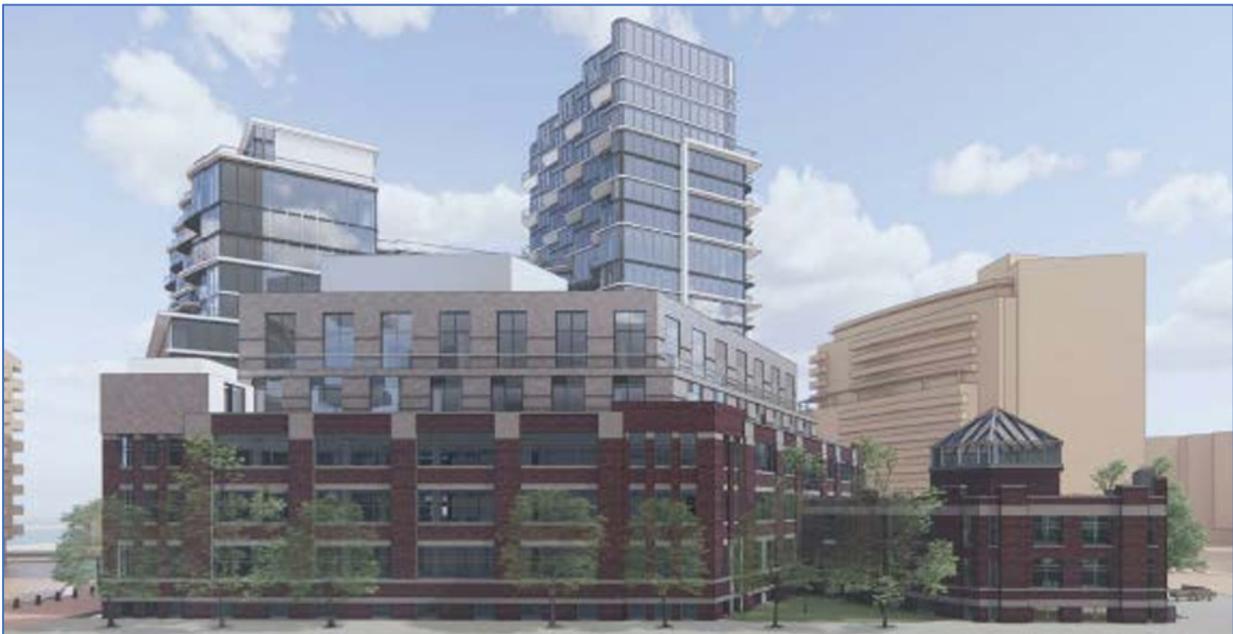
Figure 11: Rendering of the proposed redevelopment of 545 Lake Shore Boulevard West²⁸

A high concentration of the building’s heritage attributes are located on an enclosed, hexagonal pavilion at the main entrance. The proposed redevelopment retains the pavilion *in situ* and focuses new construction towards the rear of the property (Figure 11).

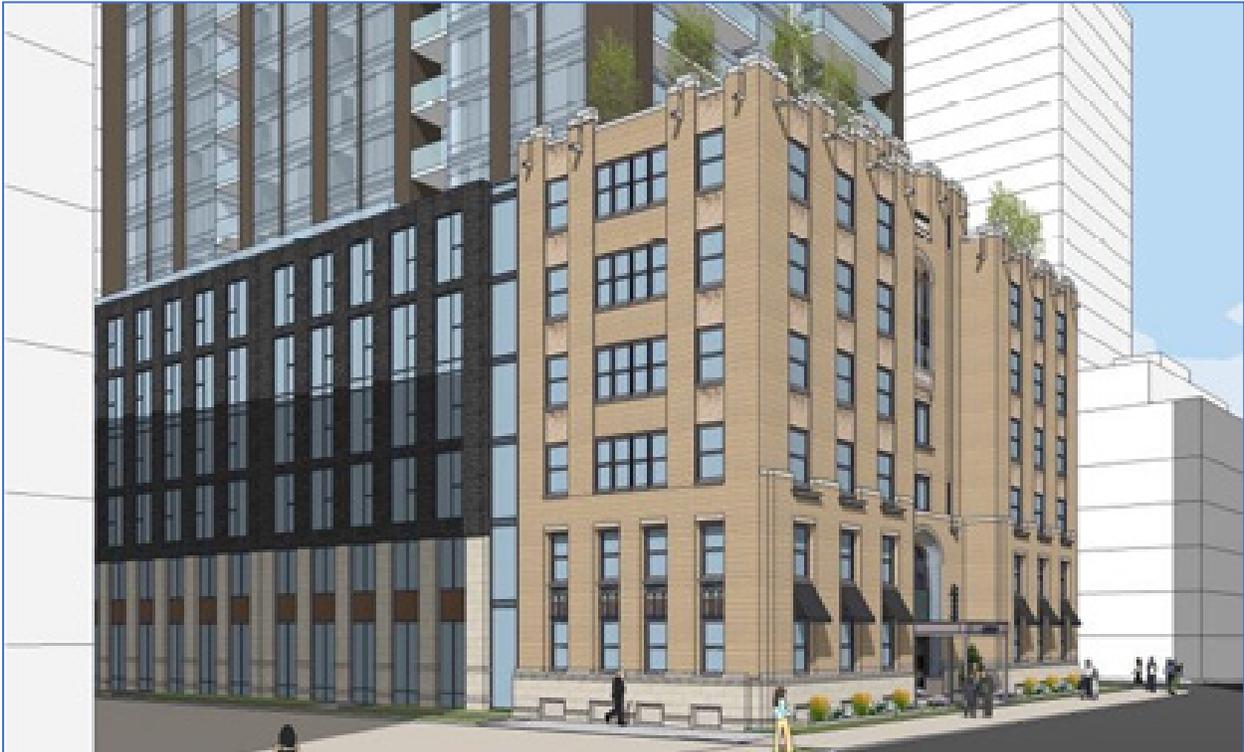
Figure 12: Rendering of the proposed redevelopment of 180 Metcalfe Street.²⁹

The property’s redevelopment retains the building’s primary elevation and sections of its side elevations (Figure 12). The retained sections of the external wall will be rehabilitated and most of the building’s internals will be demolished.
