**Heritage Evaluation Report
(Amendment to Designating By-law)**

**Breadner House (0 Tufton Crescent)
March 2021**

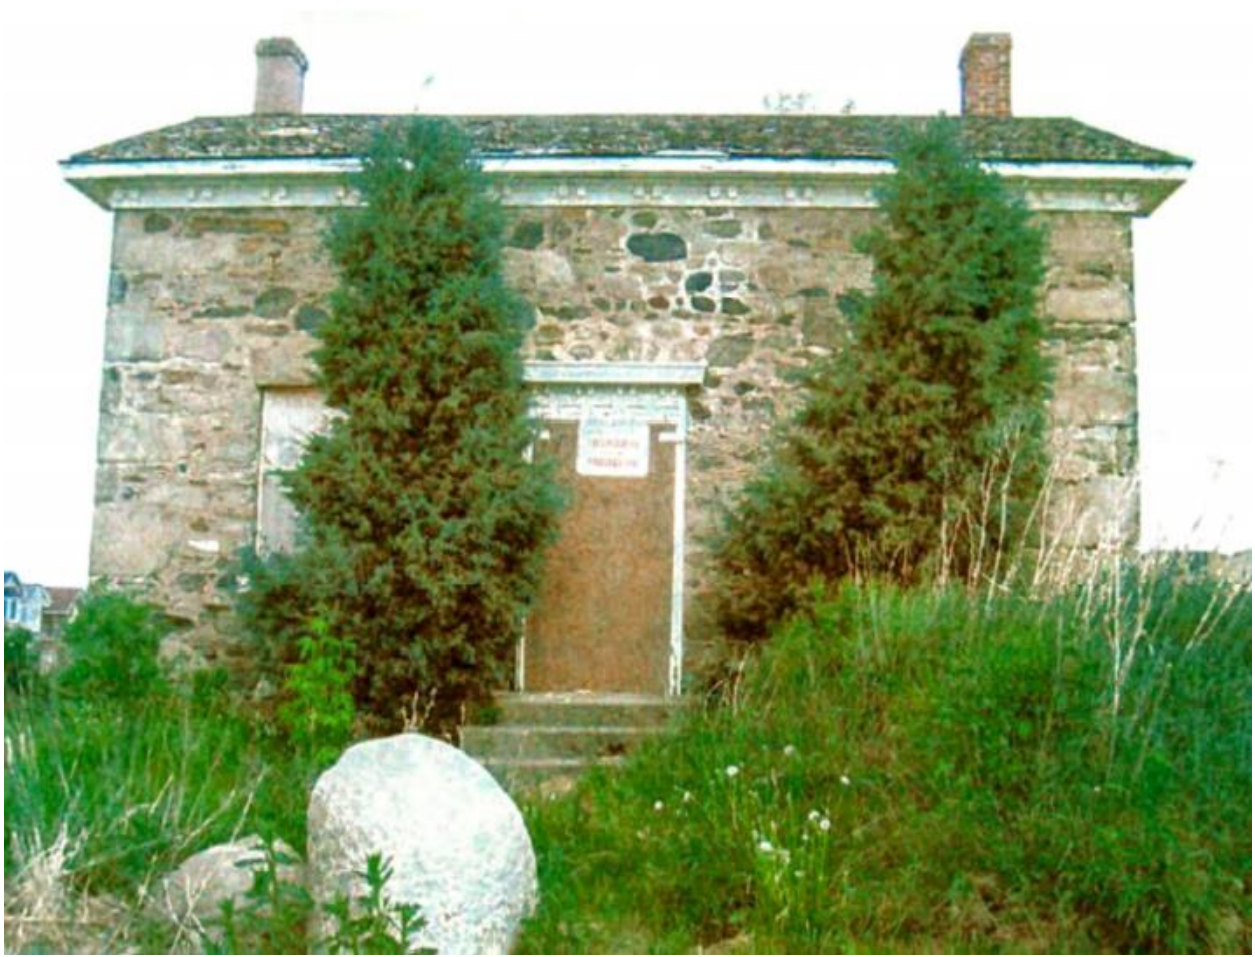
Figure 4: Front (west) elevation of the Breadner House (Source: City of Brampton, 2009)

The Breadner House exhibits a number of characteristics of the Georgian Style with Neo-Classical undertones. These include the symmetrical three bay facade, the ornamental boxed cornice and returns which are decorated with a classical frieze, and the six-over-six double hung and wood sash windows. The door surround is also distinctive with its classical entablature and geometric pattern.

- The one-and-a-half storey vernacular farmhouse;
- The saltbox form and Neoclassical and Georgian design influences;
- The three bay front elevation with a symmetrical composition consisting of a central door with flanking windows;

- The two identical chimney stacks with symmetrical placement near the gable ends of the roof;
- The front entrance, raised above a three steps with classical entablature, pilasters and decorative geometric patterning;

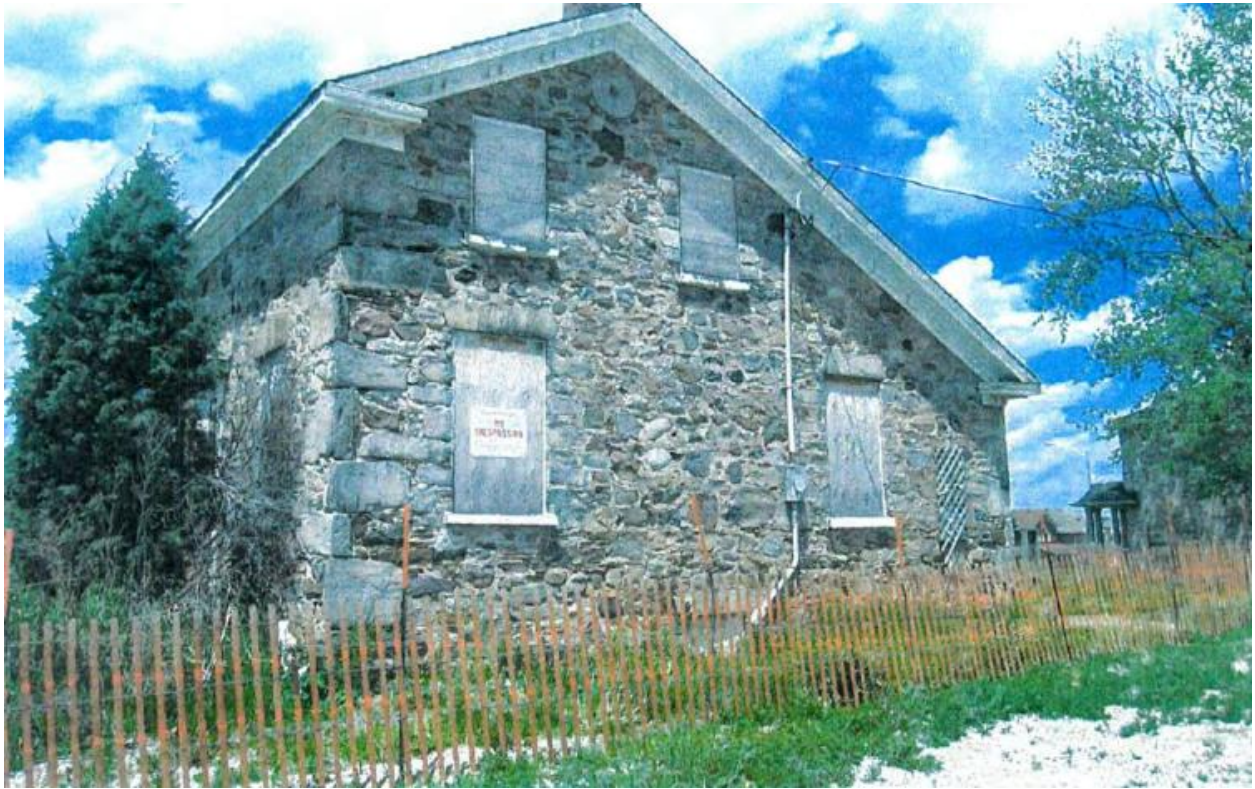
Figure 5: Side (south) elevation of the Breadner House (Source: City of Brampton, 2009)

- The millstone on the side elevation and at the centre of the gable roof;
- The six-over-six wood sash windows on the front and side elevations;
- The stone windowsills on the front and side elevations;

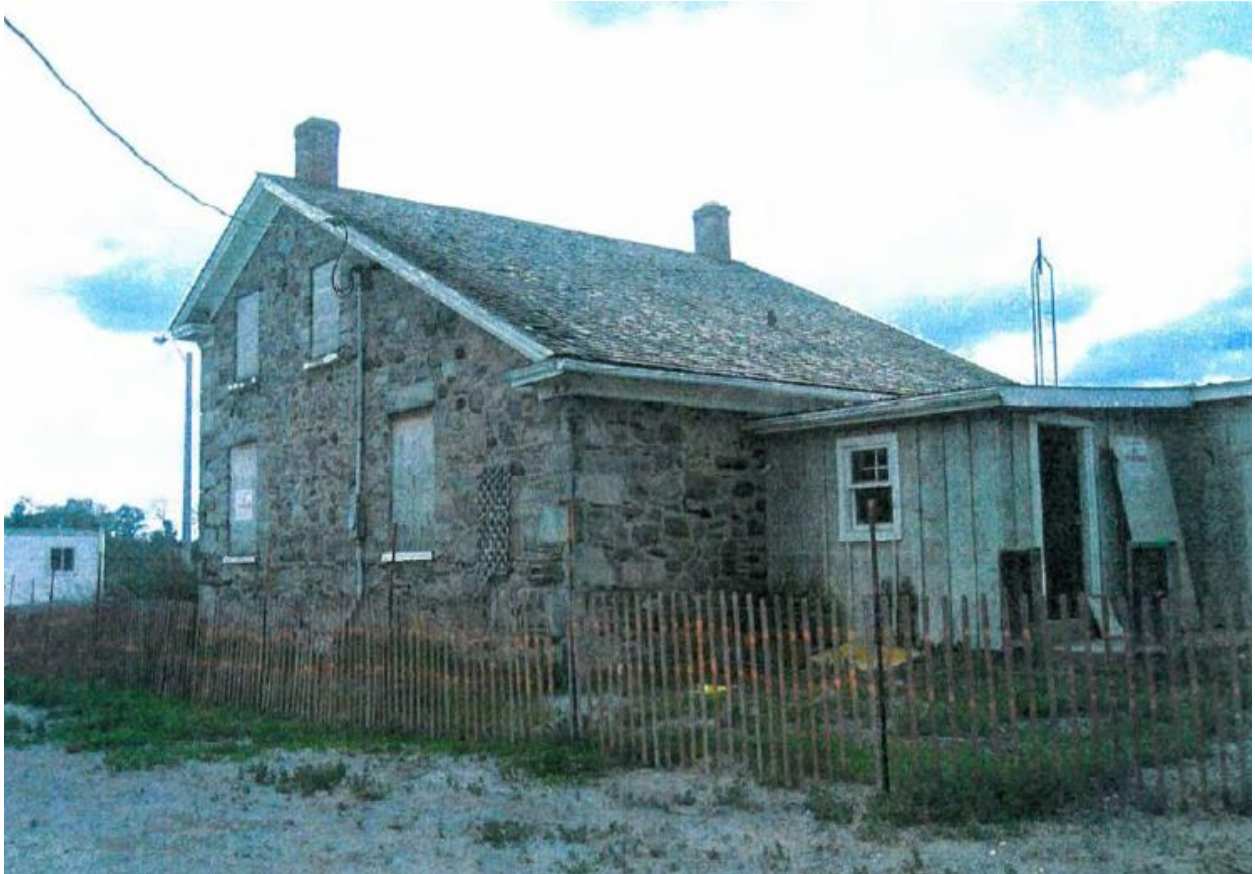
Figure 6: Side (south) and rear (east) elevations of the Breadner House (Source: City of Brampton, 2009)

The Breadner House is also representative of the saltbox house style and form, which is a traditional colonial style of house found mostly in New England. The style is characterised by a side gable roof that slopes down the back to a lower point in comparison with the front. The saltbox style and form is not common in Ontario.

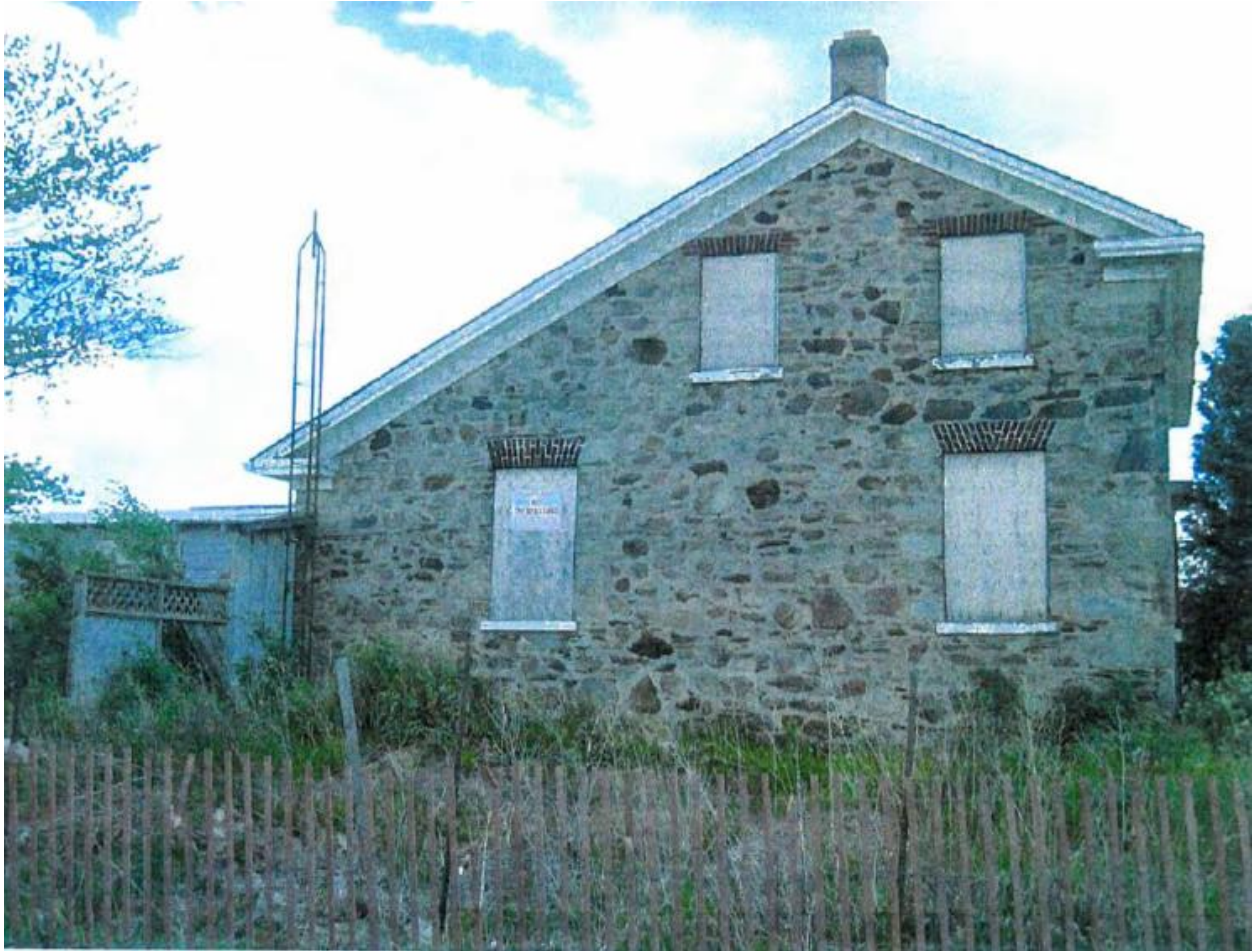
Figure 7: Side (north) elevation of the Breadner House (Source: City of Brampton, 2009)
