Villages of Rosedale Noise Walls

June 9, 2021

VOR Noise Wall Inspection - Summary

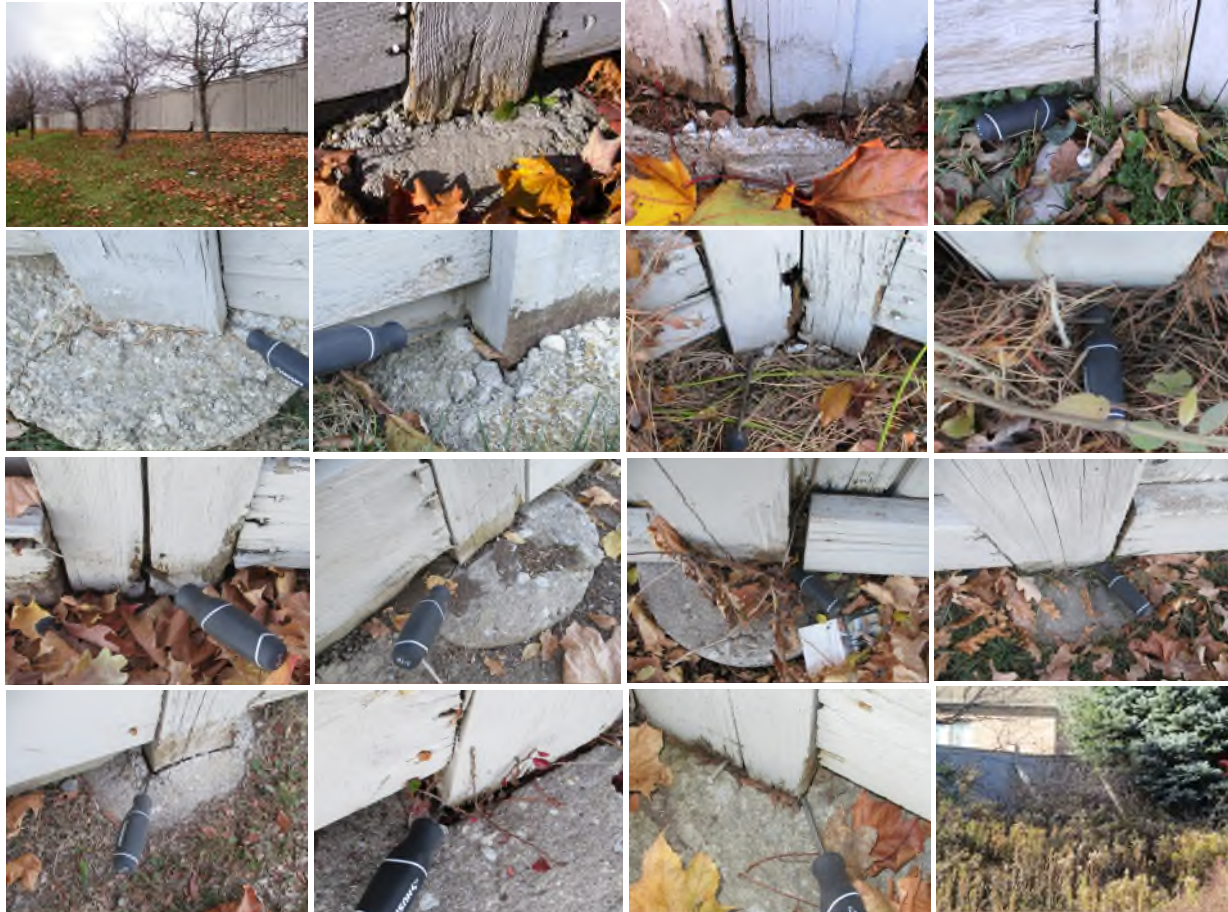
VOR Noise Wall Inspection - Images

- It is a known fact that wood embedded in concrete has a reduced life expectancy due to rot; life expectancy can be reduced by up to 50%. The wood noise fences along Sandalwood Parkway and Dixie Road have had their wood posts embedded in concrete which has led to accelerated post rot/deterioration.

- 86% of the accessible wood posts reviewed along the Sandalwood Parkway fence have various degrees of wood rot at their bases, typically at the concrete interface. This rot allowed the 14cm screwdriver blade to penetrate up to 14cm into the post where rot was present.

- Approximately 30% of the accessible wood posts reviewed along the Sandalwood Parkway fence have steel support brackets installed at the base of the posts to provide added strength as severe rot has weakened the post. The fastening bolts for these bracket supports have breached the wood preservative and will further accelerate the internal wood rot.

- 24% of the wood fence panels reviewed along the Sandalwood Parkway can easily be swayed by applying minimal force along the post/panels. This swaying is the result of the decreased strength at the wood post base.

- 50% of the wood posts reviewed along the Dixie Road fence have various degrees of wood rot at their bases, typically at the concrete interface. Rot allowed the 14cm screwdriver blade to penetrate up to 12cm into the post. Once the wood rot has passed the preservative outer layer of the surface wood it allows water to reach the inner post wood accelerating the rot process

- Two fence panels along Dixie Road have had wood support propped-up against them to prevent collapse.
 - The deteriorated posts along a portion of the Sandalwood Parkway fence resulted in the collapse of five panels, total length 40', during a windstorm in 2018. Further fence panel collapses can be anticipated with strong wind/gust events.

- In my professional opinion, based on my review/inspection, the noise wall/fences are in poor to very poor condition and will require replacement in the short term. Observations from my inspection include:
