Appendix E:

Torbram Road - Existing Conditions and Proposed Cross-Section

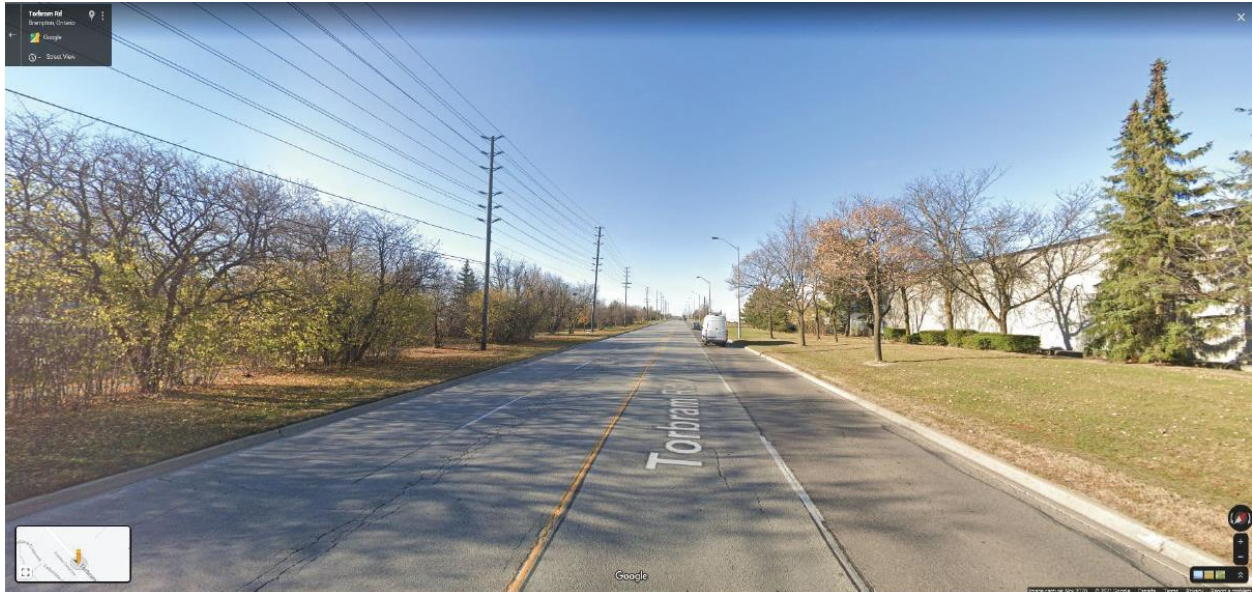
Figure 1: Existing Conditions – Torbram Road with Four- Lanes (Clark Blvd to Queen St)

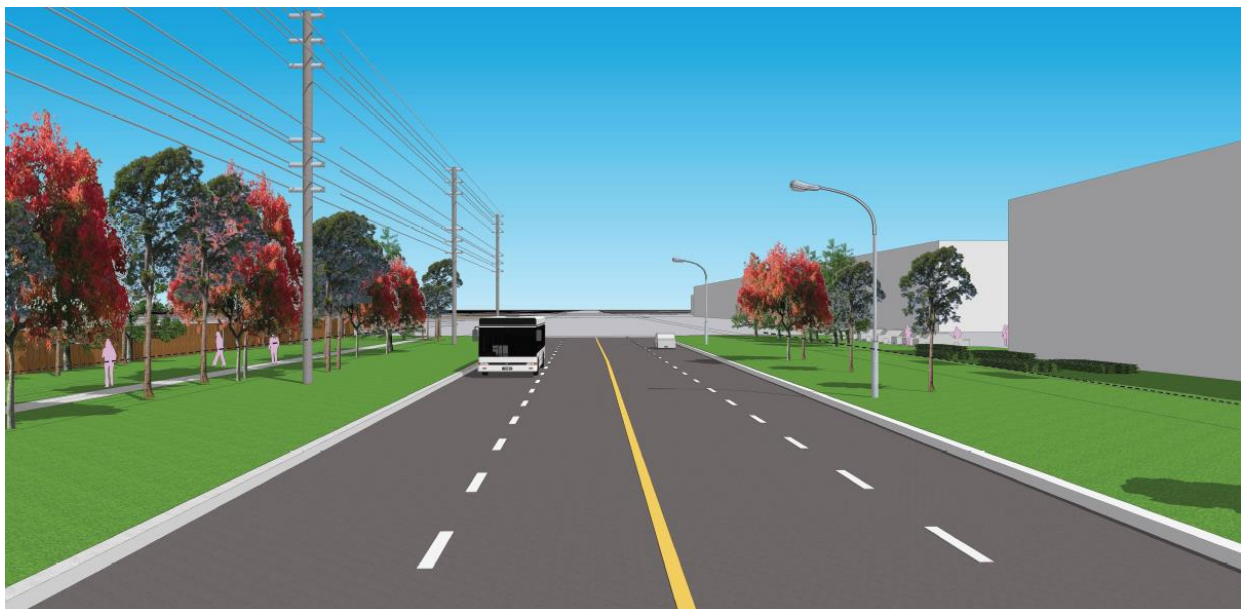
Figure 2: Rendering of Existing Condition and Cross-Section – Torbram Road with Four- Lanes (Clark Blvd to Queen St)

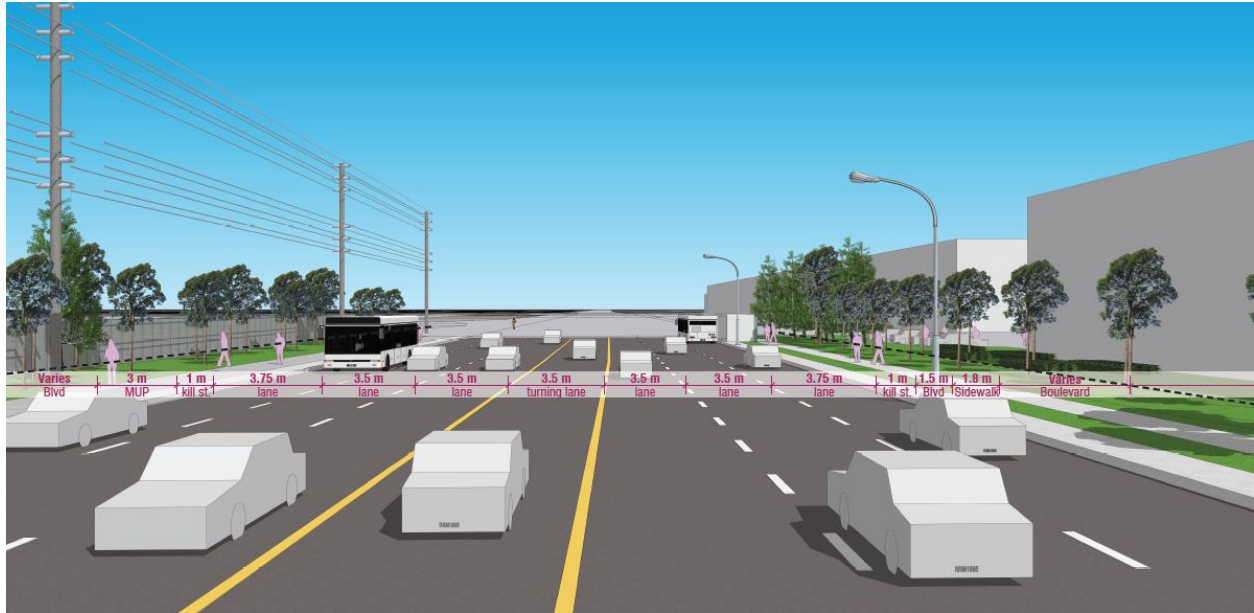
Figure 3: Rendering of Proposed Cross-Section – Torbram Road with Six-Lanes (Clark Blvd to Queen St)

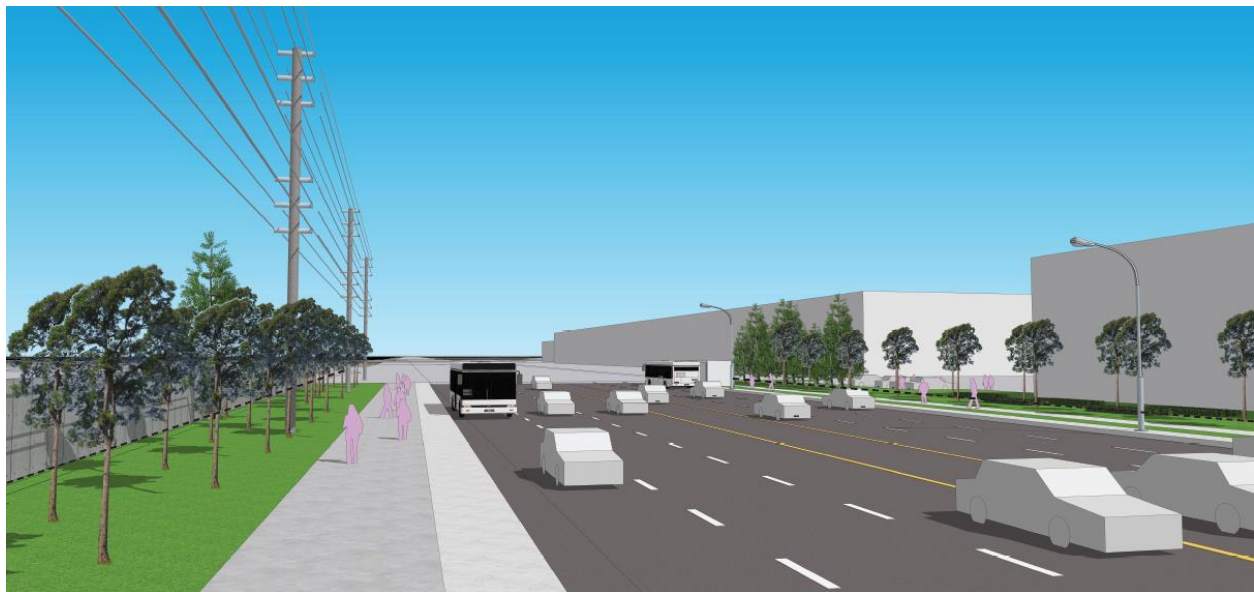
Figure 4: Rendering of Public Realm View– Torbram Road with Six-Lanes (Clark Blvd to Queen St)

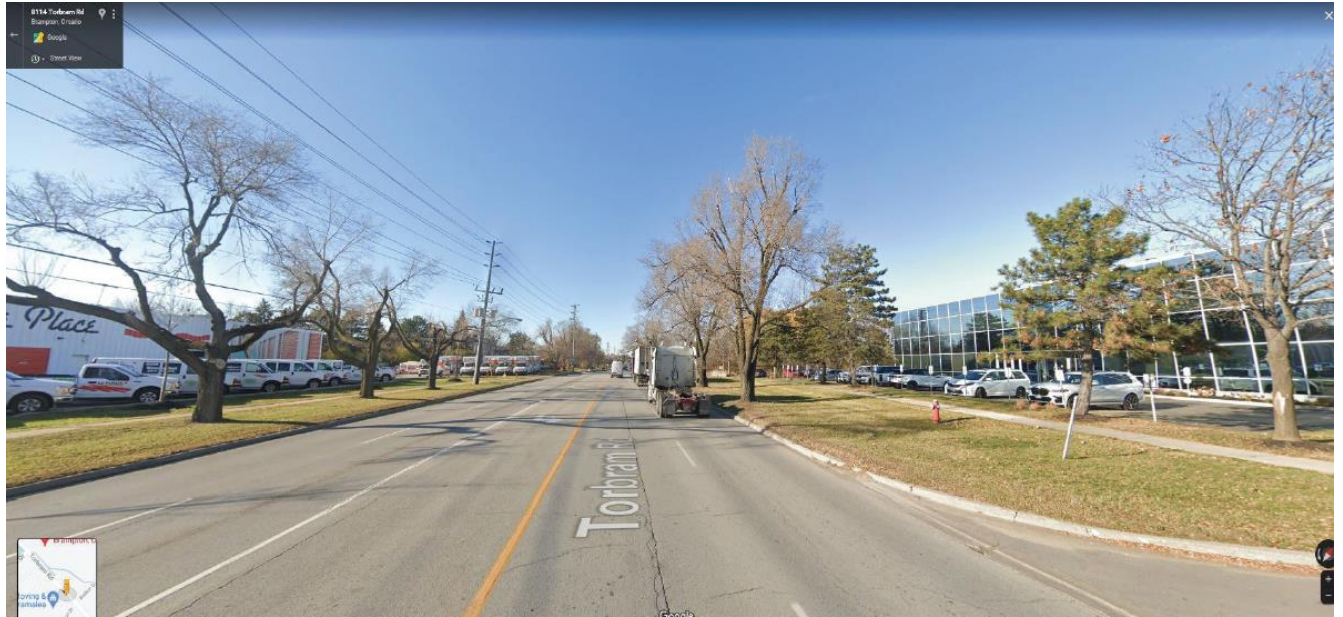
Figure 5: Existing Conditions – Torbram Road with Four- Lanes (East Dr/Walker Dr to Balmoral Dr)

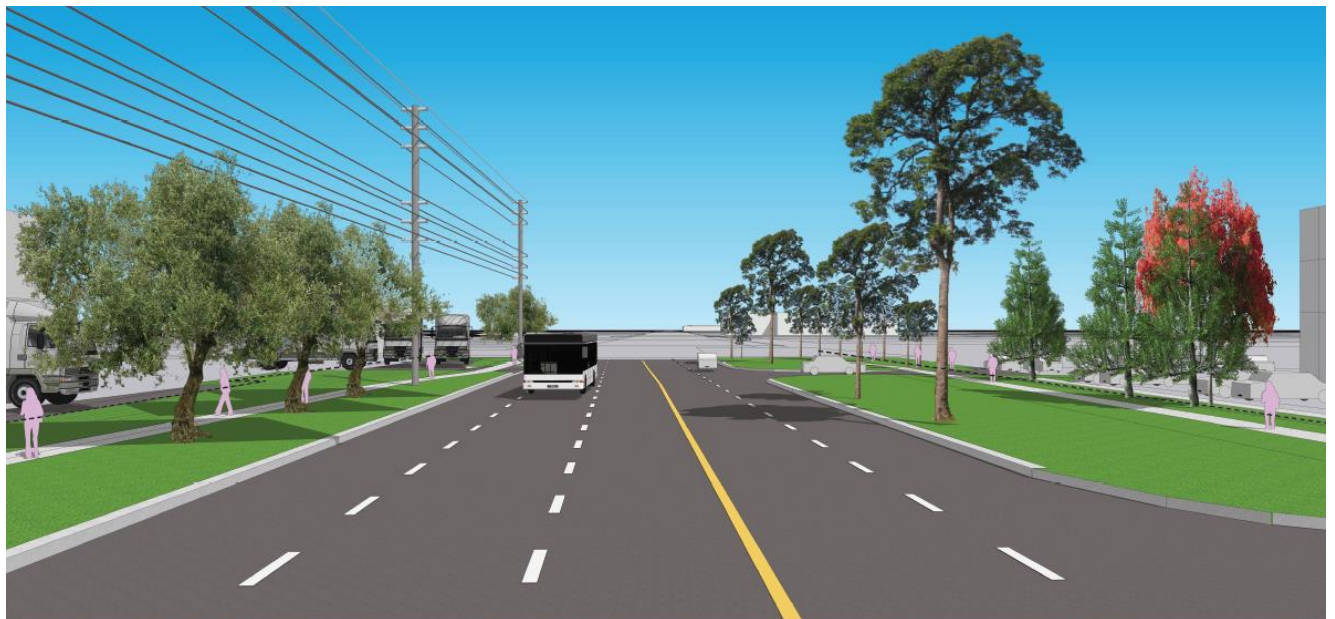
Figure 6: Rendering of Existing Condition and Cross-Section – Torbram Road with Four- Lanes (East Dr/Walker Dr to Balmoral Dr)

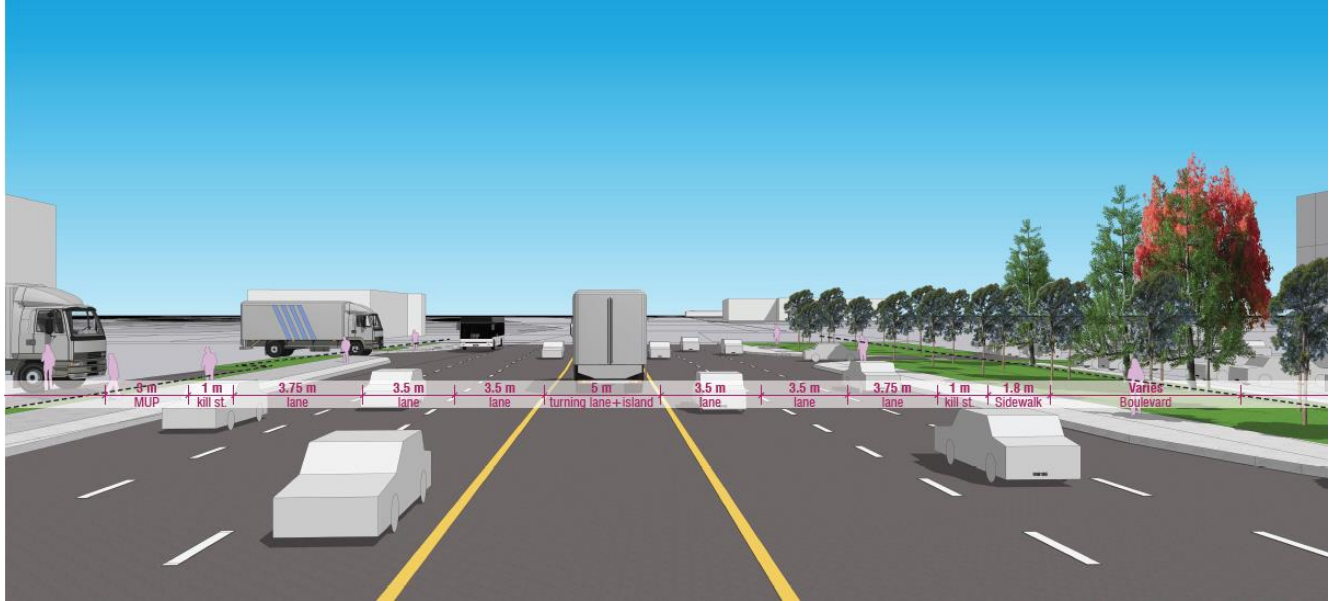
Figure 7: Rendering of Proposed Cross-Section – Torbram Road with Six-Lanes (East Dr/Walker Dr to Balmoral Dr)

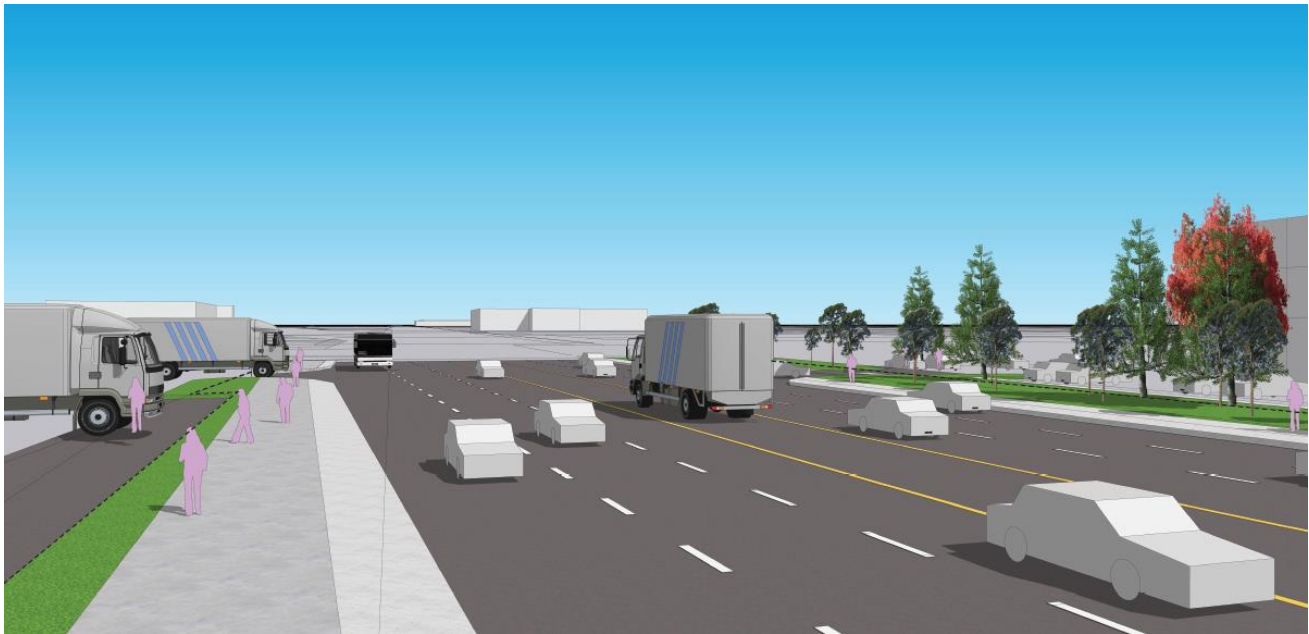
Figure 8: Rendering of Public Realm View– Torbram Road with Six-Lanes (East Dr/Walker Dr to Balmoral Dr)
