REPORT

11185 Airport Road, City of Brampton, Municipality of Peel, Ontario

Documentation and Salvage Plan Report

April 11, 2025

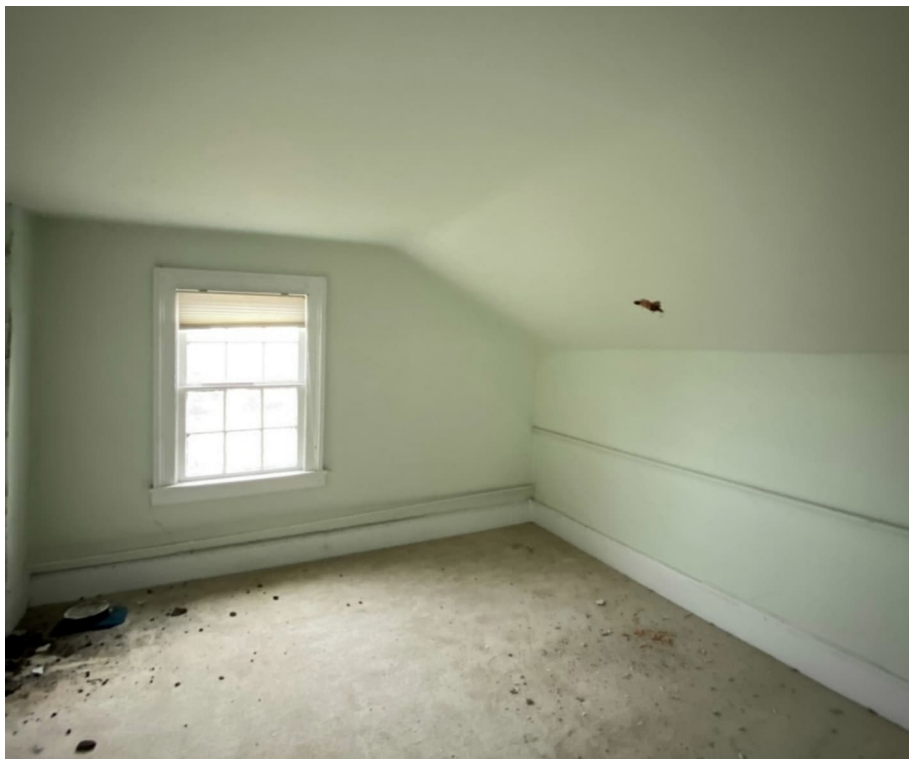
Plate 36: Bedroom 2 (southwest room), with chair rail along south and west walls, facing south (View R in Figure 9)

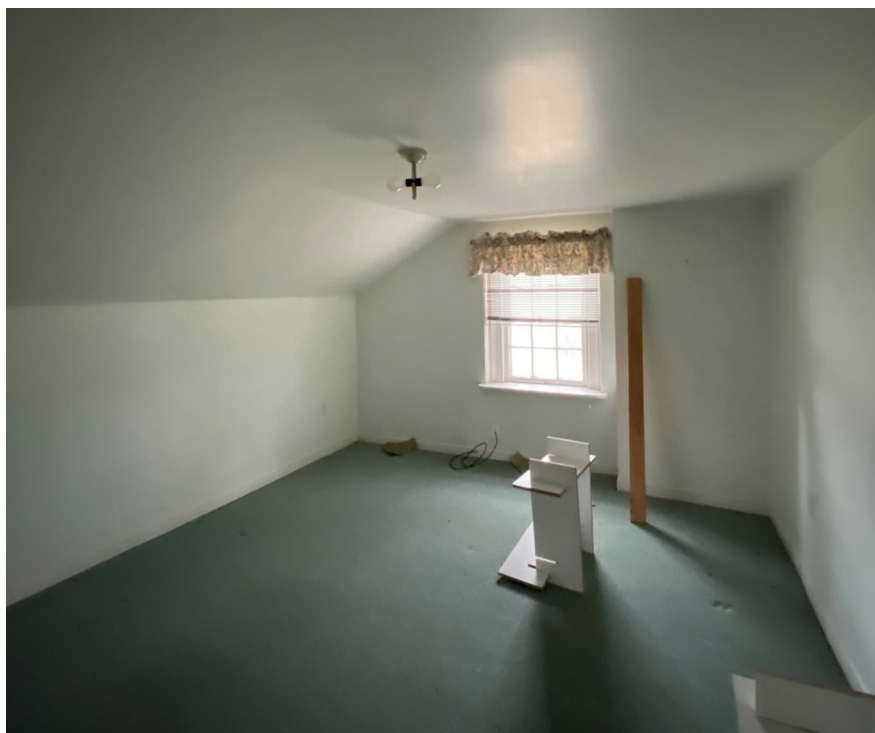
Plate 37: Primary bedroom (northwest room), facing north (View S in Figure 9)

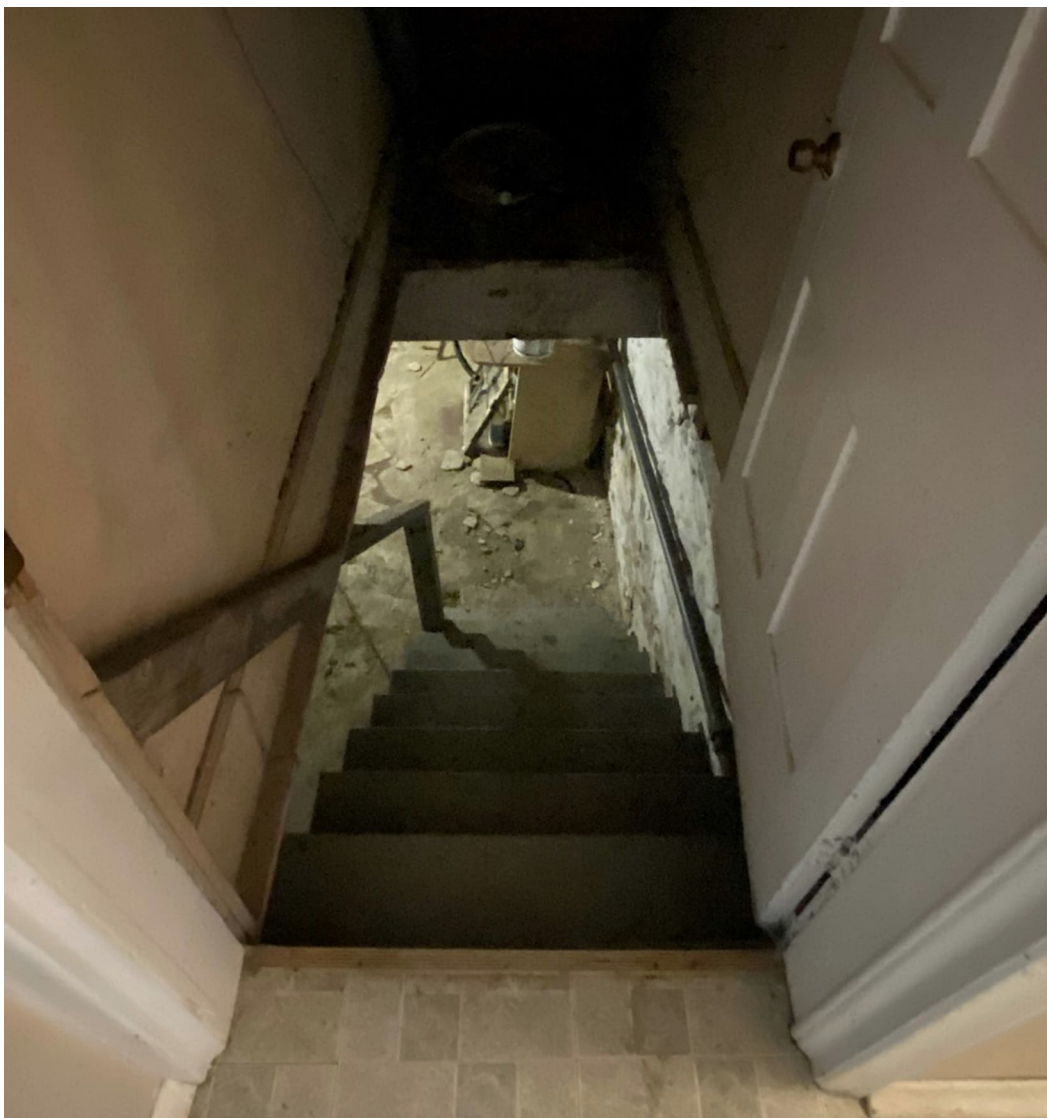
Plate 38: Basement with straight wood stairs, facing east (View U in Figure 10)

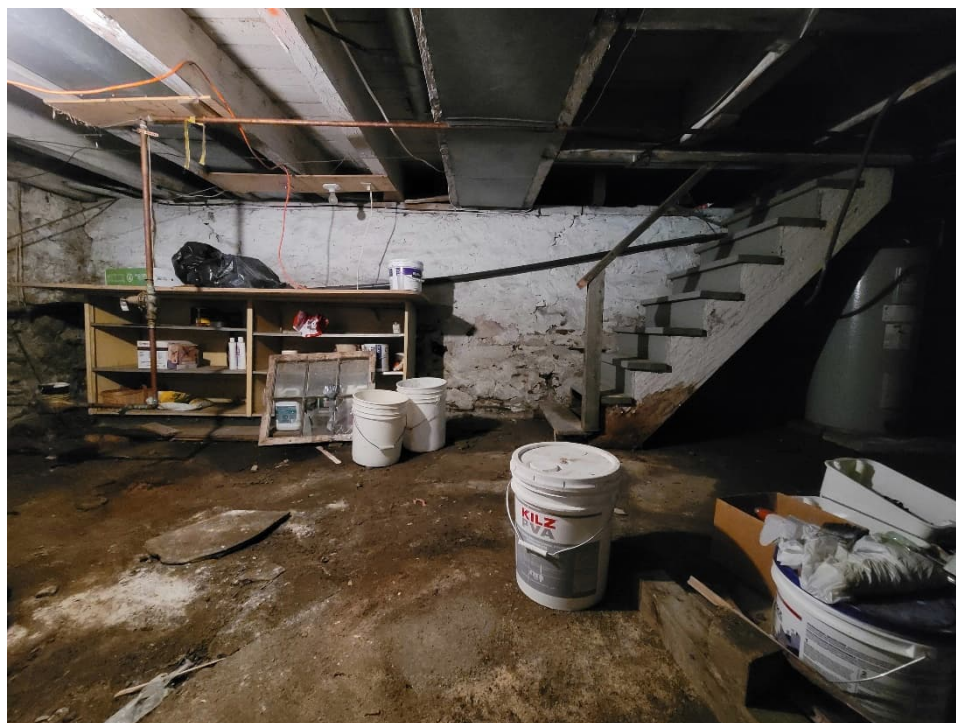
Entrance to the basement beneath the south half of the main block is a single flight of wood straight stairs from a doorway in the kitchen (Plate 38). The basement is unfinished with exposed floor joists and poured concrete floor, which is broken in several areas (Plate 39 to Plate 41). Coursed fieldstone foundation is visible in the interior of the basement with signs of deterioration due to water damage (Plate 42)

Plate 39: Basement, facing north (View V in Figure 10)

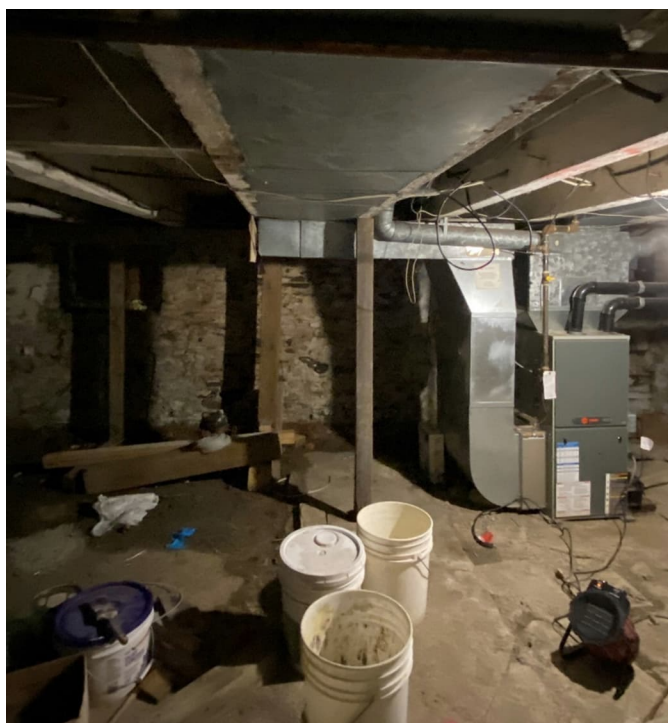
Plate 40: Basement, facing south (View W in Figure 10)

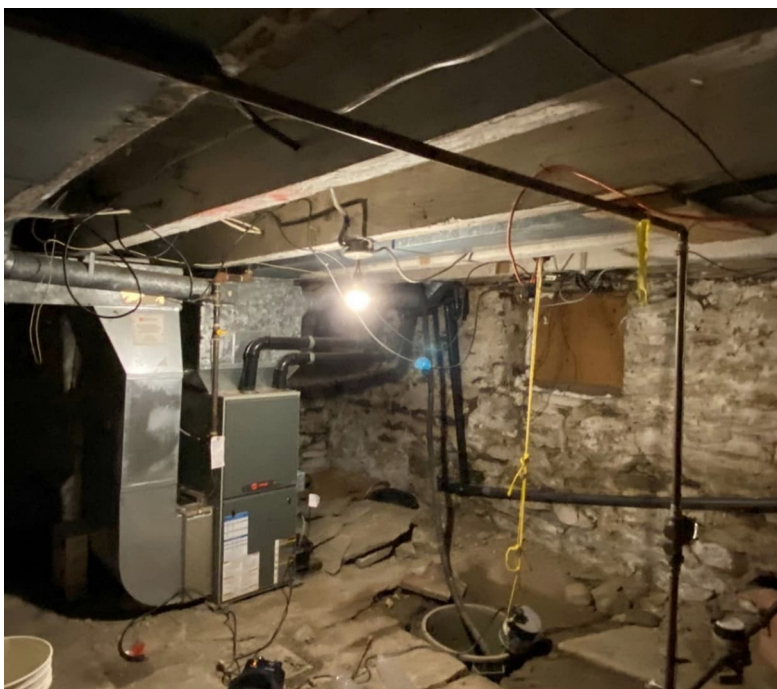
Plate 41: Basement with coursed fieldstone foundation, facing west (View X in Figure 10)

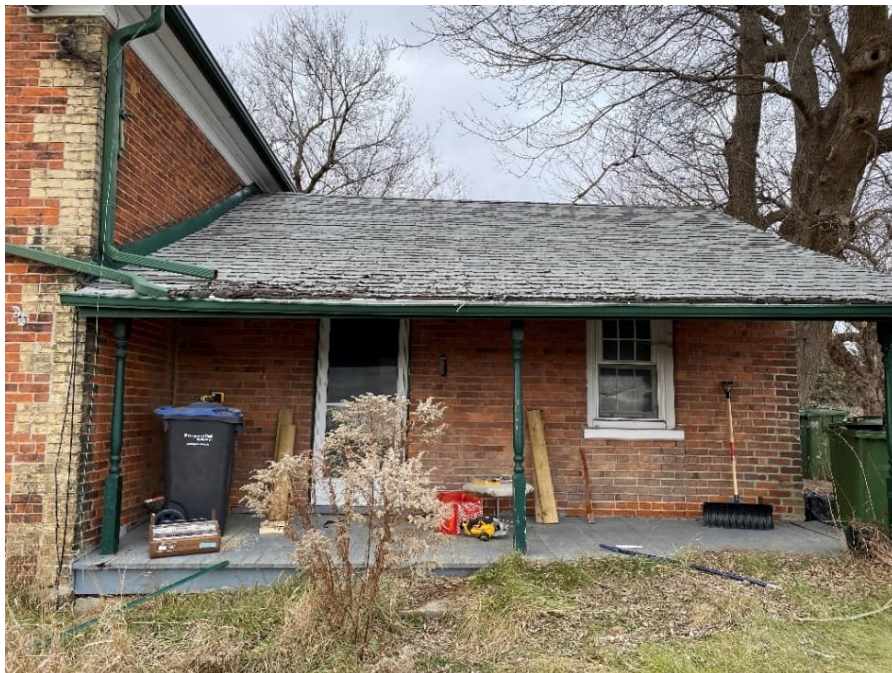
Plate 43: South elevation of the rear wing with open verandah extending from centre-south of the main block's east façade (View a in Figure 8)

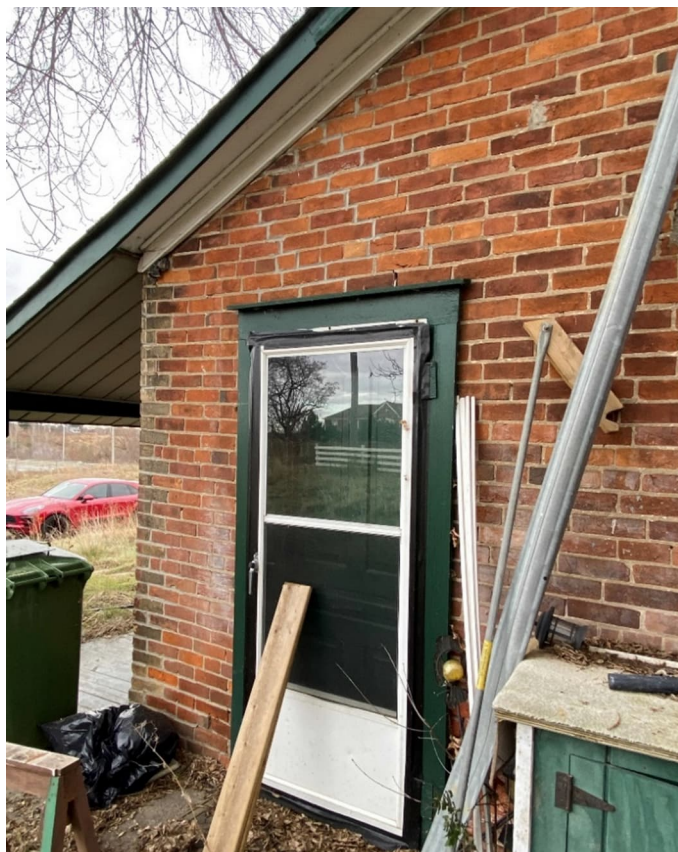
Plate 44: Buff brick quoins at the corner of east façade with a mix of faded red shade (as shown in *Figure 7*)

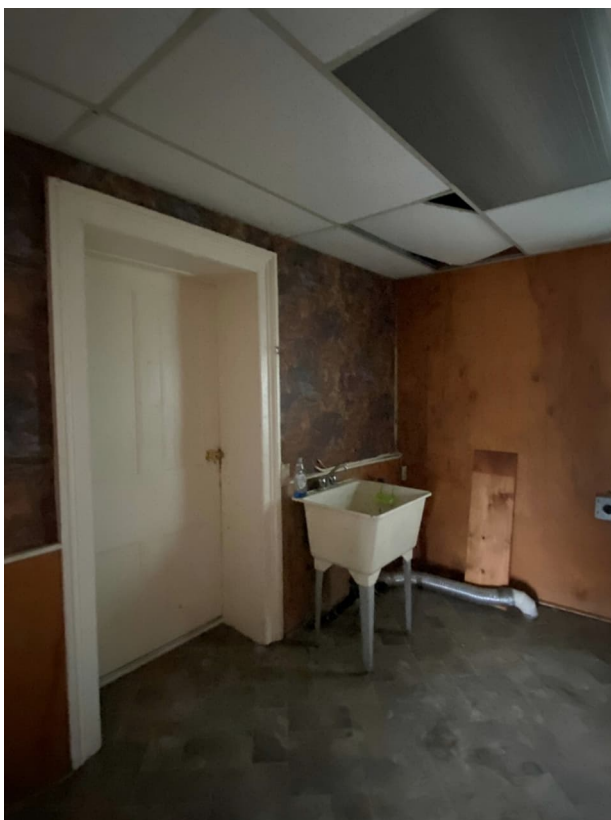
Plate 45: West half of the rear wing, facing north (View b in *Figure 8*)
