Scoped Heritage Impact Assessment

*10980 Hwy 50
Brampton ON*

File no. 2558A

May 2025 (revised)

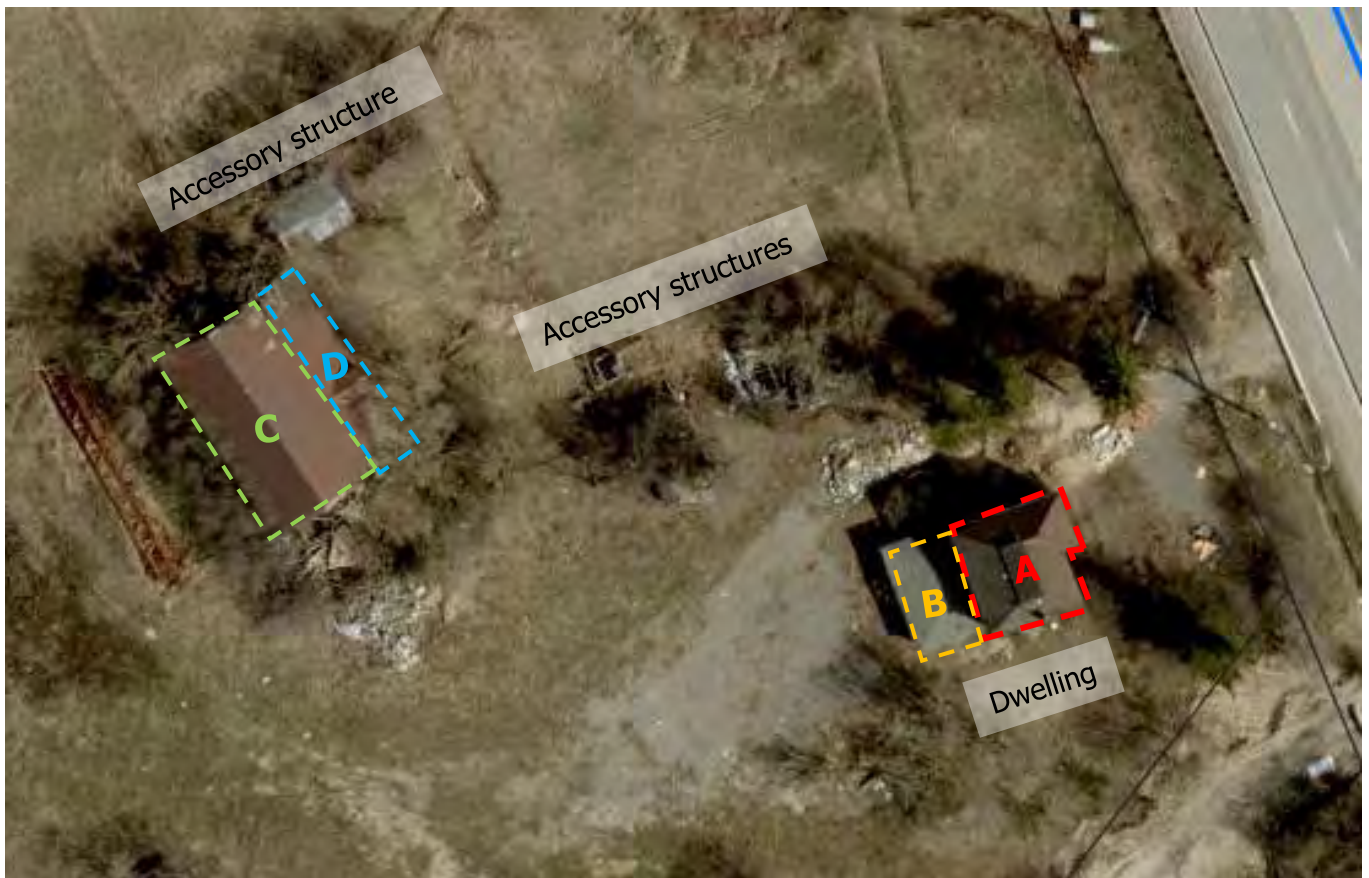
Figure 7 – Aerial photograph noting the location of existing features (Source: Brampton Interactive Map, accessed 2025)

Description of Built Features		
Identifier	Description	Construction Date
A	2 storey red brick dwelling	Bet. 1891 - 1921
B	Single story brick addition	Likely mid. to late 20 th century
C	Barn	Early to mid. 19 th century
D	Barn addition	19 th century

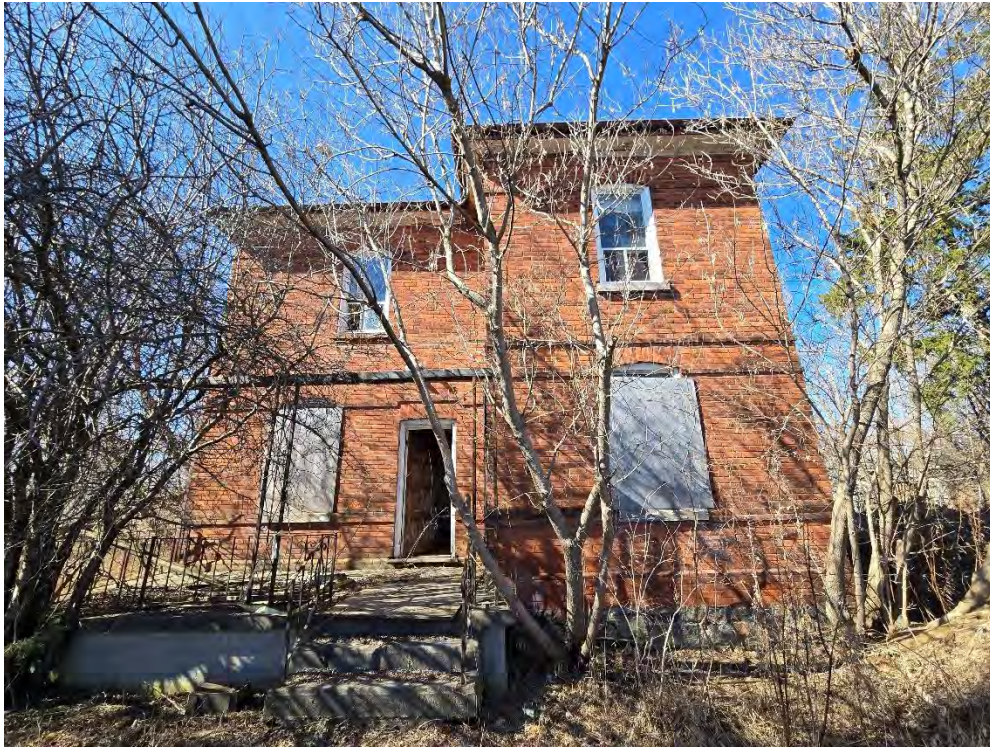
The dwelling can be described as a 2 storey wood frame brick veneer dwelling constructed in the Vernacular architectural style with Victorian influences. The building includes a contemporary single storey rear addition.

Figure 8 - (above) View of east (front) elevation of dwelling, (MHBC, 2025).

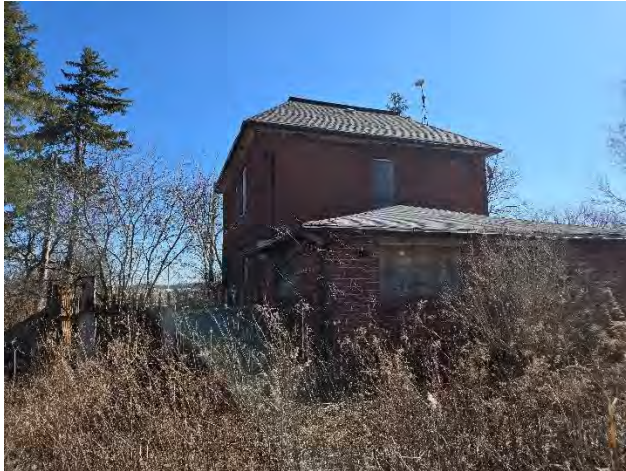
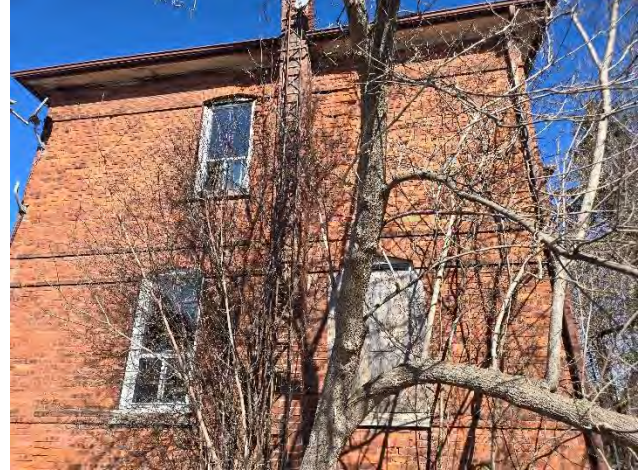
Figures 9 - 10 - (above, left) View of north and west (rear) elevations, (above, right) View of south elevation, (MHBC, 2025).

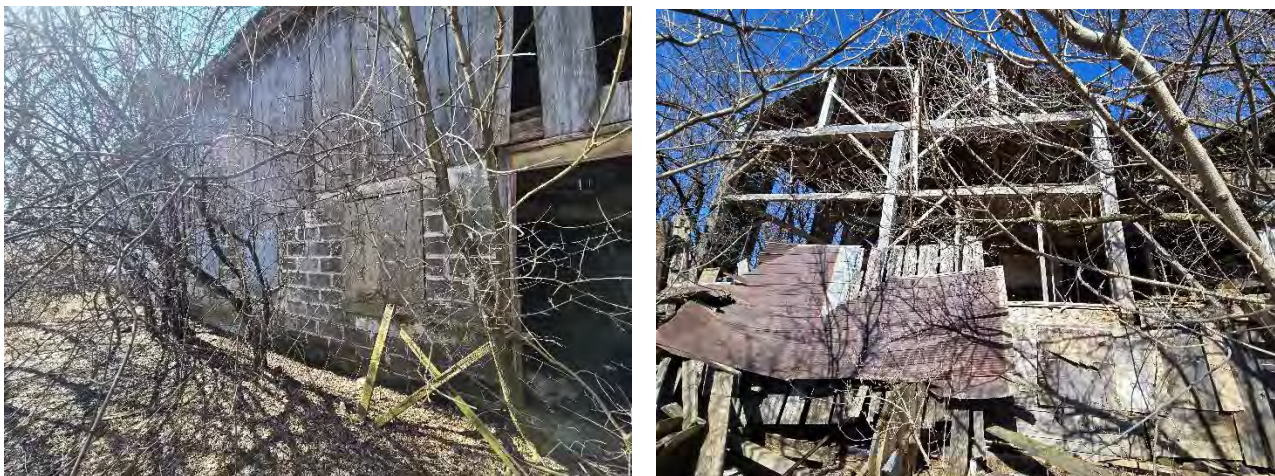
The subject property includes a 19th century wood frame barn which has partially collapsed. The barn was constructed in two sections, noted in this report as Sections "C" and "D" (See

Figure 7). The original portion of the barn (Section “C”) includes a gabled roof. Section “D” is a sloped roof addition at the east elevation. The barn includes hand hewn timbers with mortise and tenon joint construction methods. The stone foundation has been parged in areas to appear as concrete blocks.

Figures 11 - 12- (above, left) View of east elevation of barn, (below, right) View of south elevation of barn, (MHBC, 2025).

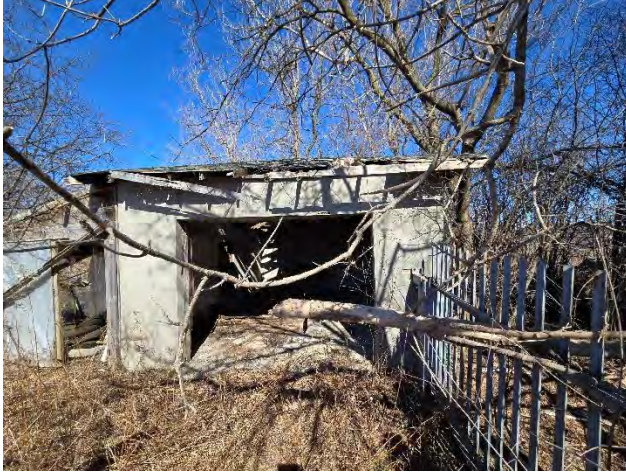
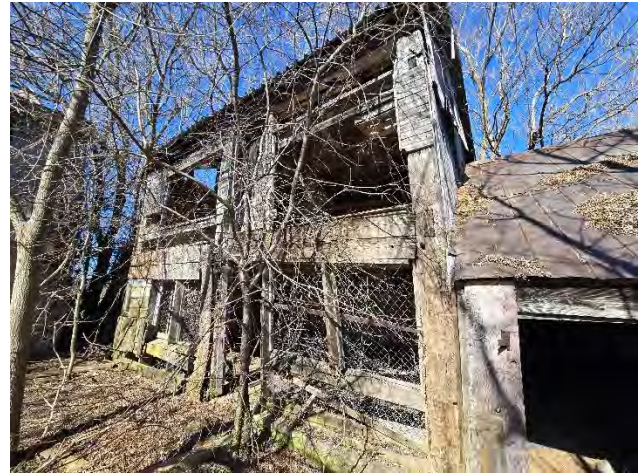
The subject property includes accessory structures, including single storey shed structure with contemporary framing as well as a 2 storey wood frame structure which was likely utilized for livestock. The 2021 HIA suggests this was utilized as a “hen house”. The property includes additional small accessory structures. While the use of these structures cannot conclusively be determined, the HIA (2021) suggests that the property may include a “milk house”.

Figures 13-14- (above, left) View of south elevation of single storey shed structure with contemporary framing, (below, right) View of 2 storey "hen house" structure (MHBC, 2025).

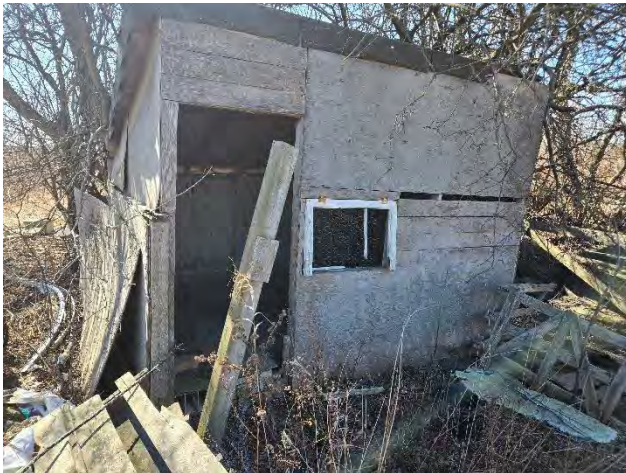
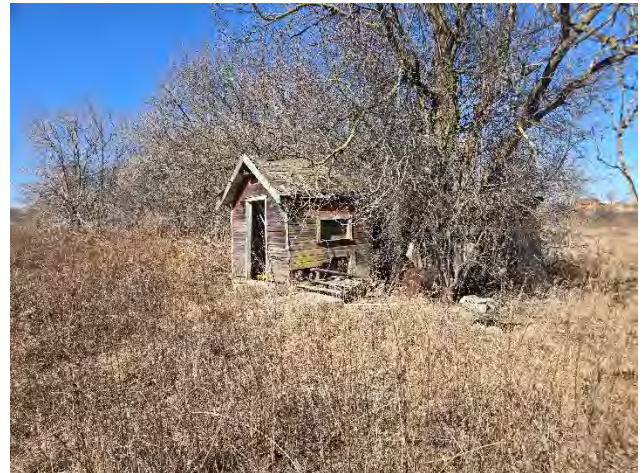
Figures 15 - 16- (above, left) View of contemporary wood frame accessory structure, (below, right) View of wood frame accessory structure, suggested in the 2021 HIA as a "milk house", (MHBC, 2025).

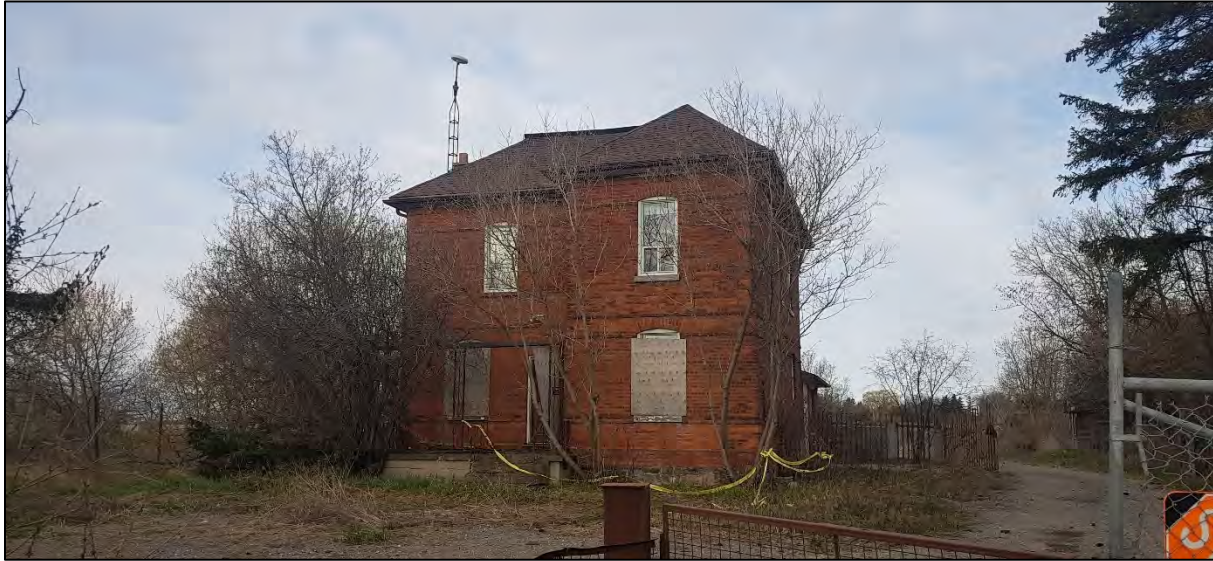
Figure 14: The farmhouse at 10980 Highway 50, east elevation (ASI 2020)

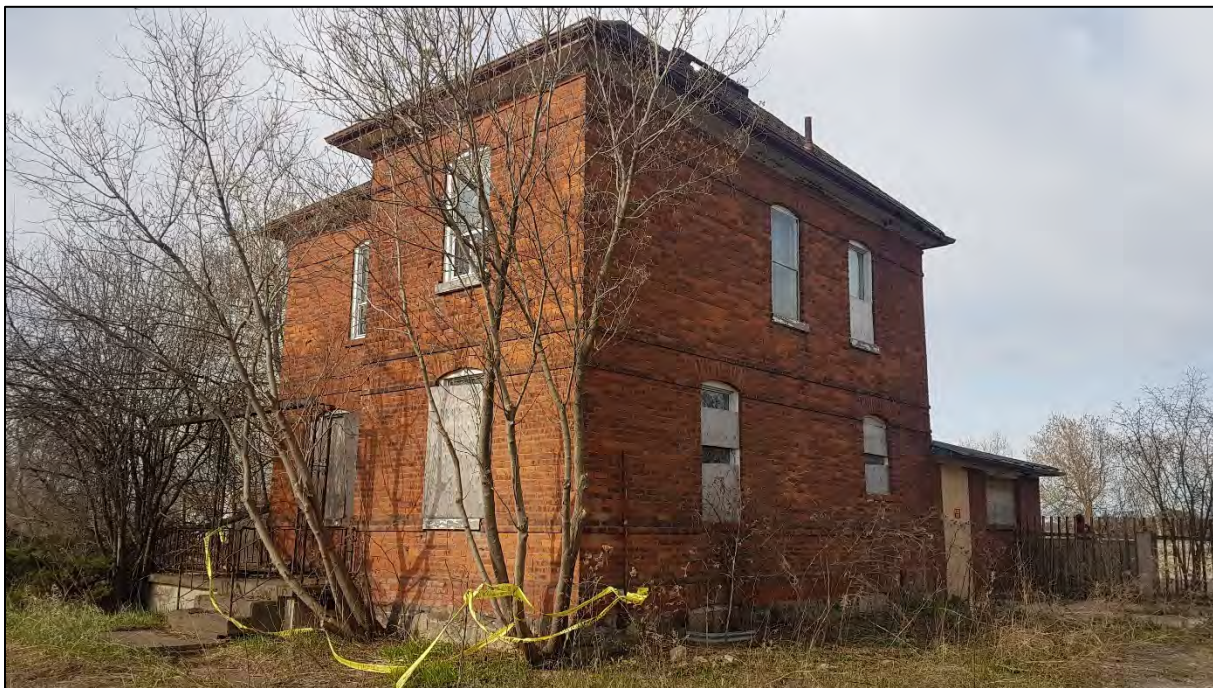
Figure 15: The farmhouse at 10980 Highway 50, north and east elevations (ASI 2020)

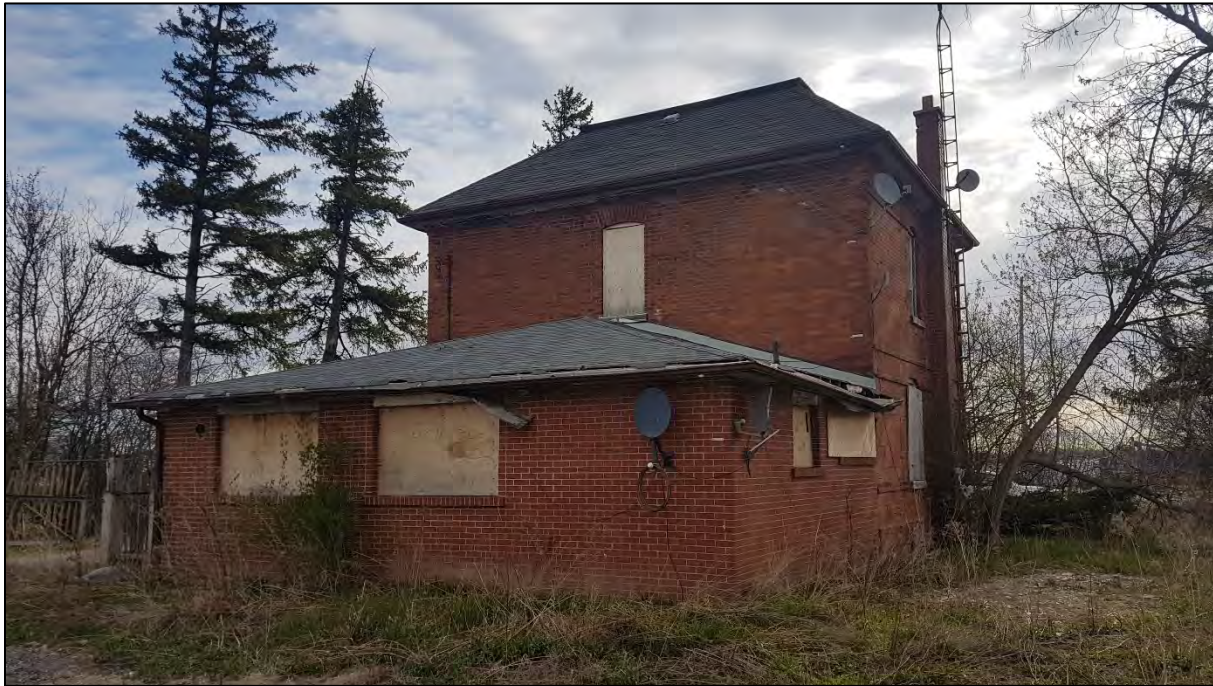
Figure 16: The farmhouse at 10980 Highway 50, west elevation showing one-storey rear addition (ASI 2020)

A single storey, circa 1960s, rear brick addition with concrete foundations and low hipped roof has been added to the west façade of the house, replacing the original kitchen tail (Figure 16). The original front porch, which extended across the front façade from the projecting bay to the southeast corner of the house, has also been removed. In its place is a modern porch (without a roof) with concrete foundations and steel railings around the perimeter (Figure 21). Evidence of the former covered porch is visible in the brick work, just above the first storey windows (Figure 22).

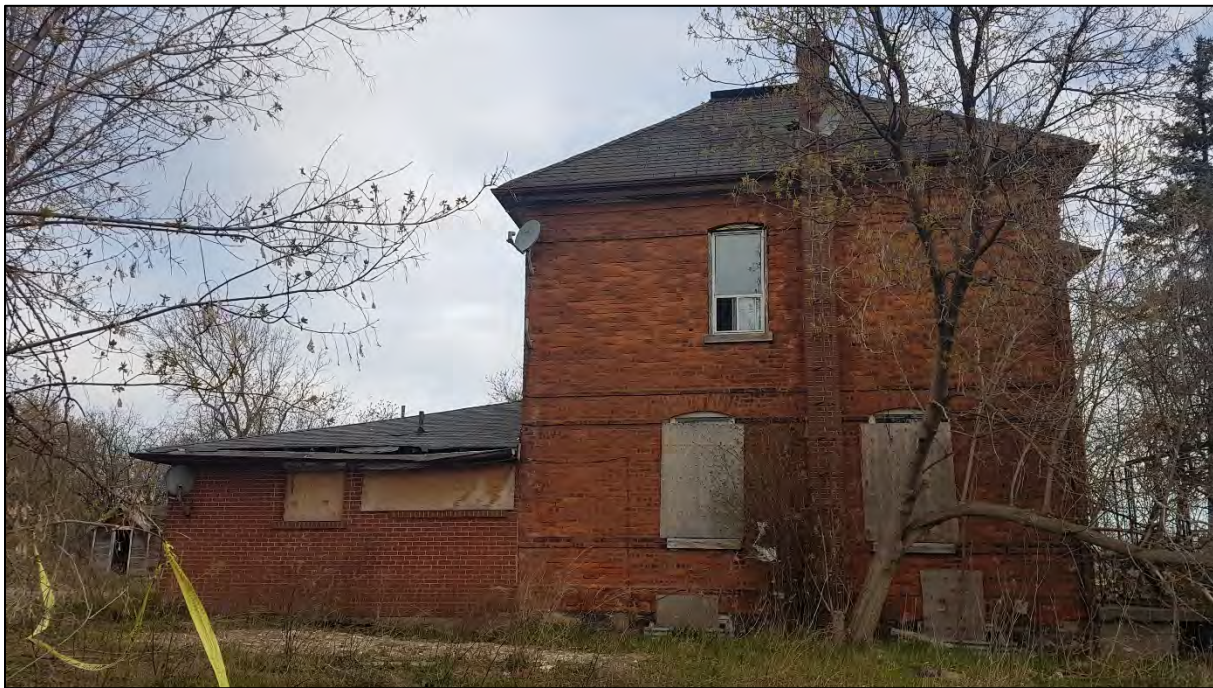
Figure 17: The farmhouse at 10980 Highway 50, south elevation (ASI 2020)

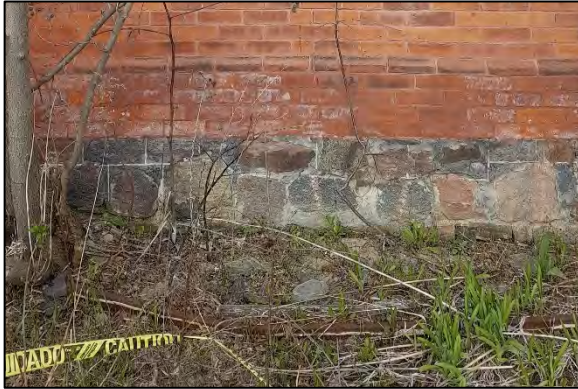
The subject residence rests on granite foundations (Figure 18) and features an L-shaped footprint created by a projecting bay on the front elevation. The medium-pitched hipped roof features asphalt shingles, minimal roof overhang, and wooden soffit. A modern chimney (Figure 19) is located on the south elevation and features an external brick stack. A historical photograph of the house (see Figure 8)

Figure 18: Granite foundations (ASI 2020)

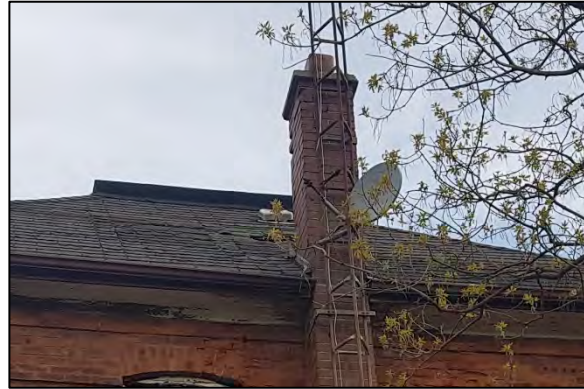
Figure 19: Chimney (ASI 2020)

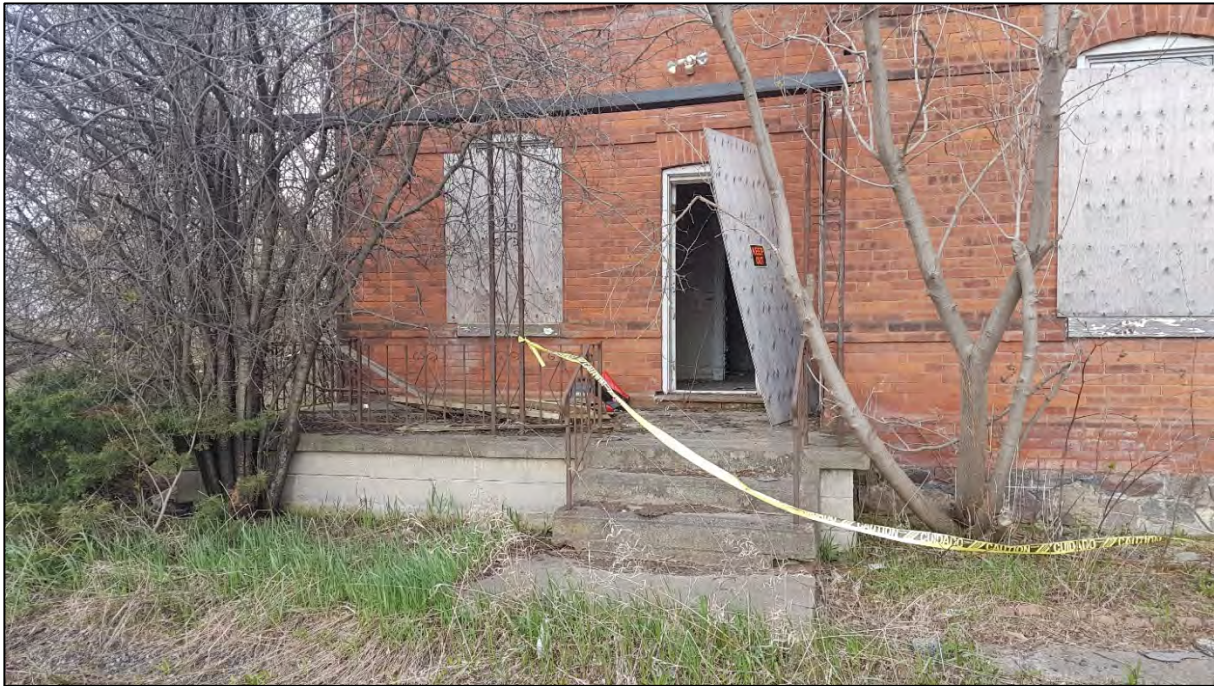
Figure 21: Concrete porch and front entrance (ASI 2020)

There are three points of entry into the house. The east elevation features two doors off the front porch. One is located on the south side of the projecting bay (though this was covered by plywood), the other is located just to its left, slightly off-centered on the front elevation (Figure 21). Both entrances feature segmentally-arched brick voussoirs, wooden frame, and wooden sill. The entrance on the side of

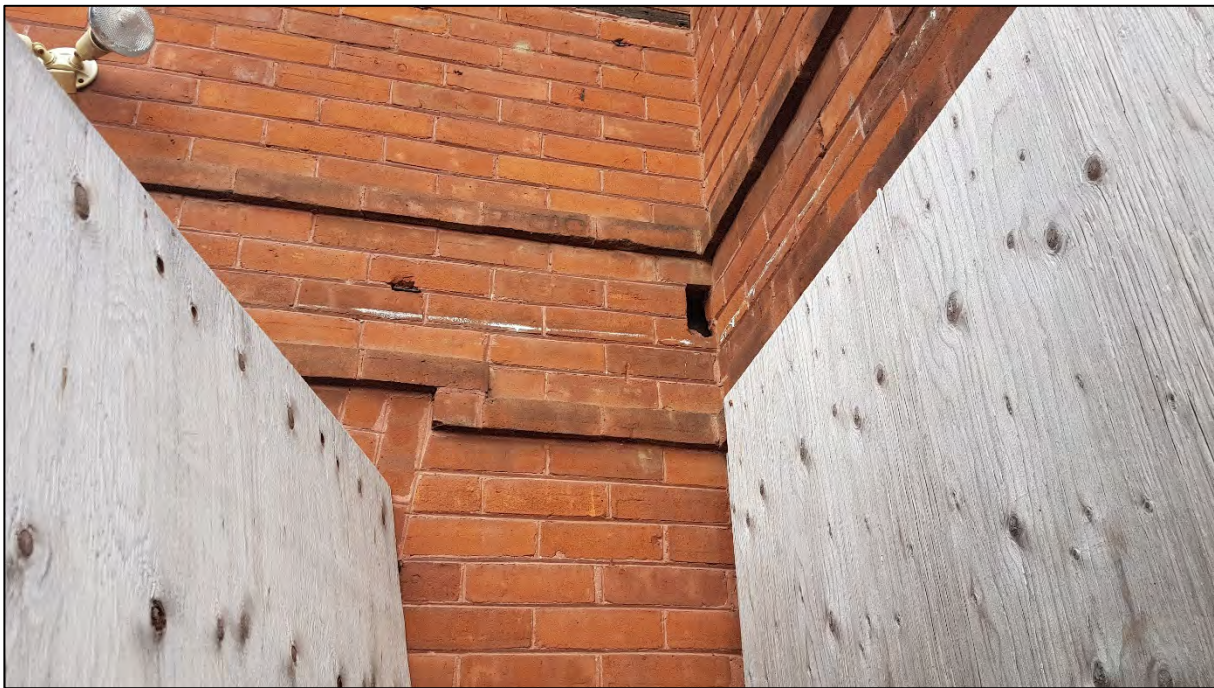
Figure 22: Joist hole where the original porch roof connected to the farmhouse (ASI 2020)

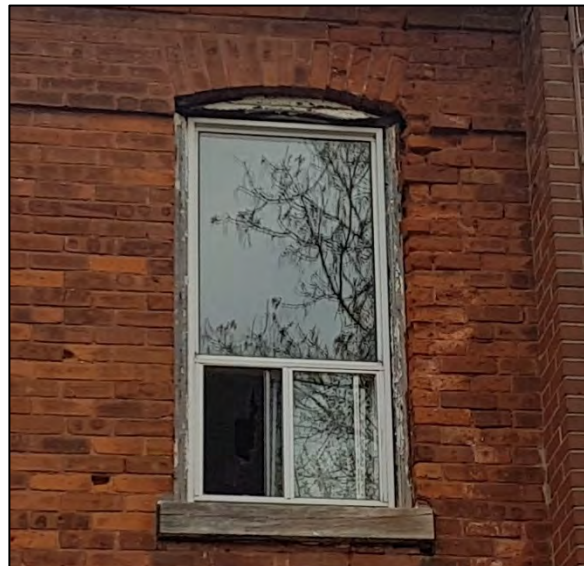
Figure 24: Second storey window showing the modern window with brick arch and wooden sill (ASI 2020)

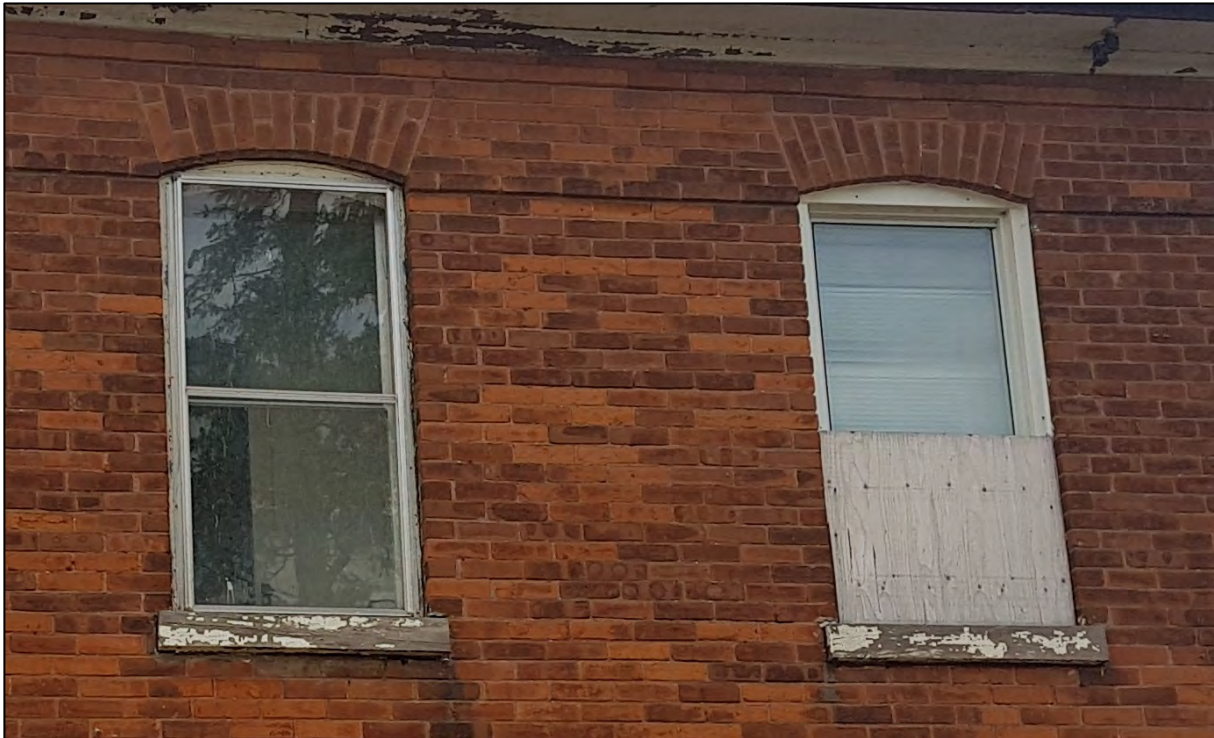
Figure 25: Second storey windows, showing two different types of modern windows (ASI 2020)

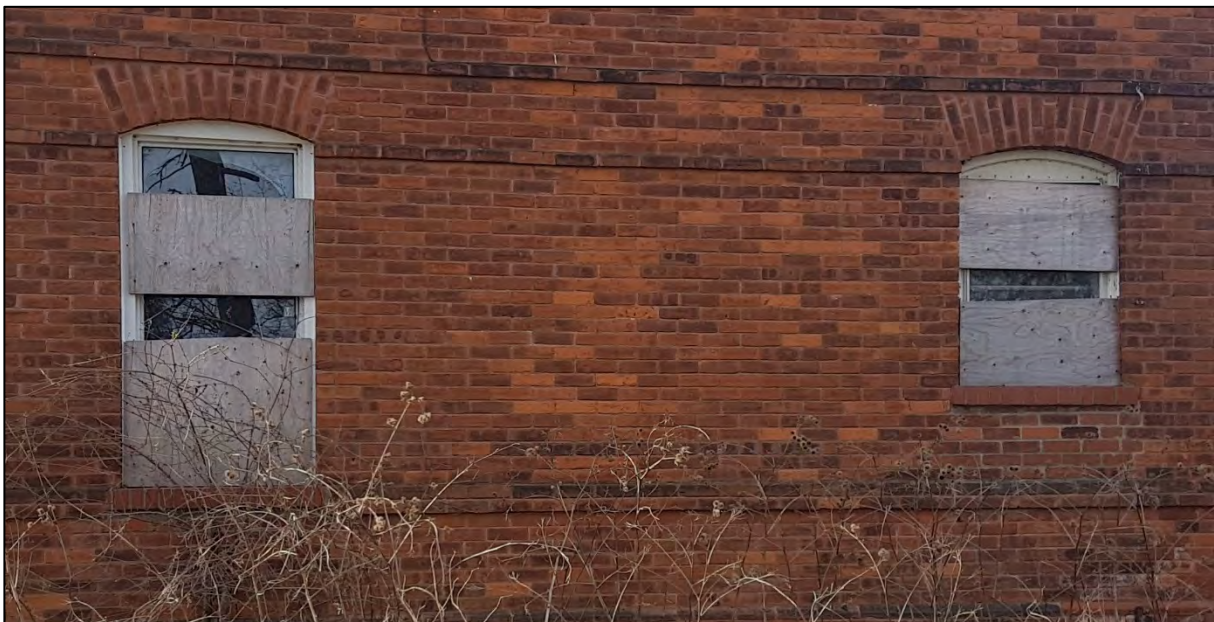
All of the first storey windows were covered in plywood (Figure 23). All of the windows in the original structure and rear accretion are modern, including the basement windows. A review of a historical photograph of the house indicates that the original openings on the main and second floors were one-over-one pane sash windows in wooden frames. While the original windows have been replaced with modern materials, the fenestration or window arrangement remains intact (Figure 24 and Figure 25). All windows openings are segmentally arched, and some windows feature wooden sills, while others feature brick sills, which were likely added when the new windows were put in (Figure 26).

Figure 26: First storey windows with brick sills (ASI 2020)

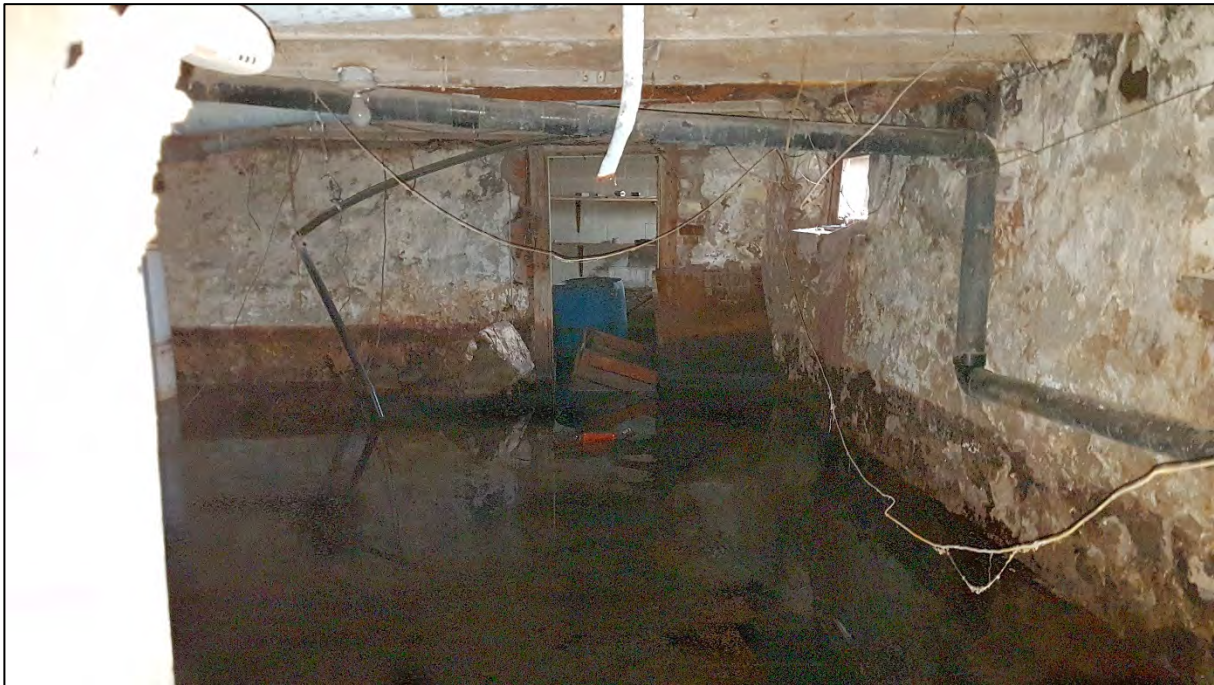
The subject dwelling at 10980 Highway 50 in the City of Brampton features a basement, main floor, and upper floor. Given that the basement was flooded, it was not accessed during this assessment. A quick cursory assessment was made from the bottom step of the stairs, where it was possible to confirm that the foundations were stone, the windows were modern although in their original wooden frame, and the floor joists above were sawn (Figure 27).

Figure 27: Basement (ASI 2020)

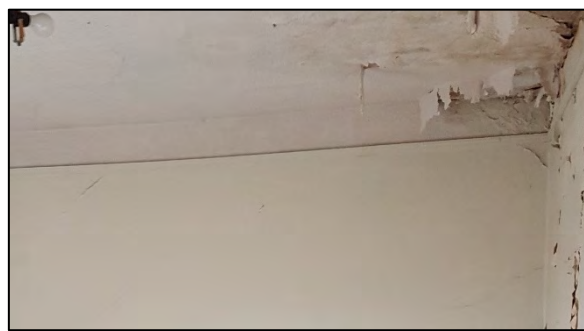
Figure 53: Evidence of crown moulding in upstairs bedrooms (ASI 2020)

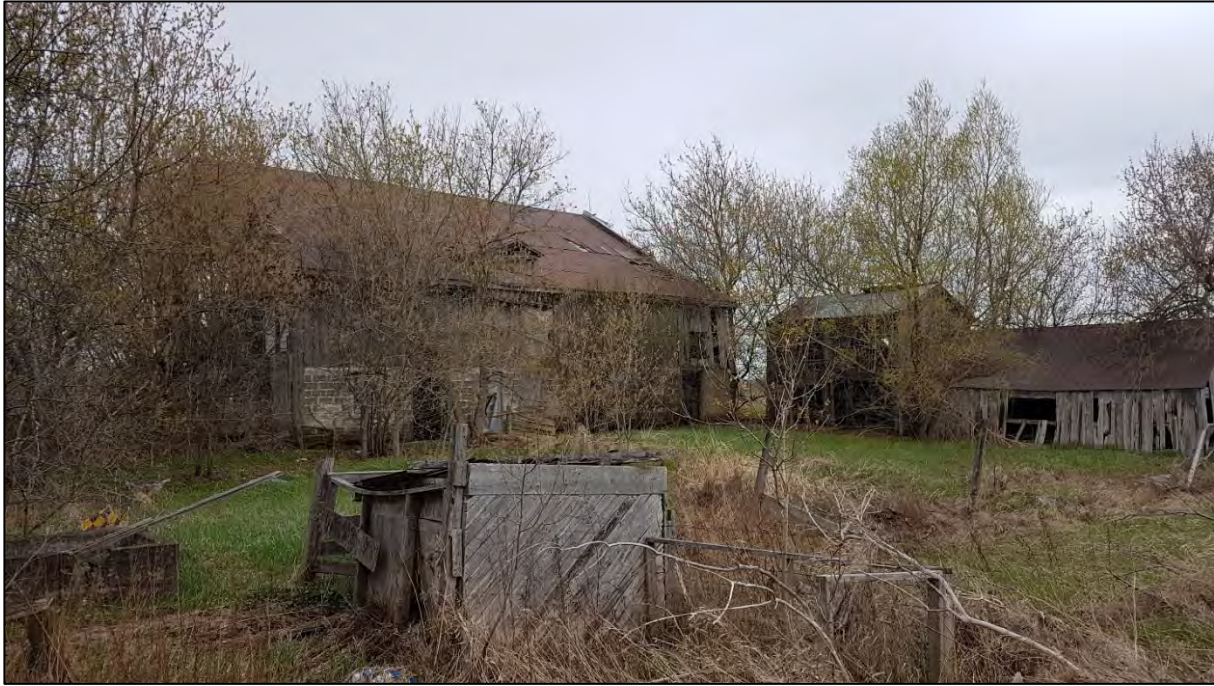
The barn (Figure 55 to Figure 68), located northwest of the farmhouse, is comprised of three different structural areas that appear to have been altered at different times as the farm has evolved over time. The southern portion of the barn was partially collapsed at the time of field review. This section does not rest on foundations and features hewn structural uprights, sills and beams with pin connected joints. While there are a number of hewn structural members that have empty mortises, this is more likely a result of the recent structural failure and collapse rather than an indication that this section of the barn was at one time reclaimed from another structure. A review of aerial mapping confirms that this section of the barn had a gable roof. The northern part of the barn features a rectangular footprint with gable roof, metal roofing material, and stone foundations on the north, west, and part of the south elevation. A view of the barn interior from the collapsed section to the south confirmed that the northern part of the barn also features hewn structural elements with pin connected joints. A lean-to addition has been made to the east elevation and the east elevation is composed of concrete blocks and poured concrete. Given that the stone foundations on the north elevation were noted to support both the northern portion and the eastern elevation of the barn, these structures were likely constructed at the same time, and the concrete found on the east elevation is probably the result of twentieth-century modifications or repairs. A single, gabled dormer is located on the east elevation. Most windows on the barn were blocked with plywood, while the doors were not secured.

Figure 55: East elevation of the barn (ASI 2020)

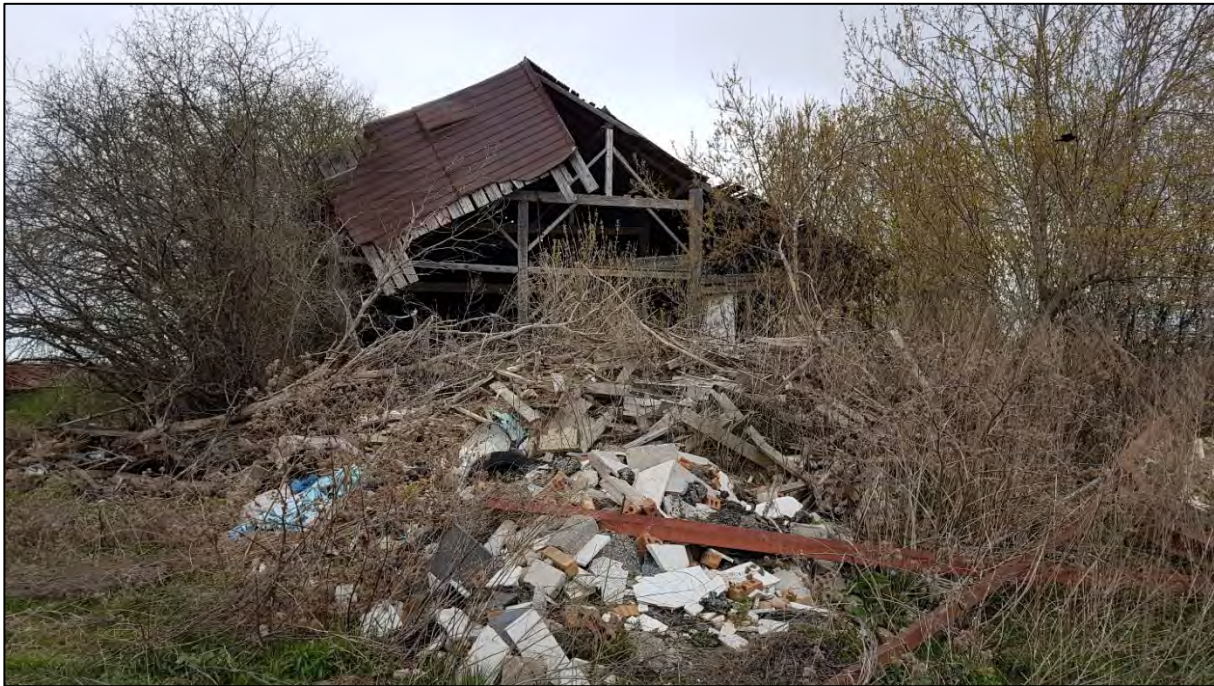
Figure 56: South elevation of the barn (ASI 2020)

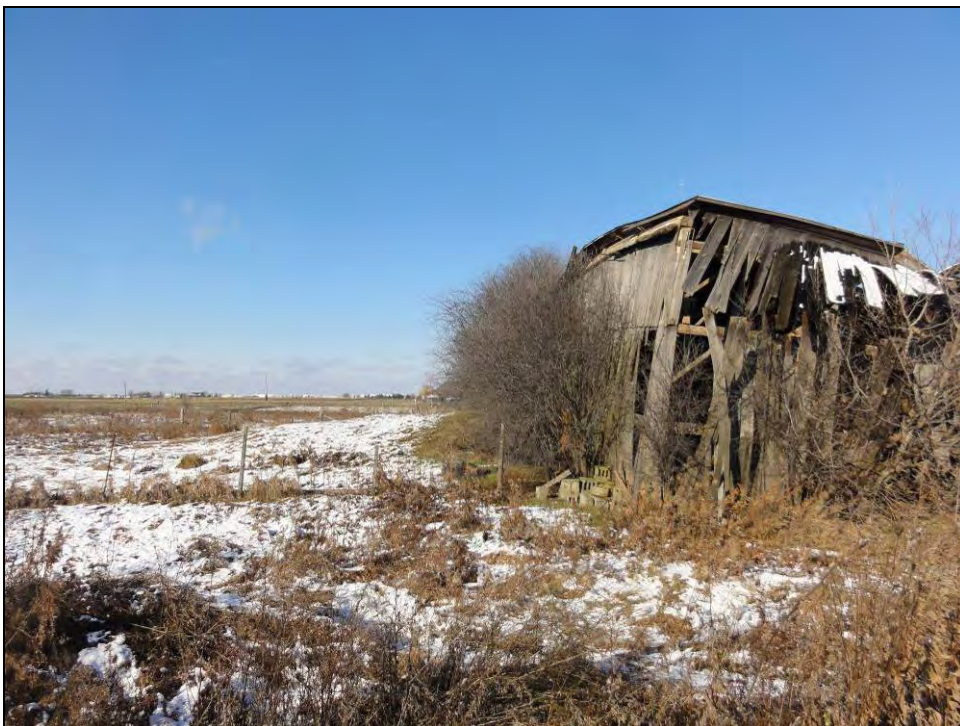
Plate 54: South
elevation of barn
(partially
collapsed).

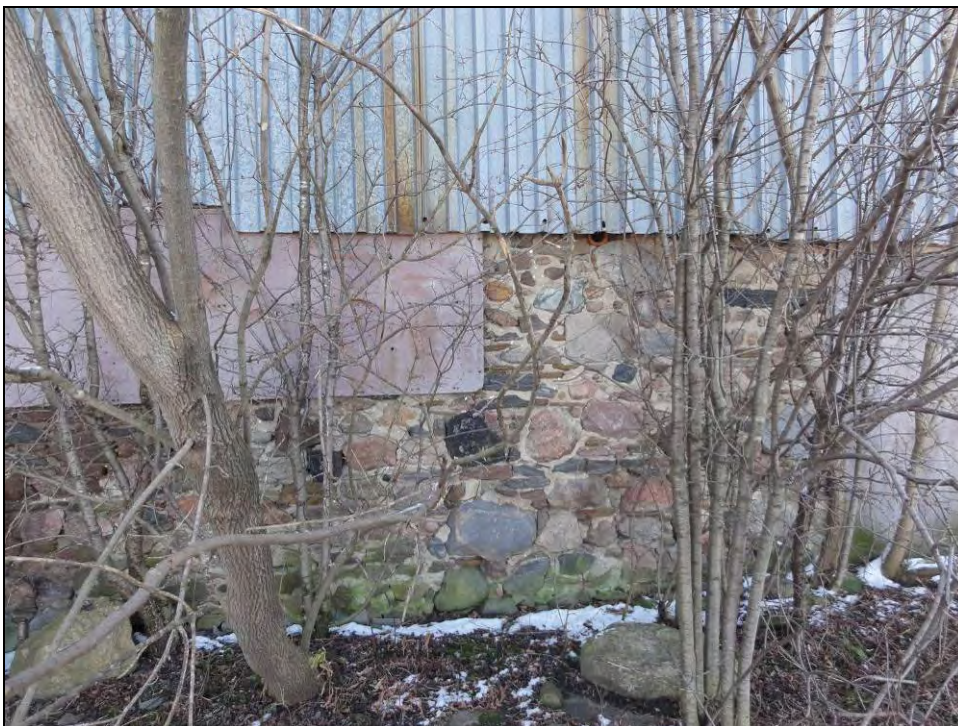
Plate 59: View of south elevation of Section 2 of barn, and collapsed section of barn.

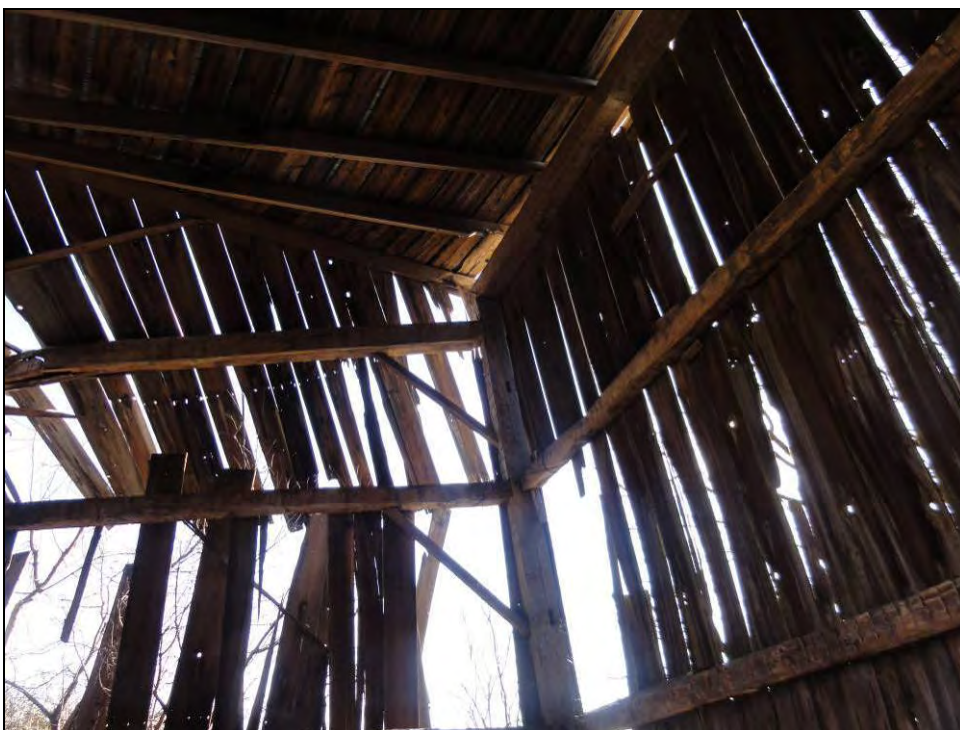
Plate 60: View of southwest corner of collapsed portion of barn.

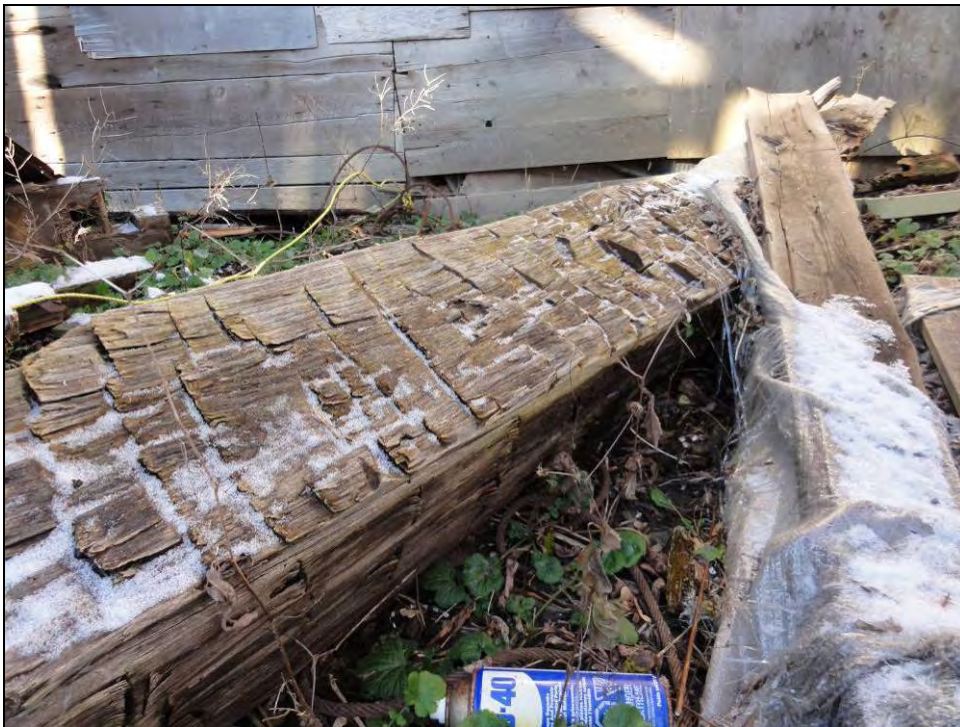
Plate 63: Detail of hewn structural beams that have collapsed.
