# PRELIMINARY DESIGN REPORT NO.2

WILEY BRIDGE

CLAIREVILLE CONSERVATION AREA

**PROJECT NO 10009703**

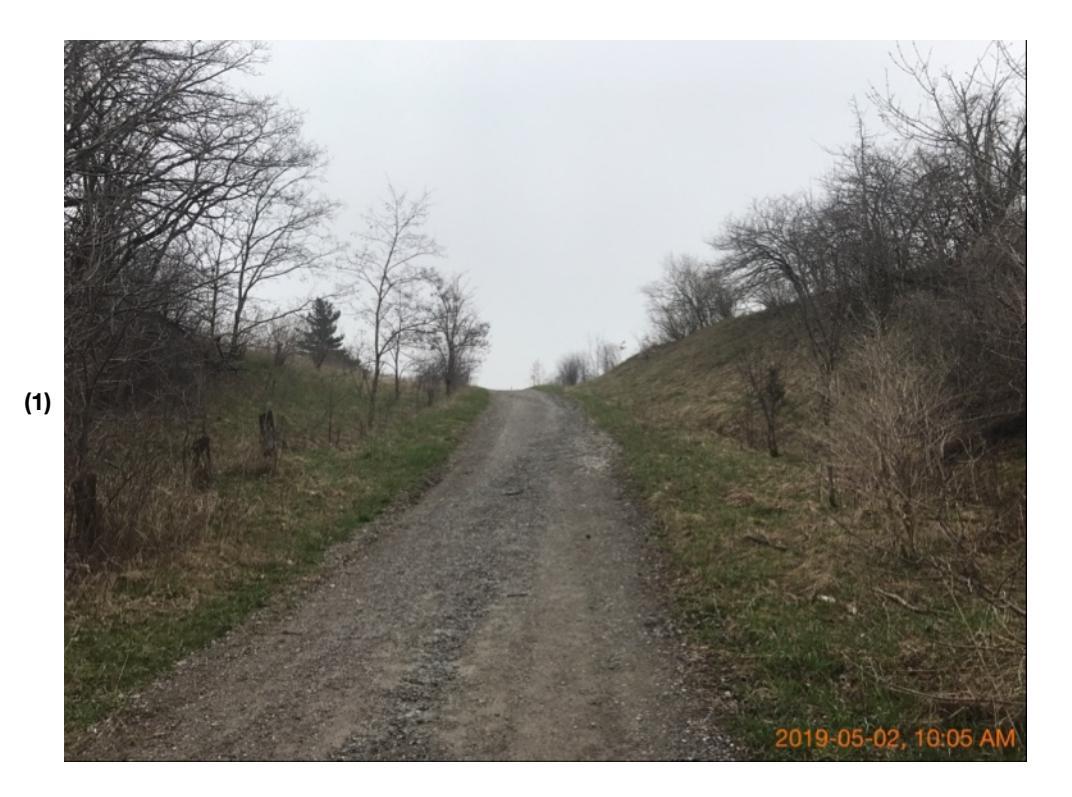
#### South approach (looking south).

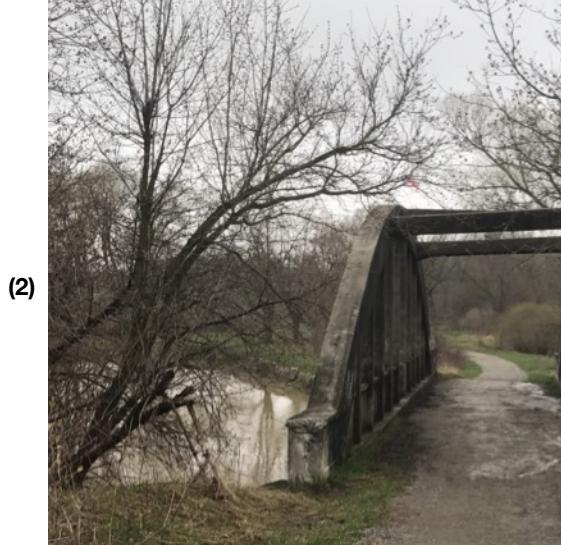
South elevation (looking north).

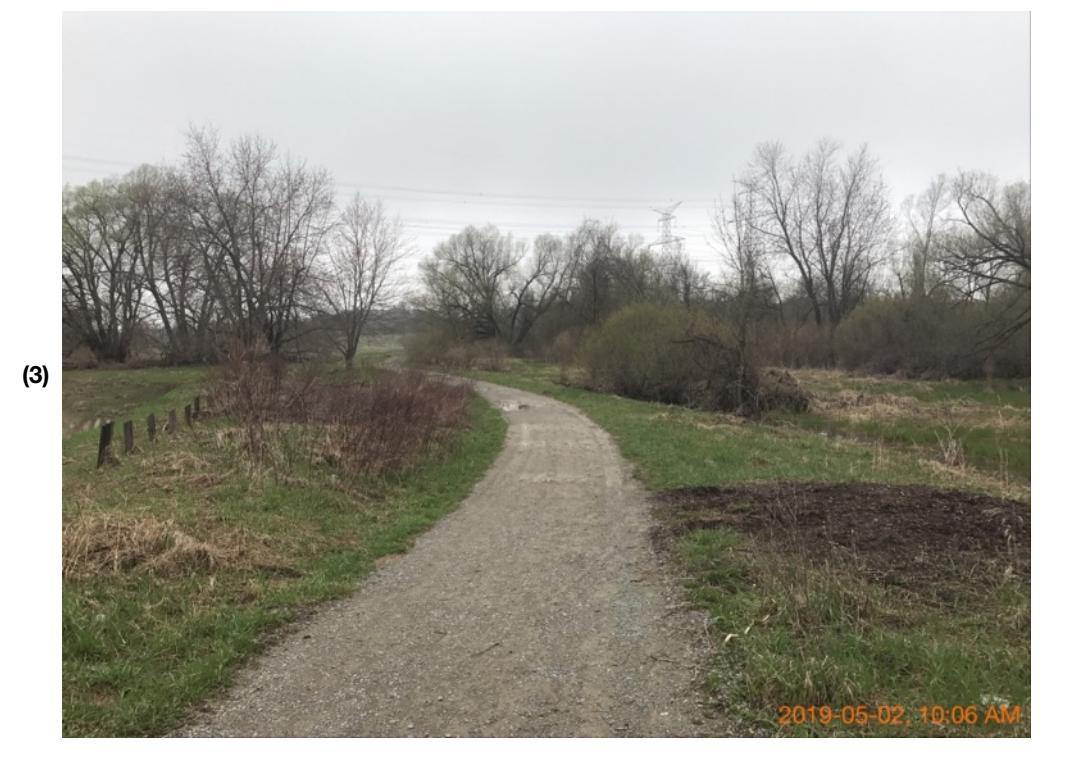
#### North approach (looking north).

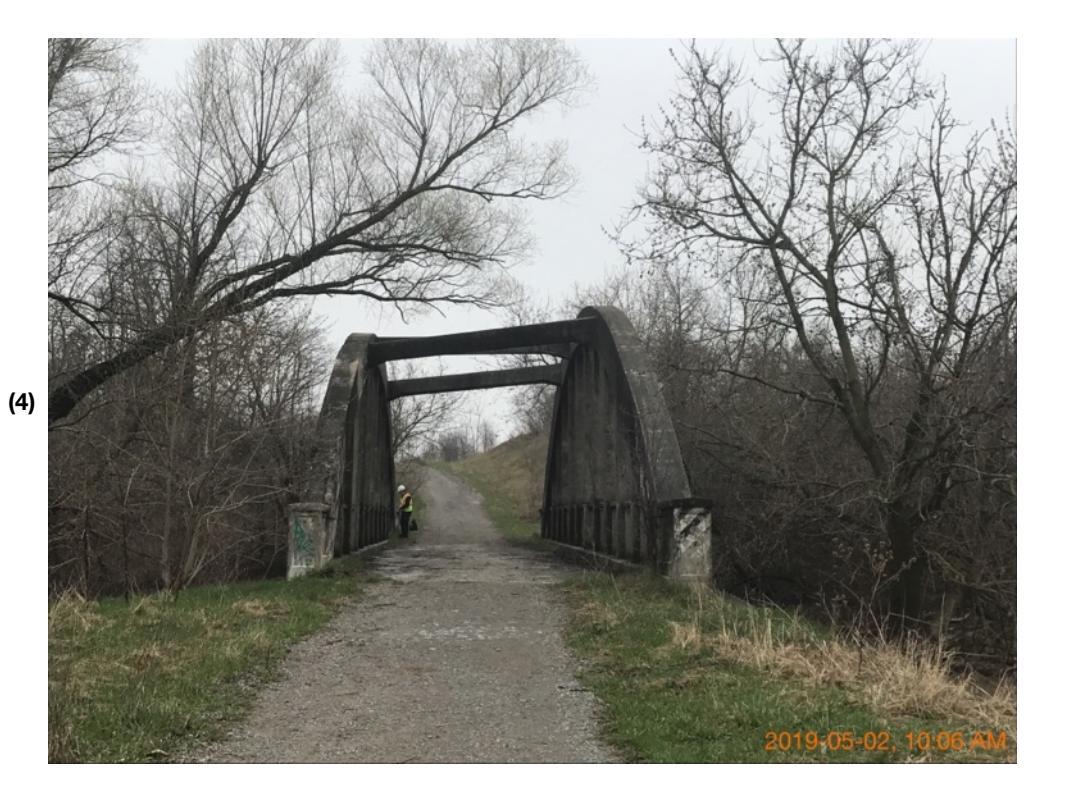
North elevation (looking south).

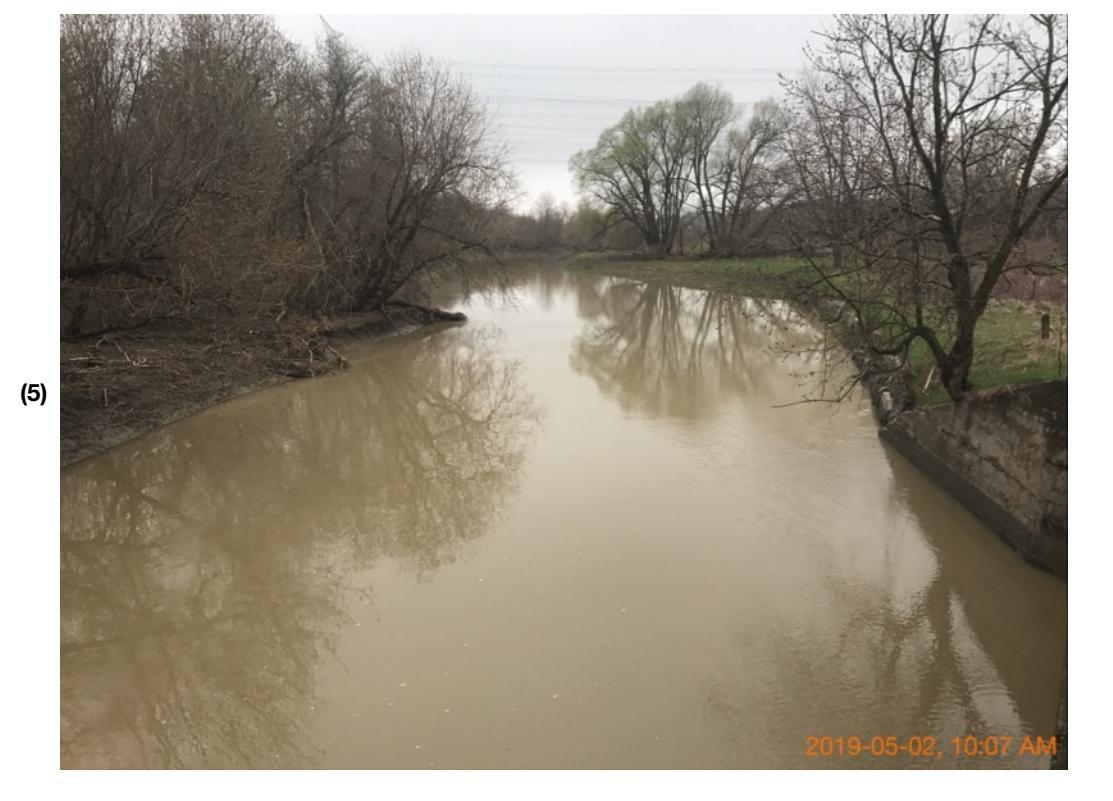
Looking west (upstream).

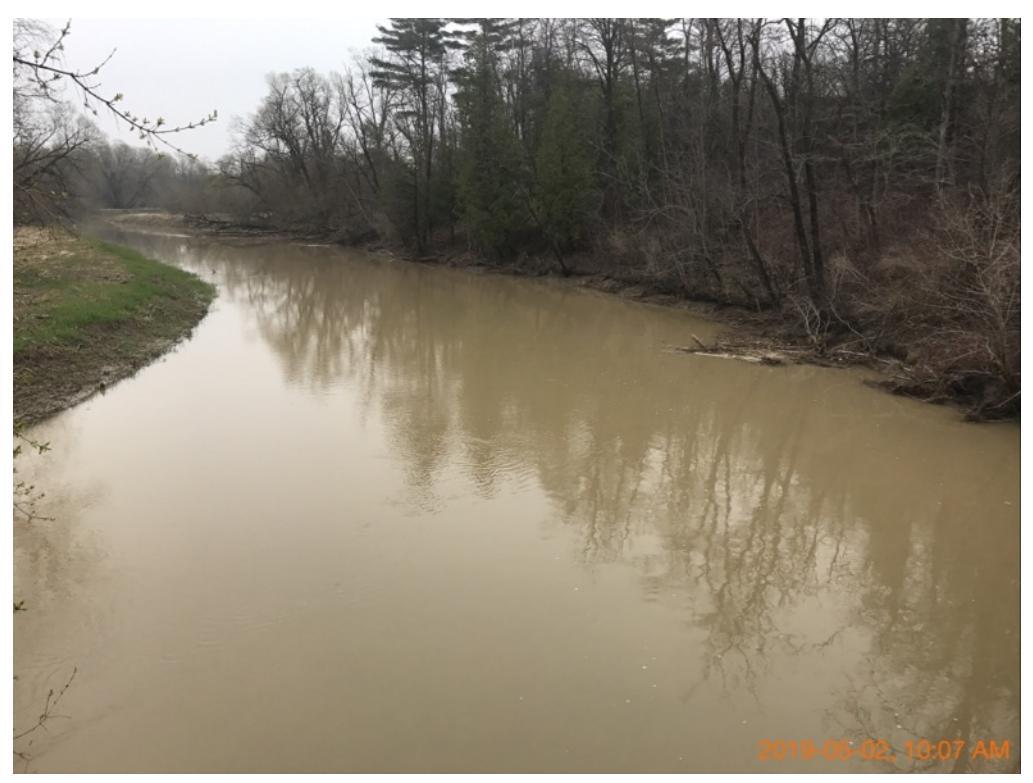
Looking east (downstream).

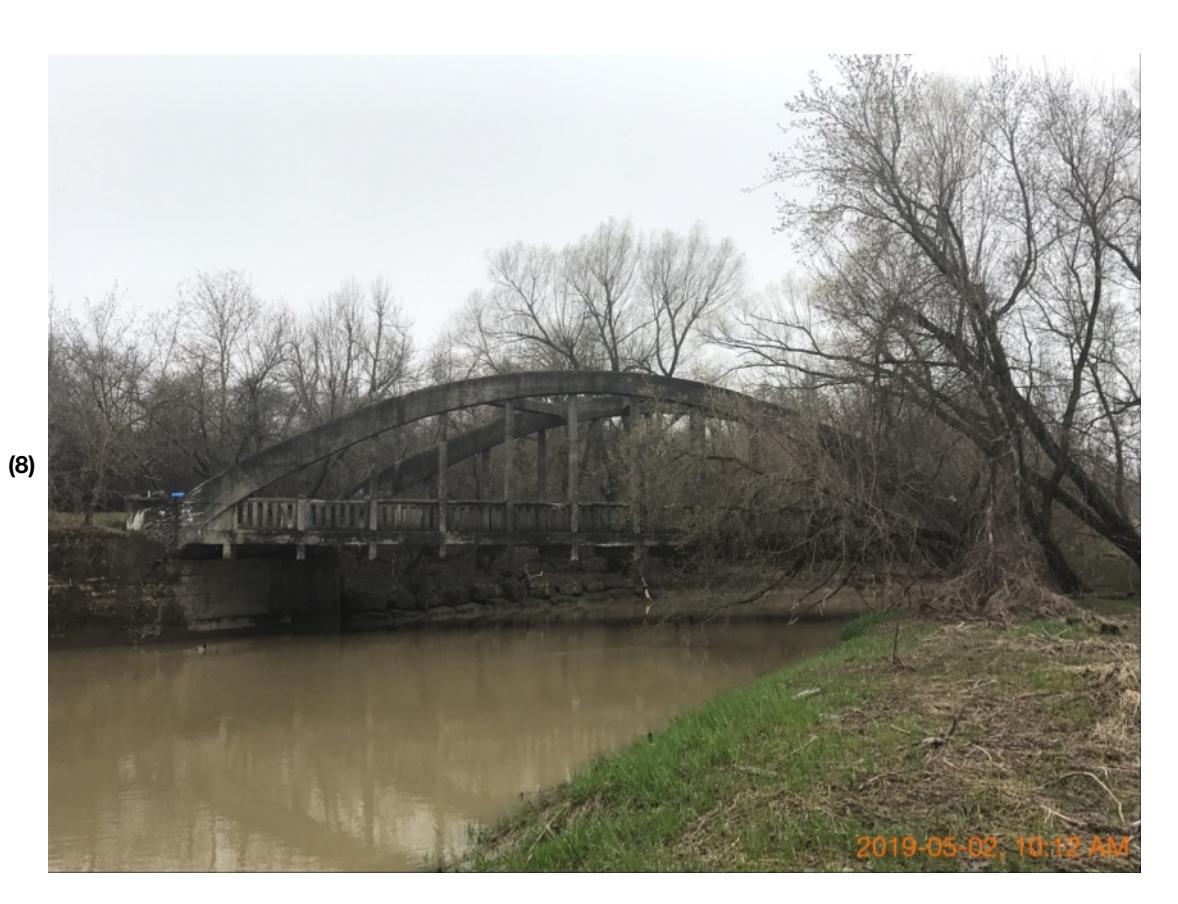
East elevation.

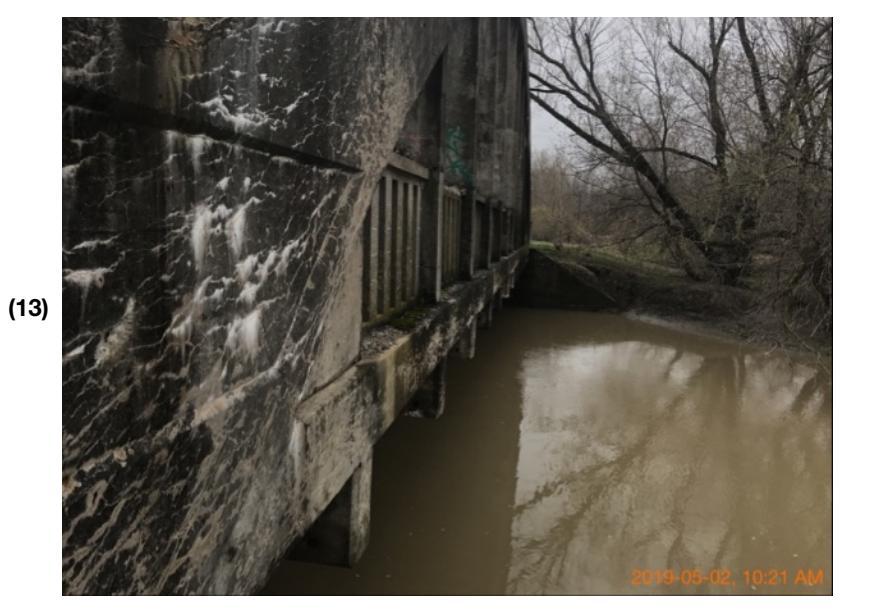
Potential Alkali Silica Reaction (ASR) in outside face of east arch rib (end), near south approach.

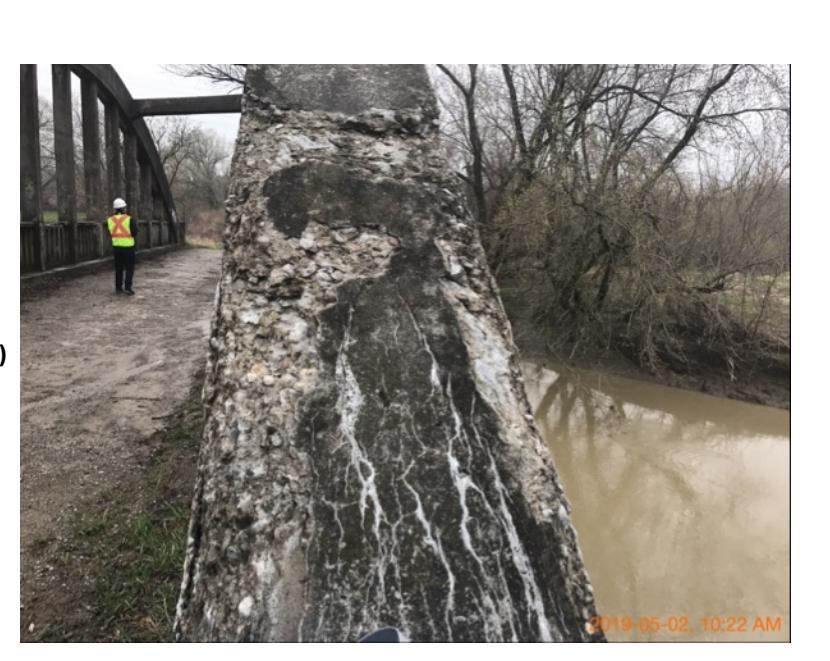
Concrete disintegration, honeycombing and potential ASR in top of east arch rib near south approach.

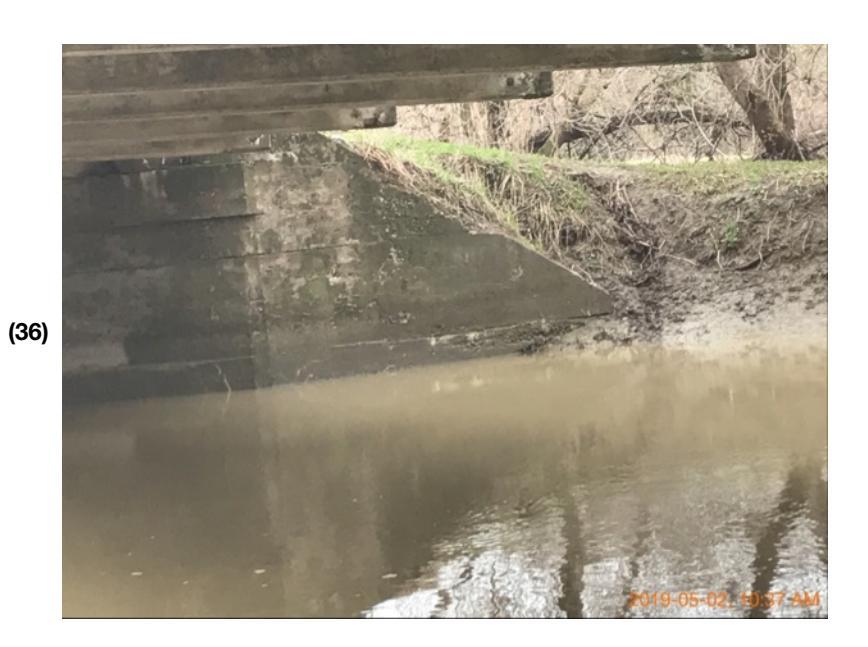
Northeast retaining wall.

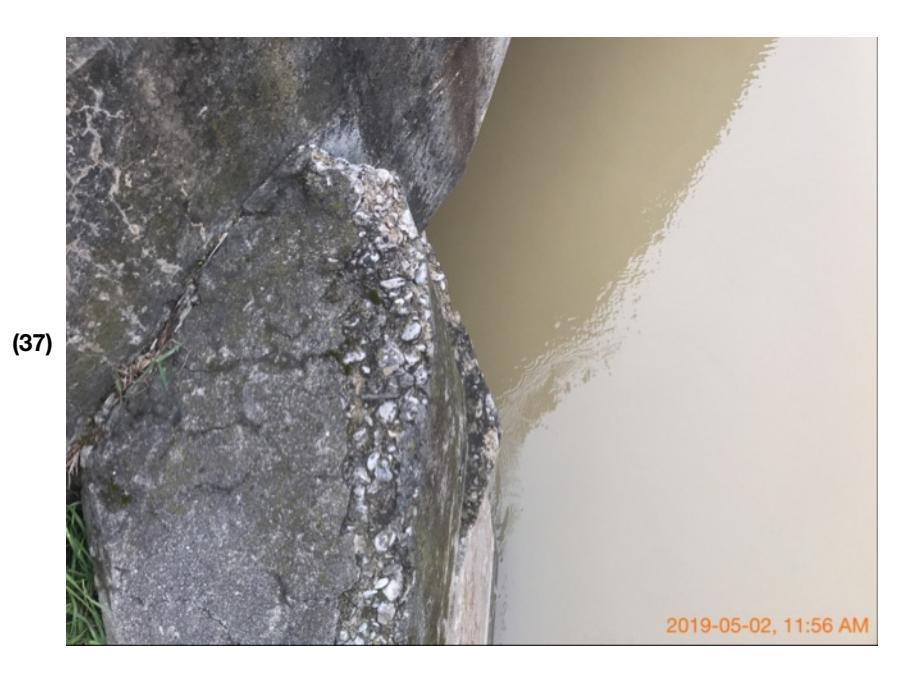
Honeycombing in top of southeast retaining wall.

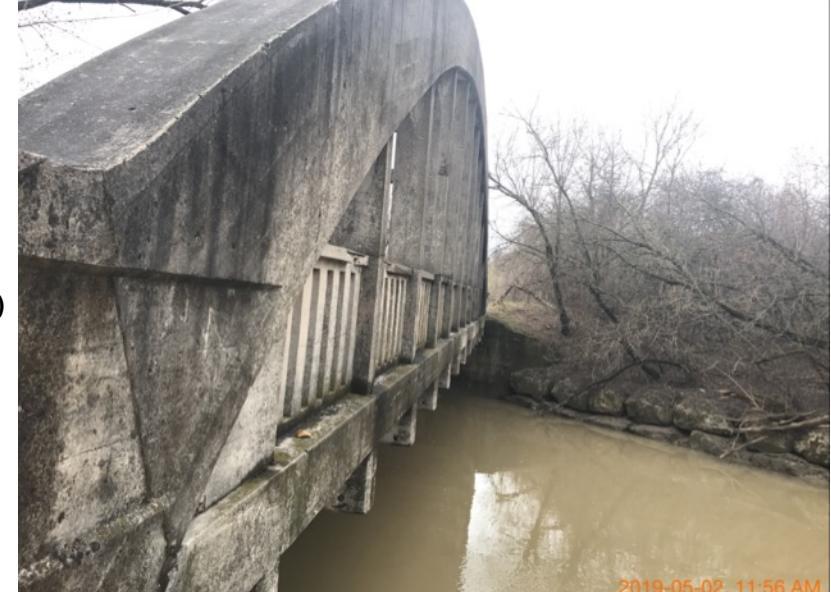
East fascia (looking north).

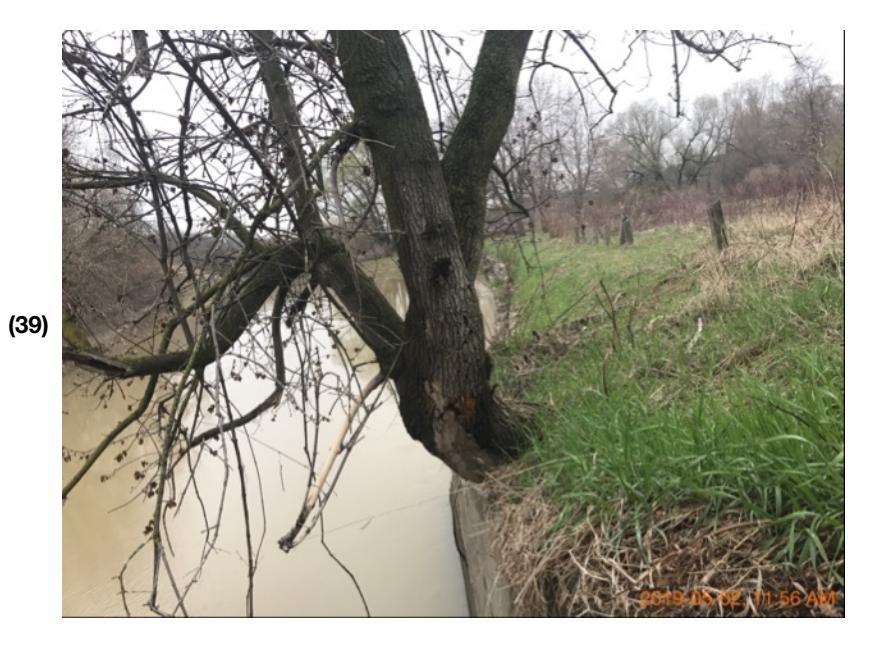
Northwest embankment. Note the tree in contact with the retaining wall.

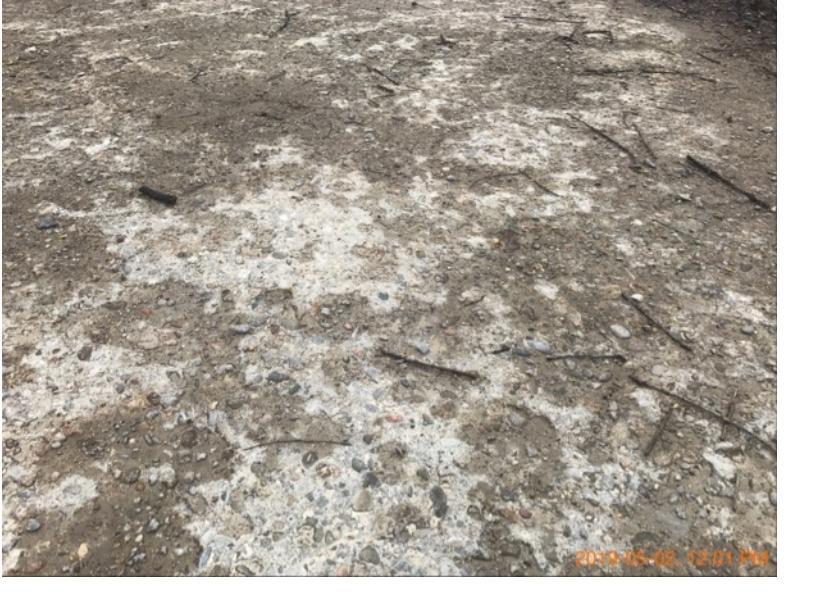
Concrete delamination and concrete cracking with efflorescence staining (potential ASR) along the outside face of the east arch rib, near the north approach.

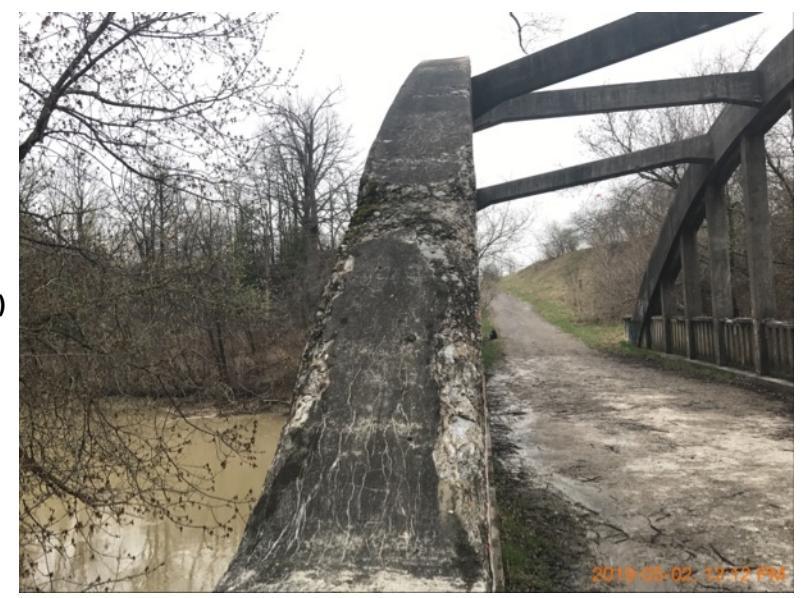
(43)

Locally scaling and scaling was noted in the deck surface throughout (see Photograph 43).

Concrete disintegration, honeycombing and potential ASR in top of east arch rib, near north approach.

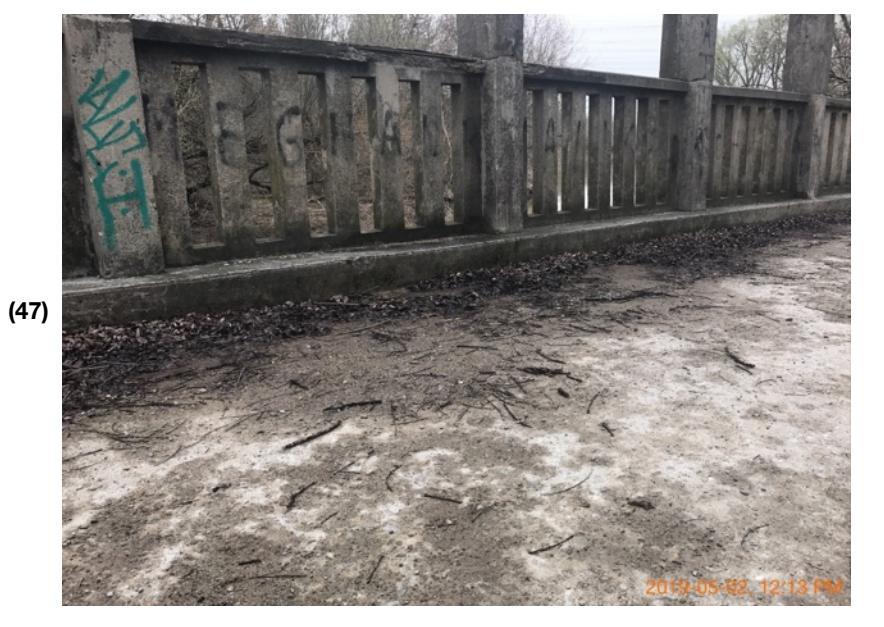
West curb and parapet wall. Note the debris accumulation along the shoulder.

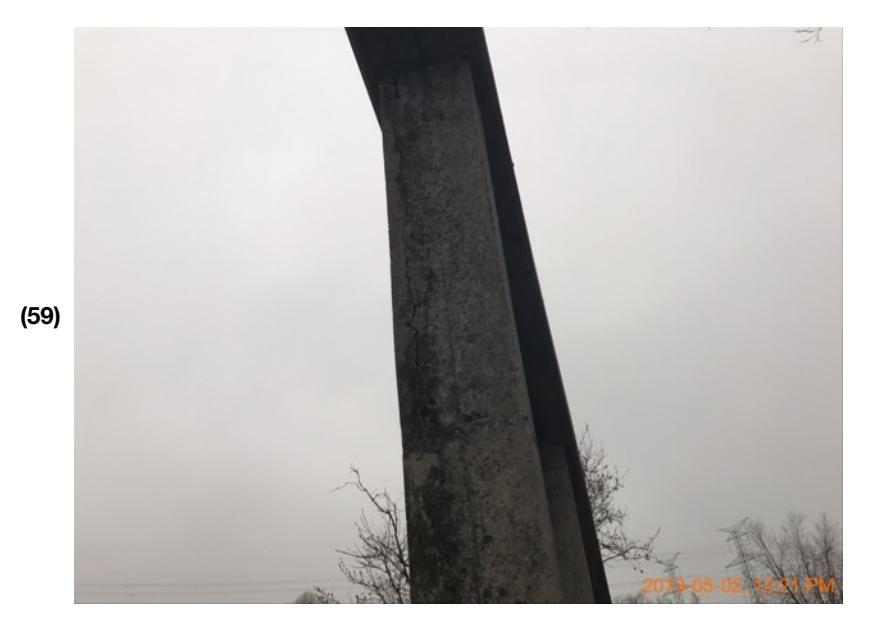
Wide vertical cracking in west hanger (second from north approach).

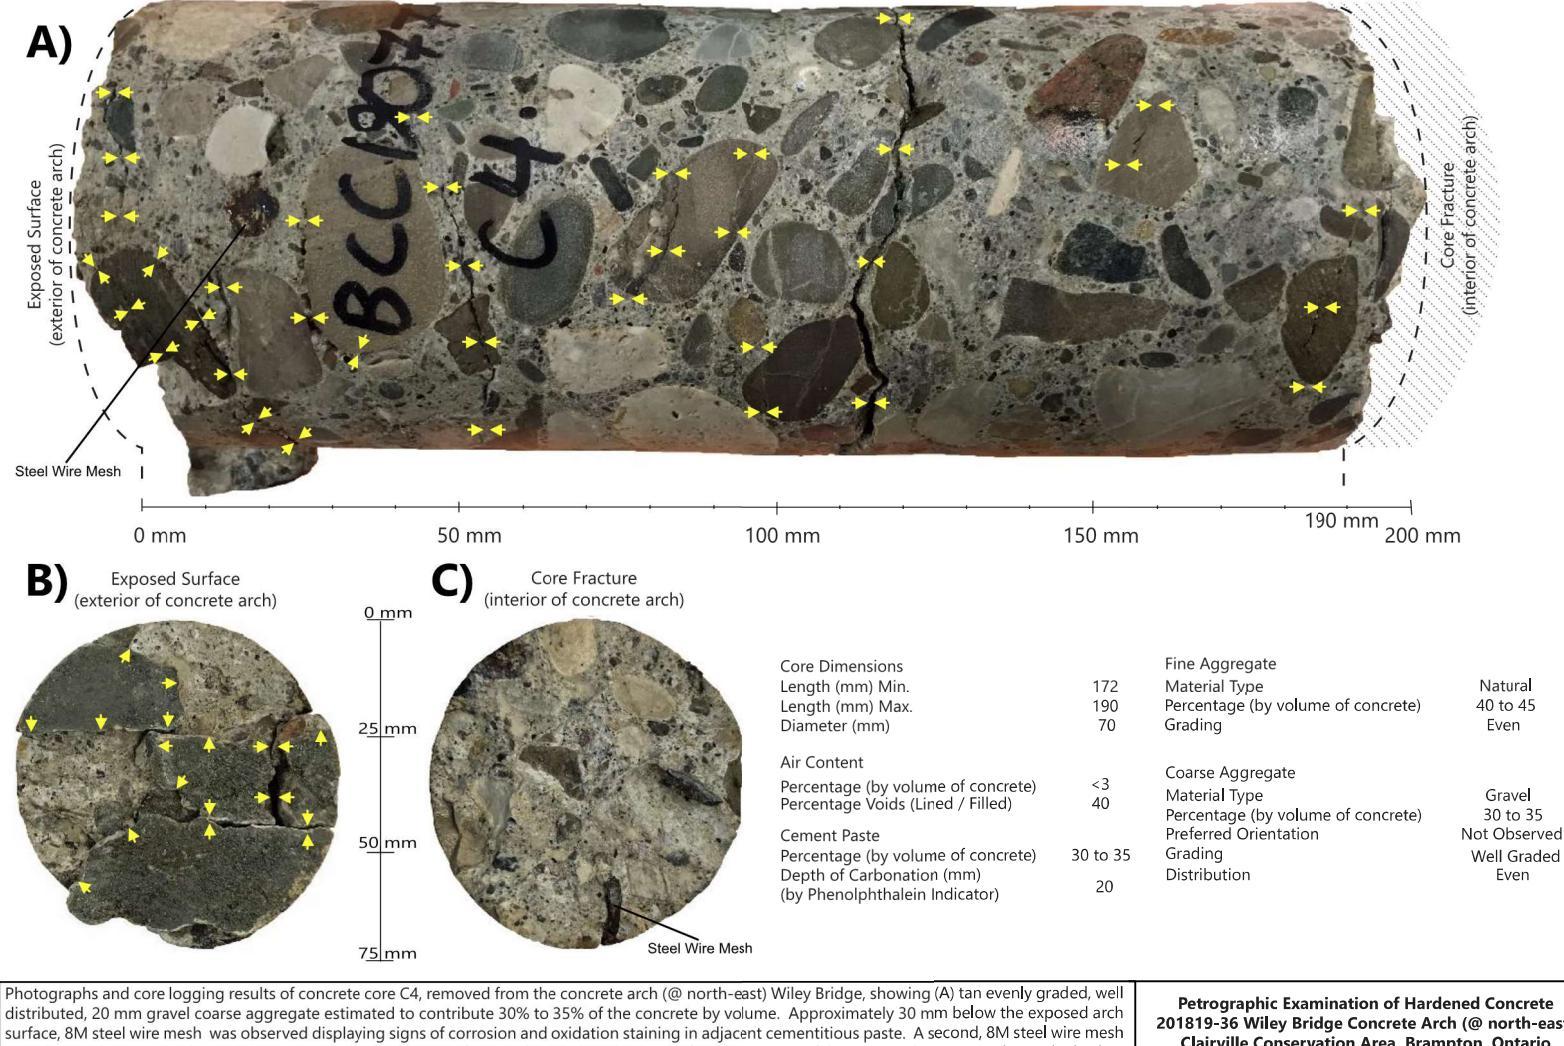
Concrete Core C4 removed from concrete arch (@ north-east) 201819-36 Wiley Bridge located at the Claireville Conservation Area, Brampton, Ontario shows damage features indicative of cyclic freezing and thawing inaddtion to Alkali-Aggregate Reactivity (AAR).

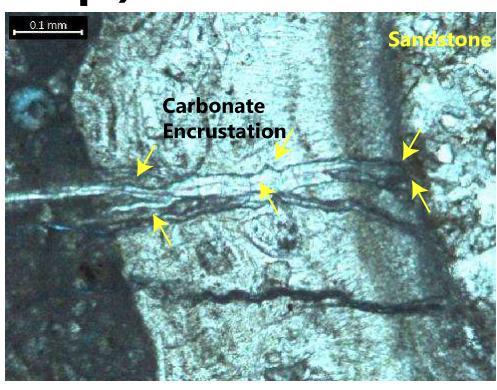
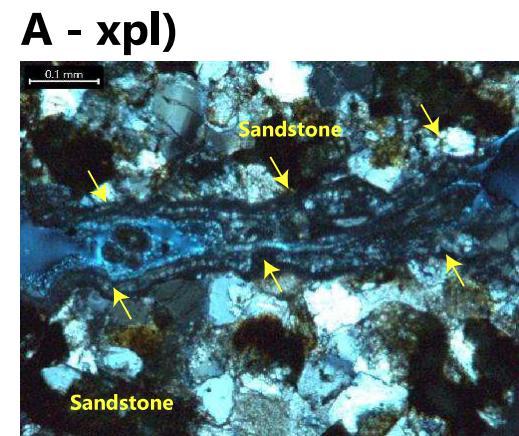
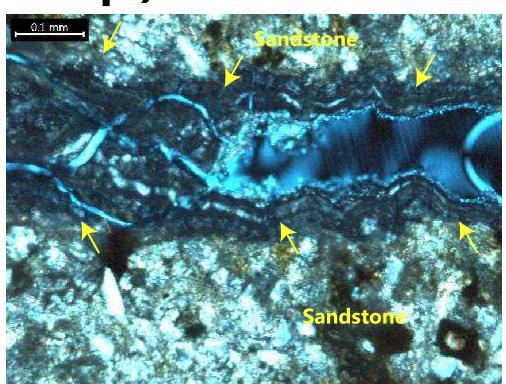
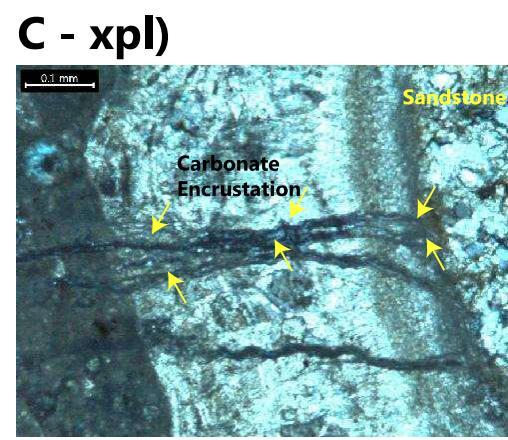
ENCLOSURE 4 (Core C4)         Core C4)         WOO           PROJECT No:         SCB198391.209077         VOO	Micropictographs of the cross-sectional polished surface of concrete core C4, removed from the concrete arch (@ north-east) Wiley Bridge, viewed under plain light (A - pl, B - pl, and C - pl) revealing the presence of layered Alkali-Aggregate Reactive (AAR) gel within microcracks (yellow arrows) primarily associated with sandstone particles. The same micropictographs viewed under cross-polarized plain light (A - xpl, B - xpl, and C - xpl).	Petrographic Examination of Hardened Concrete 201819-36 Wiley Bridge Concrete Arch (@ north-east) Clairville Conservation Area, Brampton, Ontario		
PROJECT No: SCB198391.209077		ENCLOSURE 4 (Core C4)       PROJECT No:     SCB198391.209077       SCALE:     As Indicated       DATE :     February 2020		wood
SCALE: As Indicated DATE : February 2020				bruary 2020
