Heritage Impact Assessment, 8940 Creditview Road, Part of Lot 5, Concession 4 West of Center Road, Chinguacousy Township, Now City of Brampton, Regional Municipality of Peel

Project number: PHC-2021-027

Report Type: Revised

Report Date: 2 November 2021

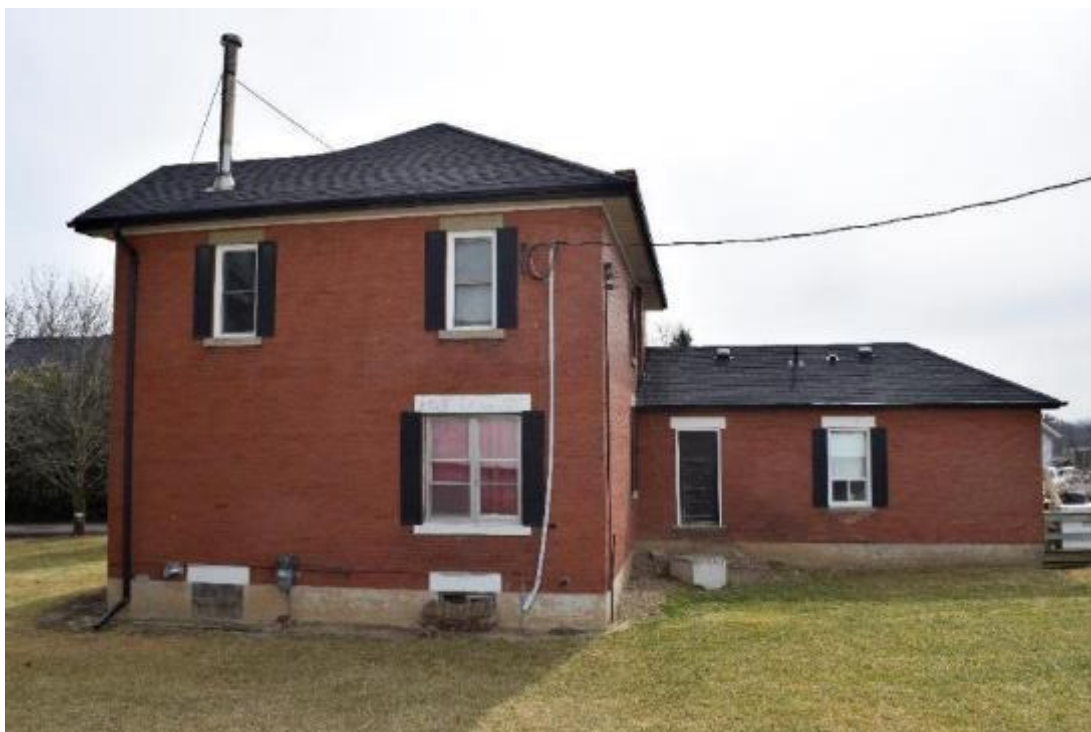
Image 15: West side of structure showing original construction and later rear addition.

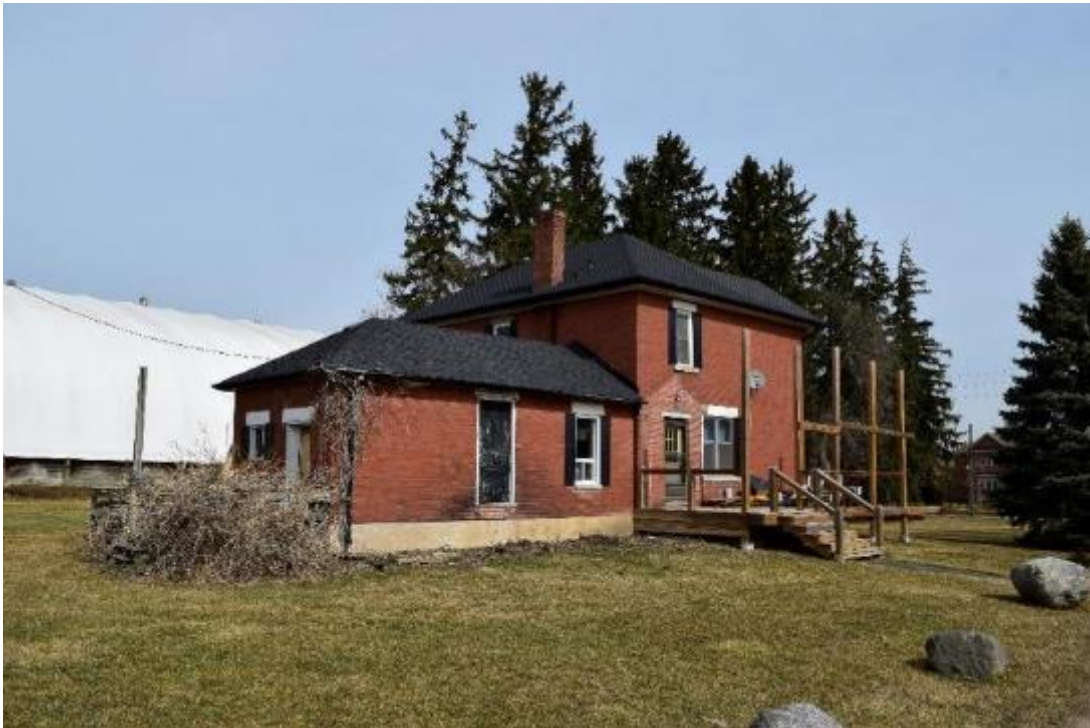
Image 17: Southeast side of structure, showing original construction and later addition.

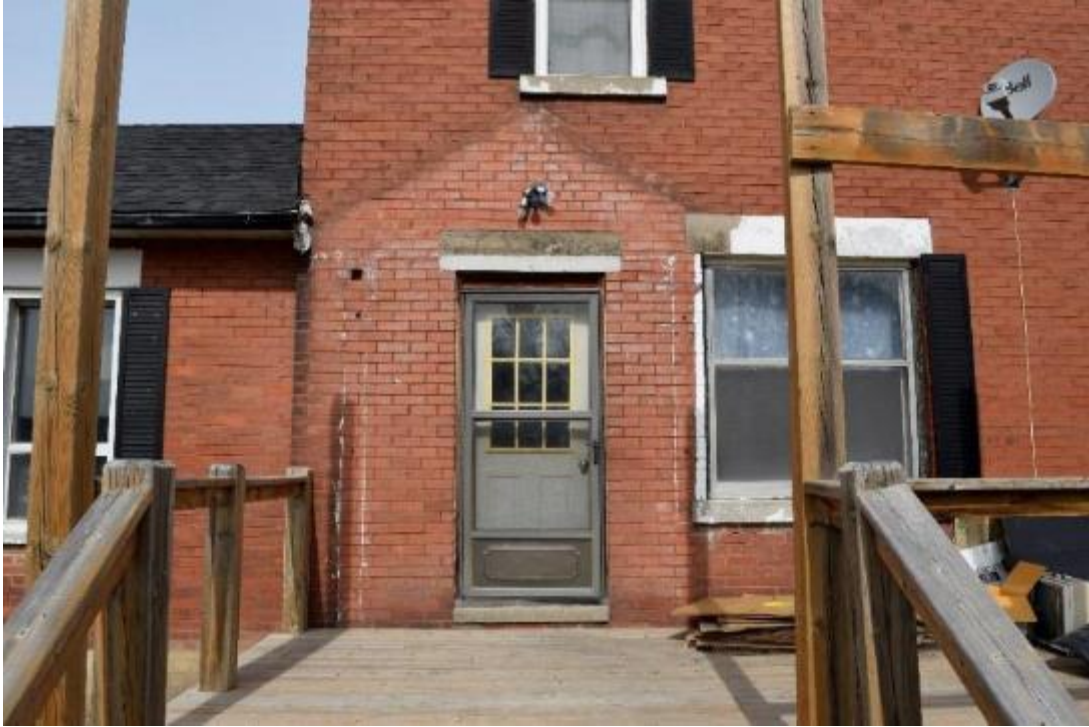
Image 20: Ghosting of previous porch associated with entrance on southeast corner of structure.

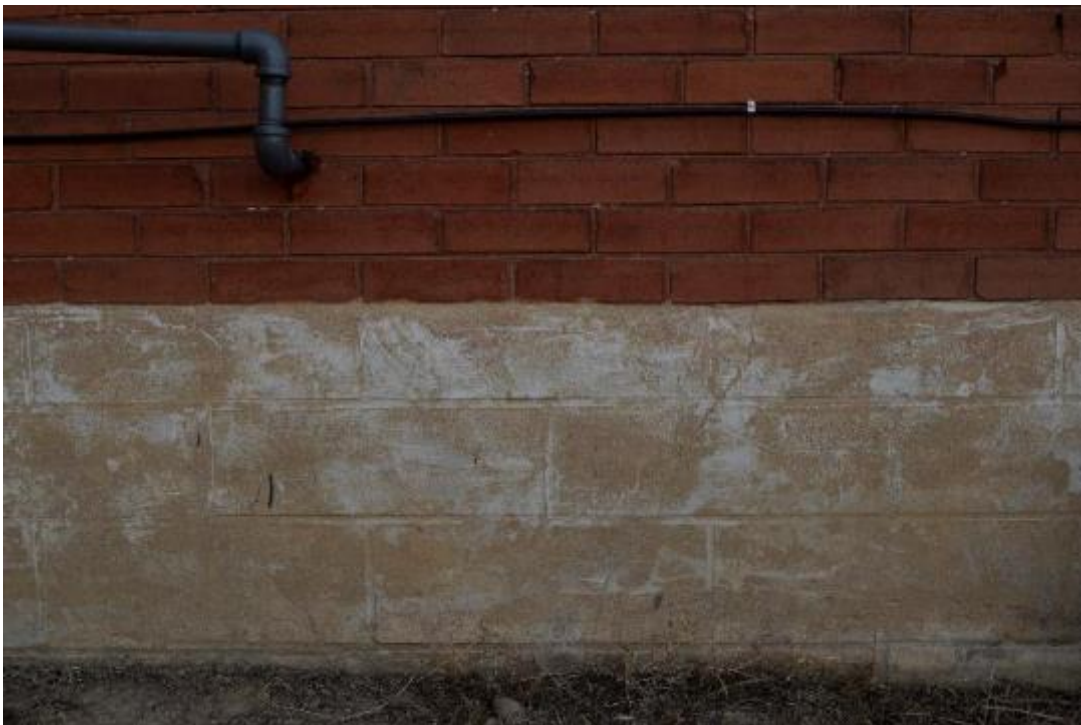
Image 23: Tooled finish of poured concrete foundation.

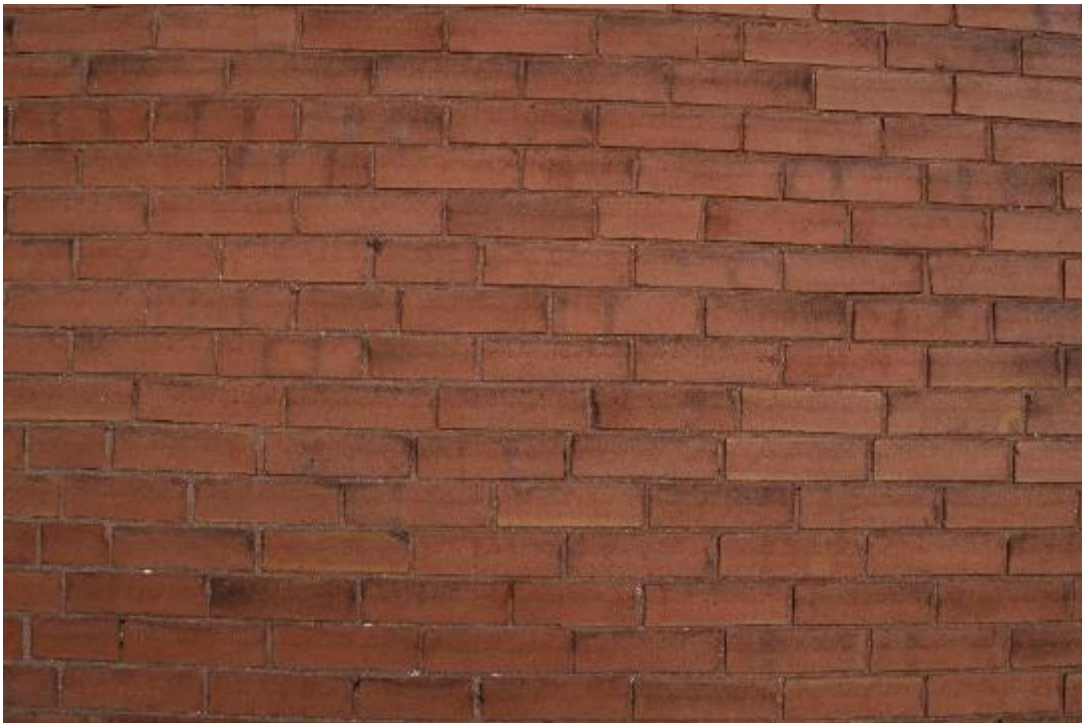
Image 27: Stretcher bond brick work, typical of that used on original home and addition.

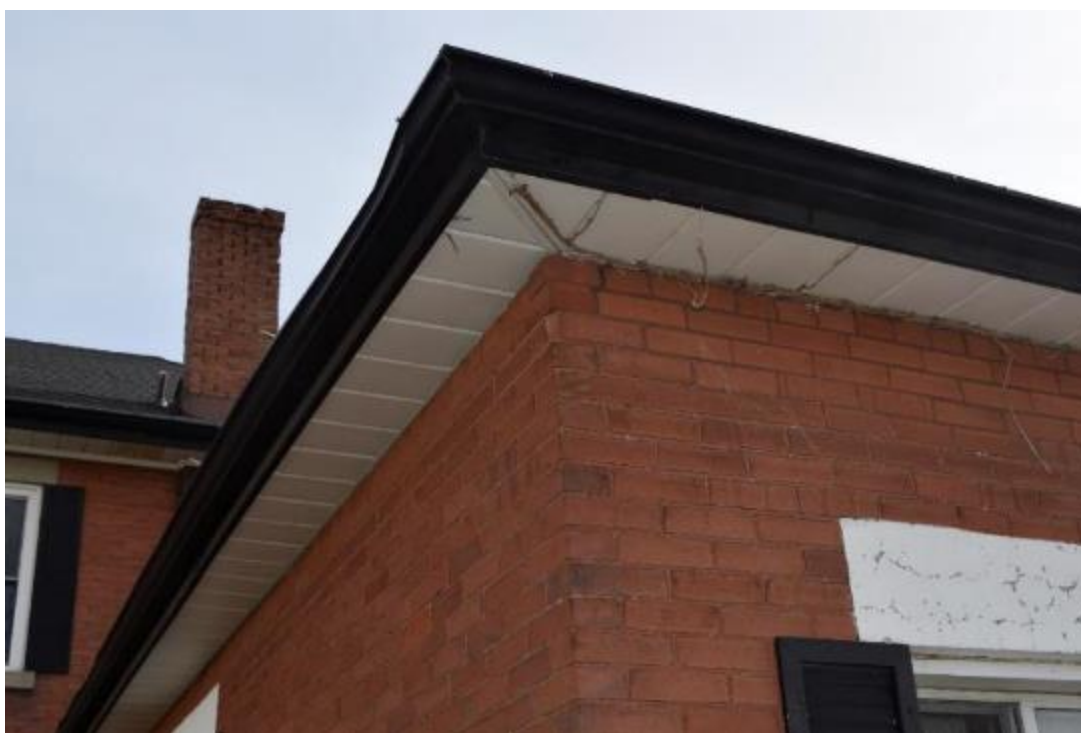
Image 29: Typical aluminum fascia, soffit and eavestrough. Note chimney in left quadrant of image.

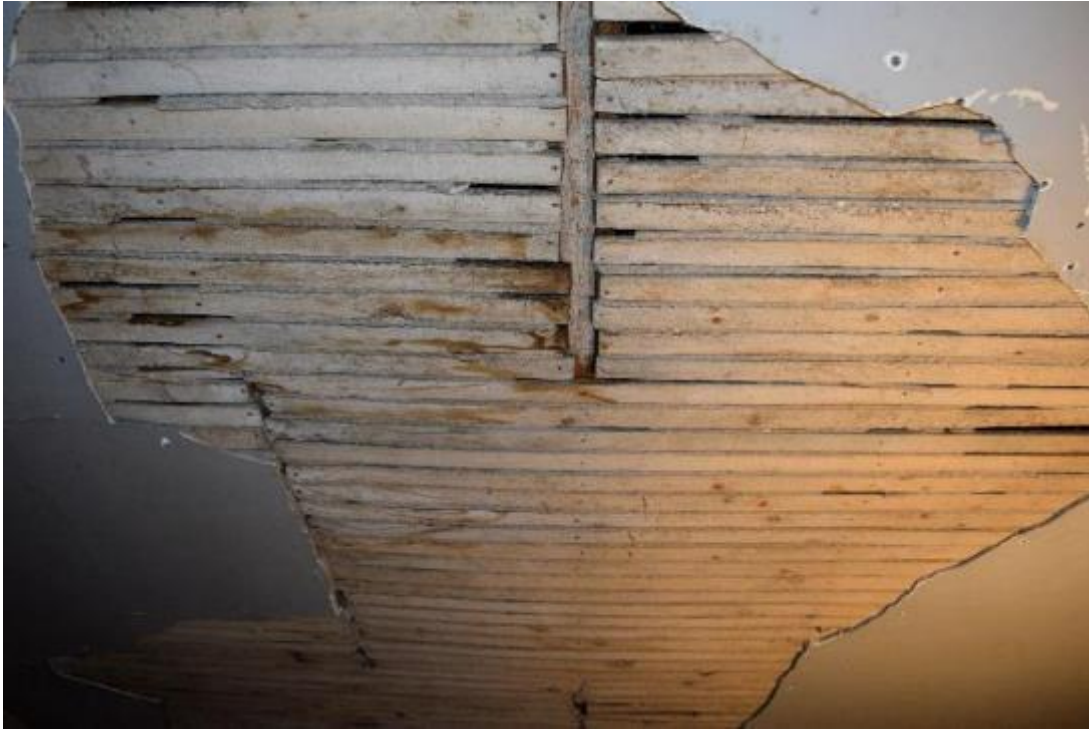
Image 38: Exposed cut lath, typical of that used in wall and ceiling construction.

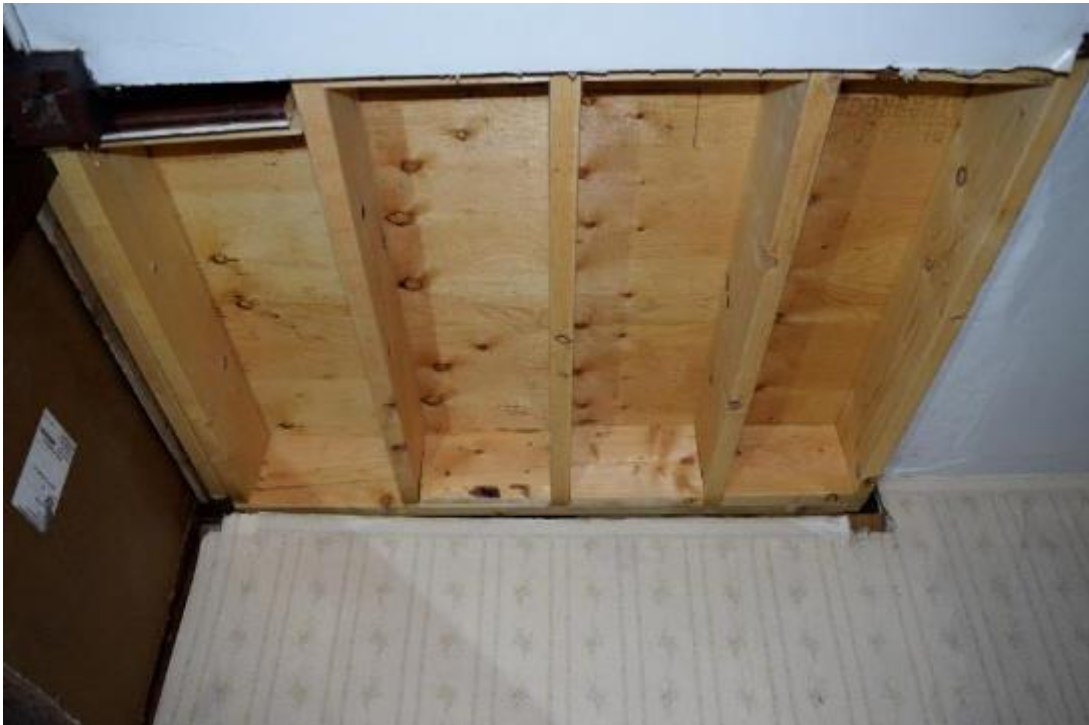
Image 43: Exposed framing installed when main stairs were removed.

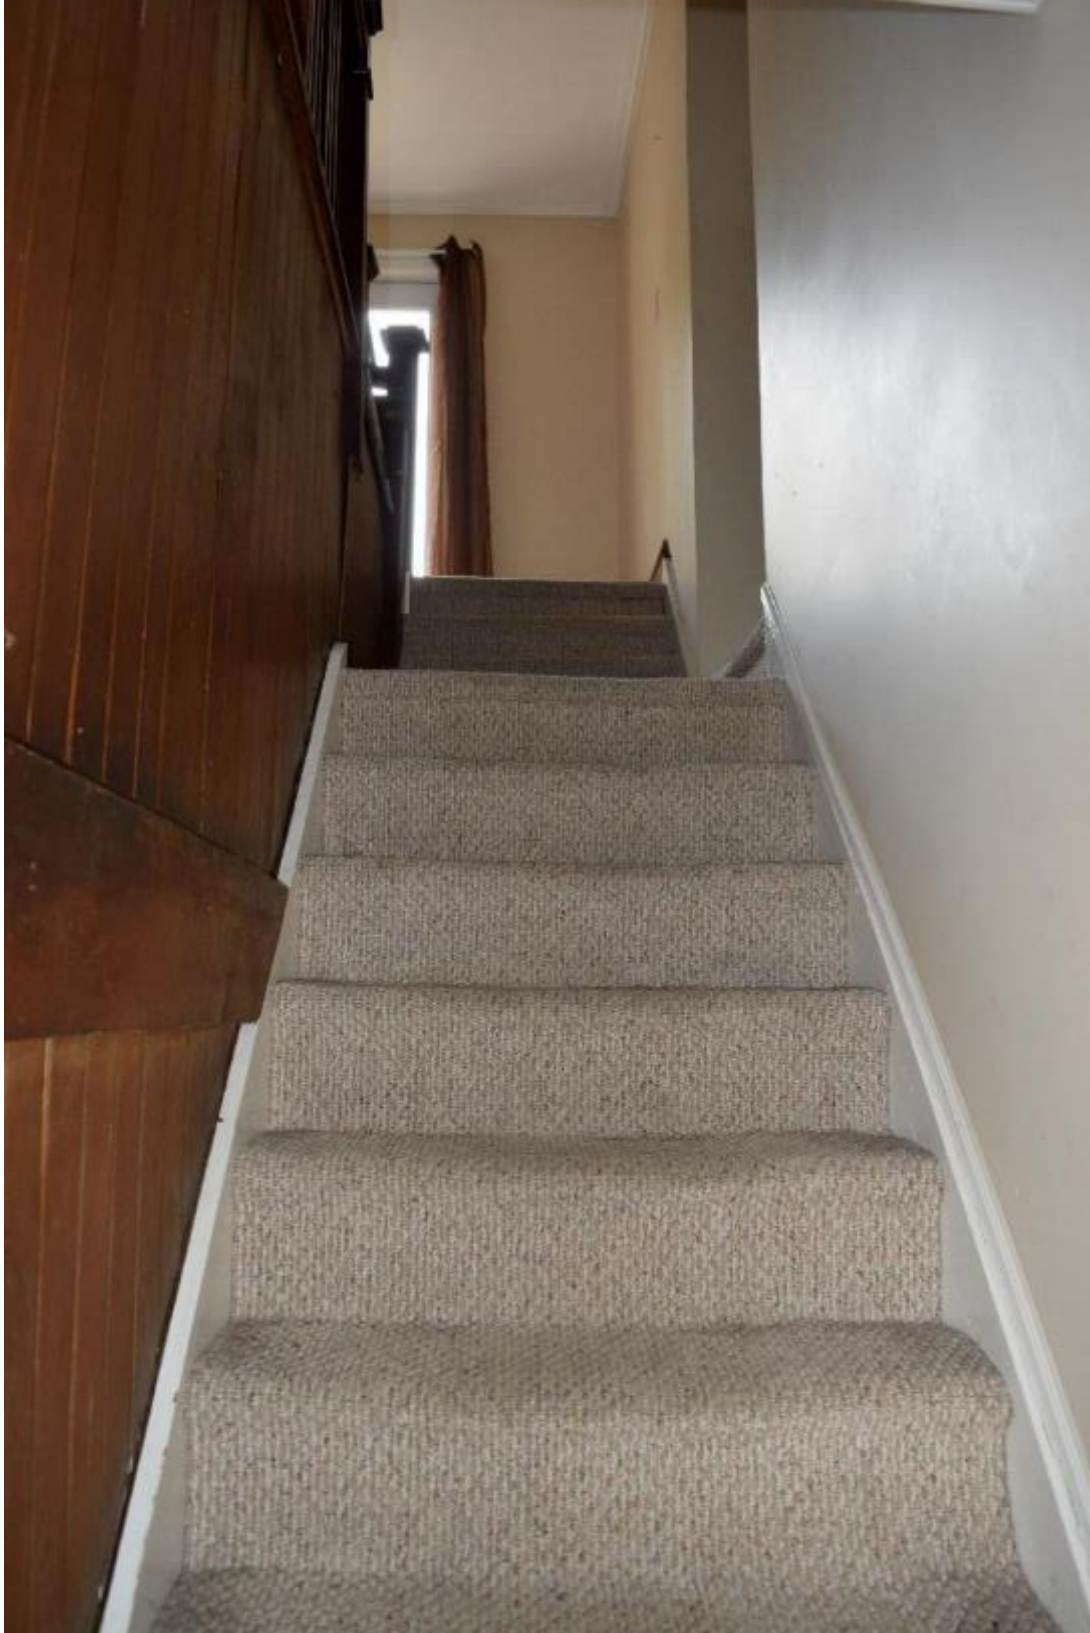
Image 44: Stairs. Used to be the backstairs and are now the only operable stairs.

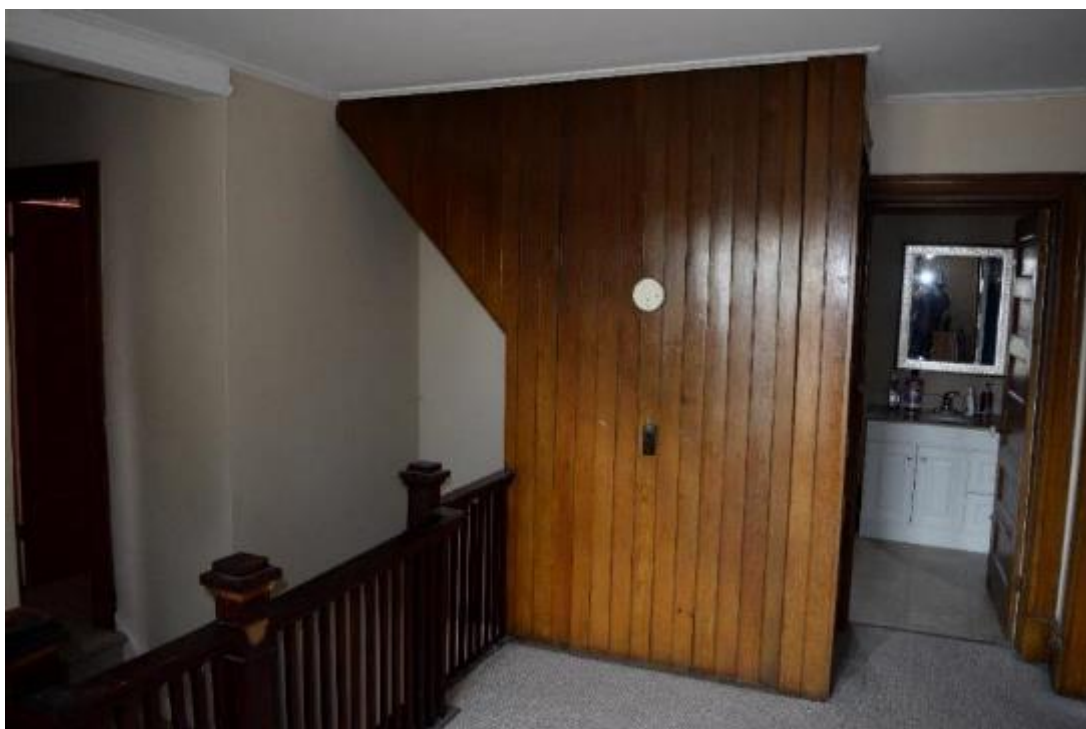
Image 46: Second floor landing at top of stairs. This area has been reconfigured and is no longer original.

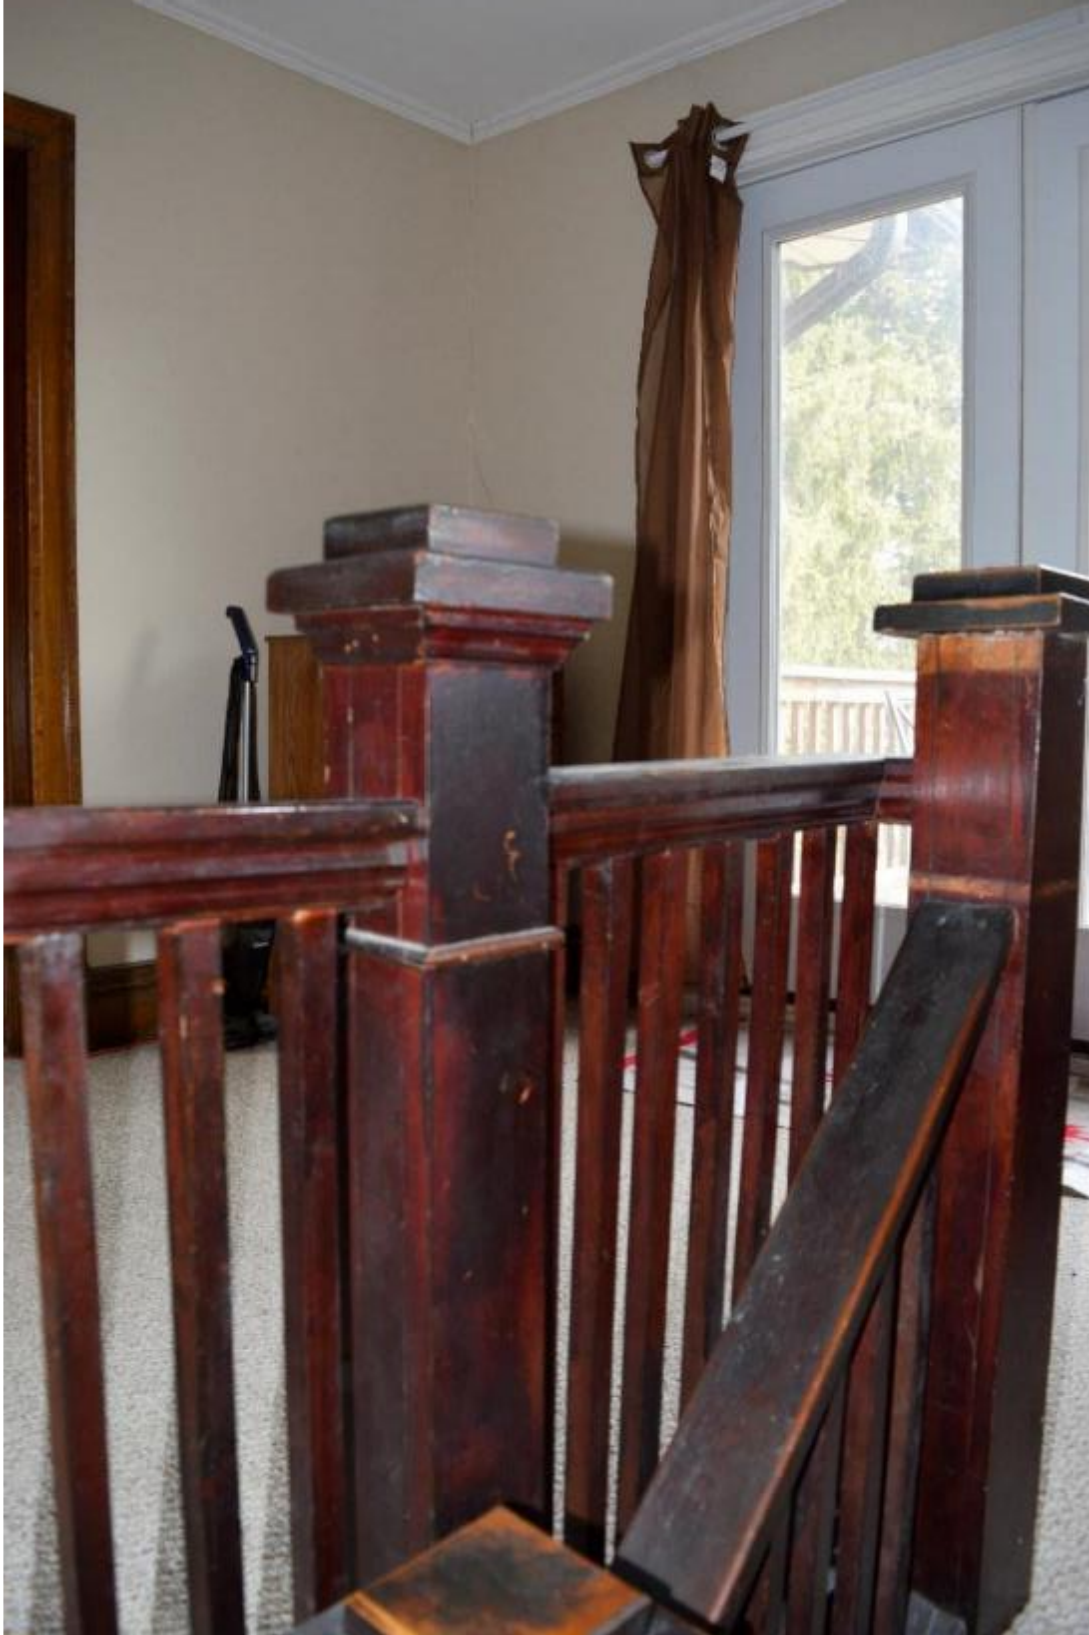
Image 47: Remains of balustrade on second floor.

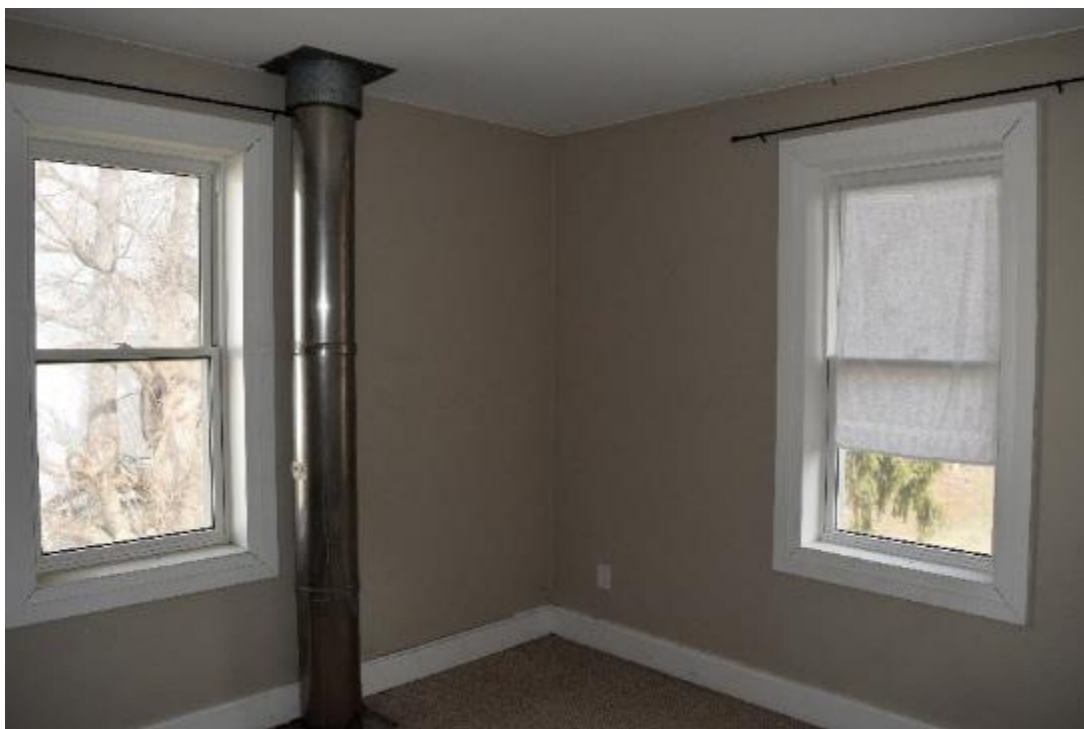
Image 52: Northwest bedroom on second floor facing north. Note use of modern one over one double hung windows.

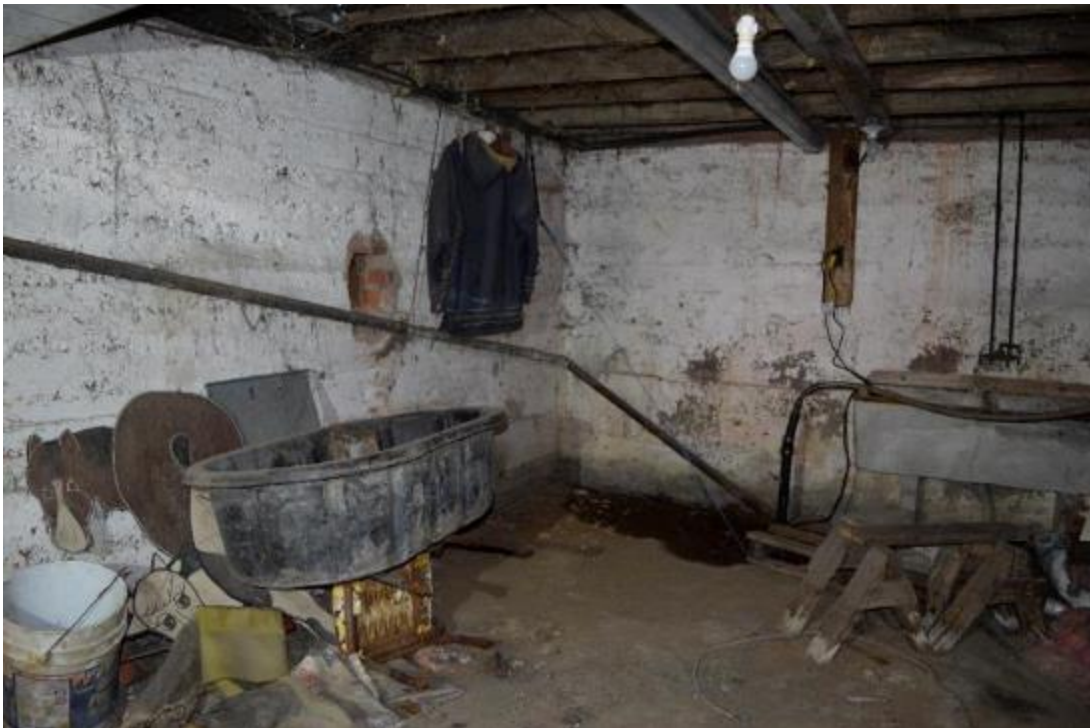
Image 69: Poured concrete foundation in northwest corner of home, note extent of water staining indicating seasonal flooding of basement. Light colour represents high water mark.

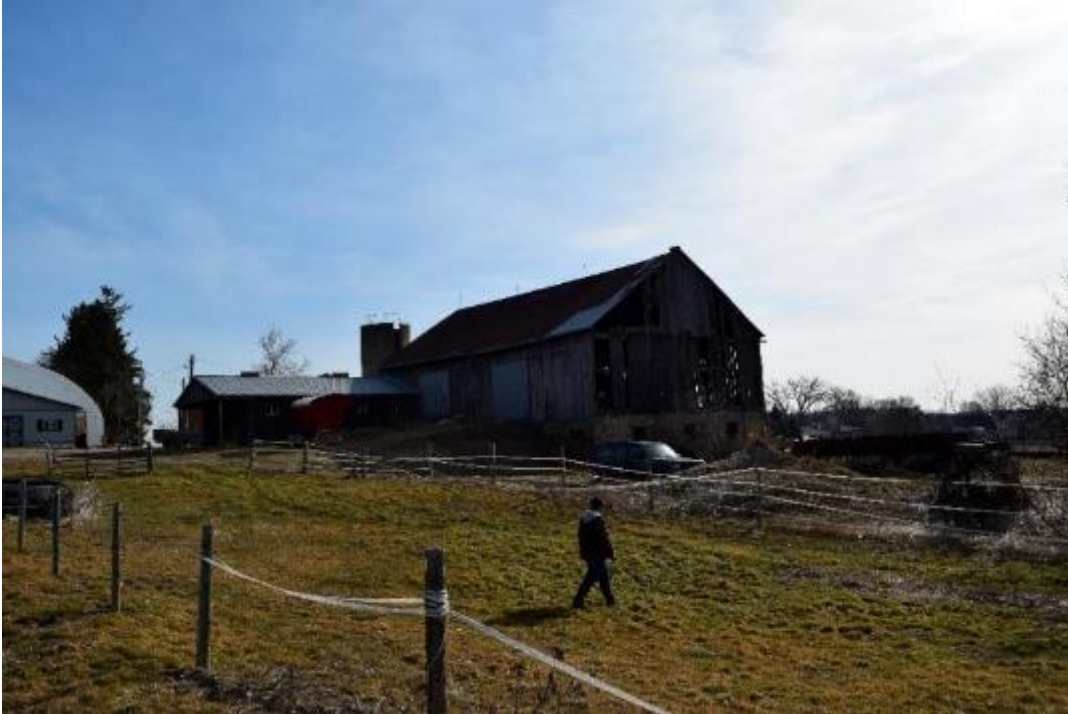
Image 86: Overview of timber frame barn and later horse stable constructed in 1996, facing east.

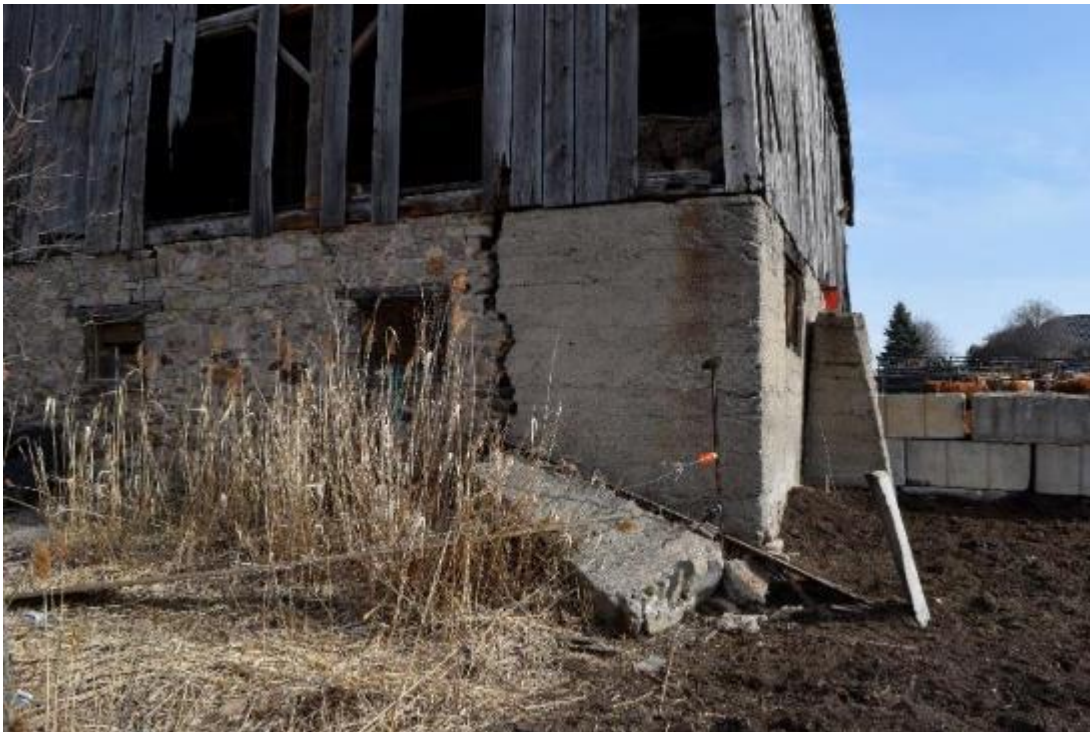
Image 88: Closeup of timber frame barn foundation.

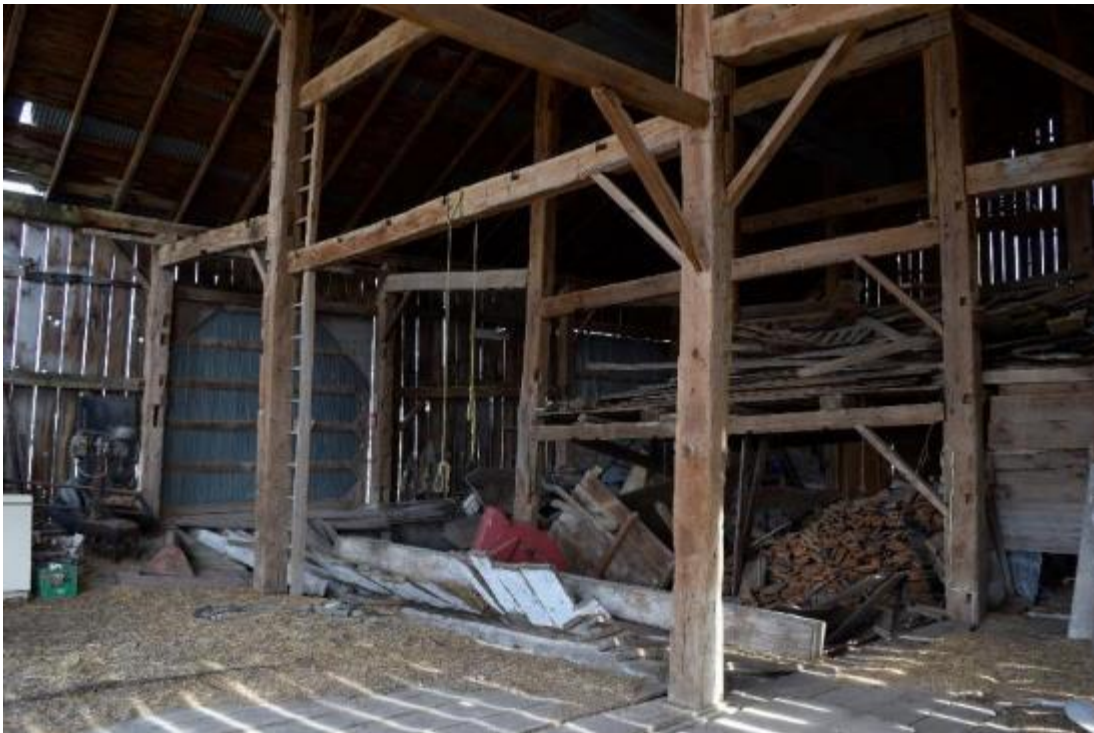
Image 92: Timber framing of barn, facing north.

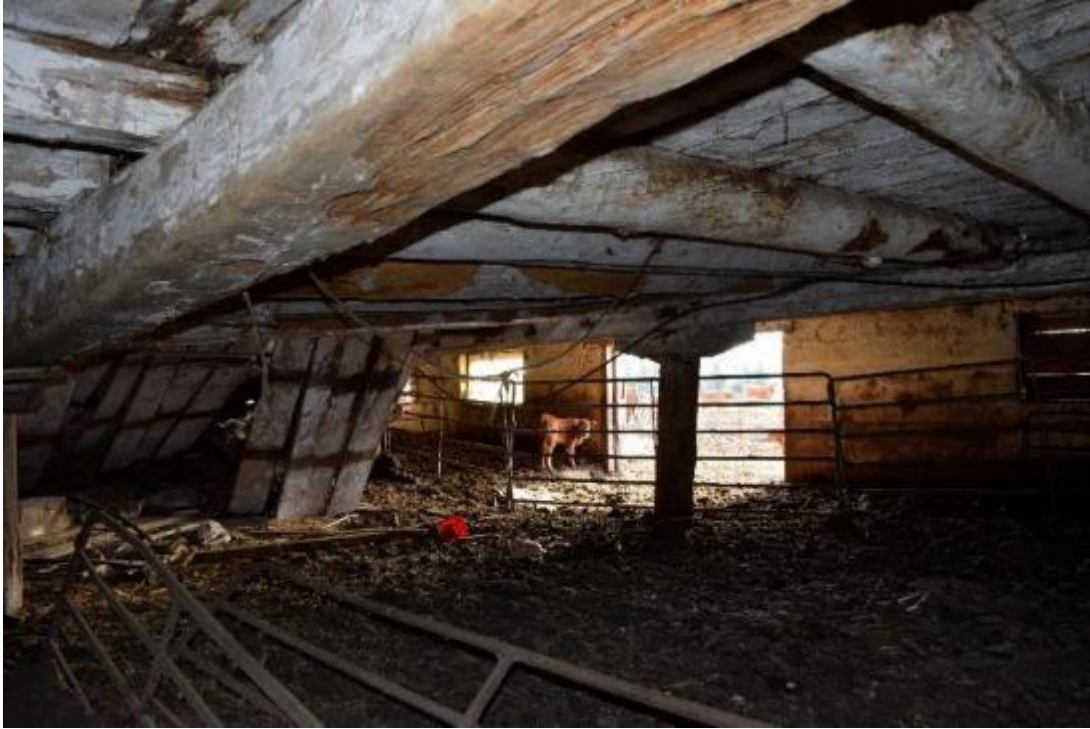
Image 93: Lower level of timber frame barn, suffering from structural collapse.

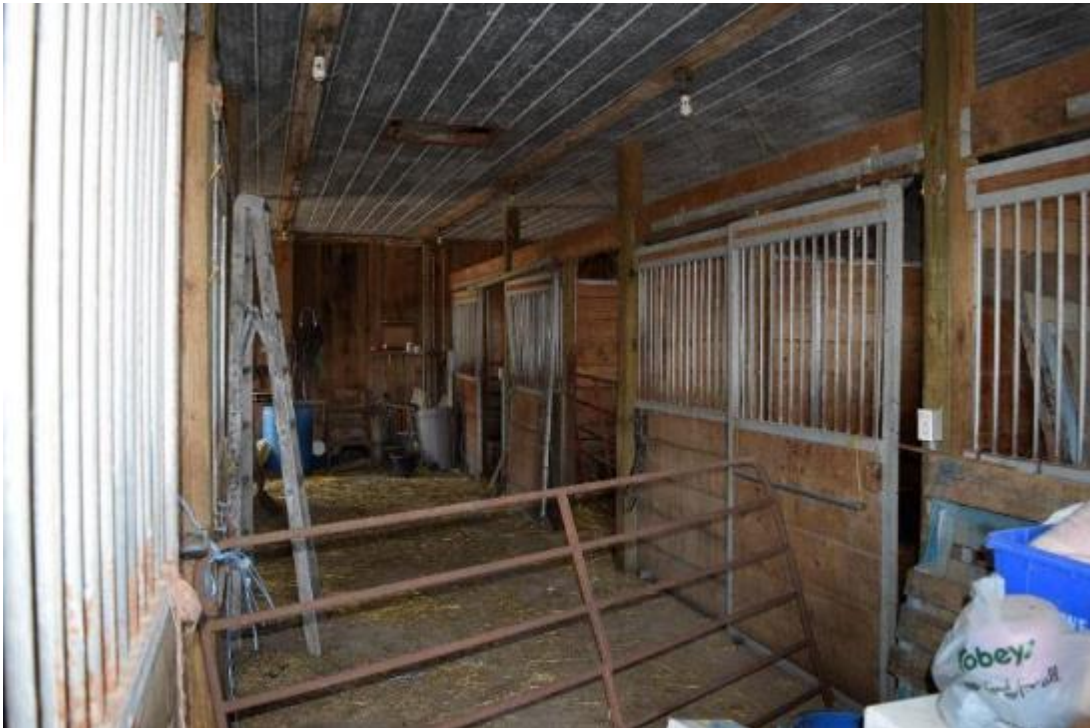
Image 94: Interior of 1996 stable.

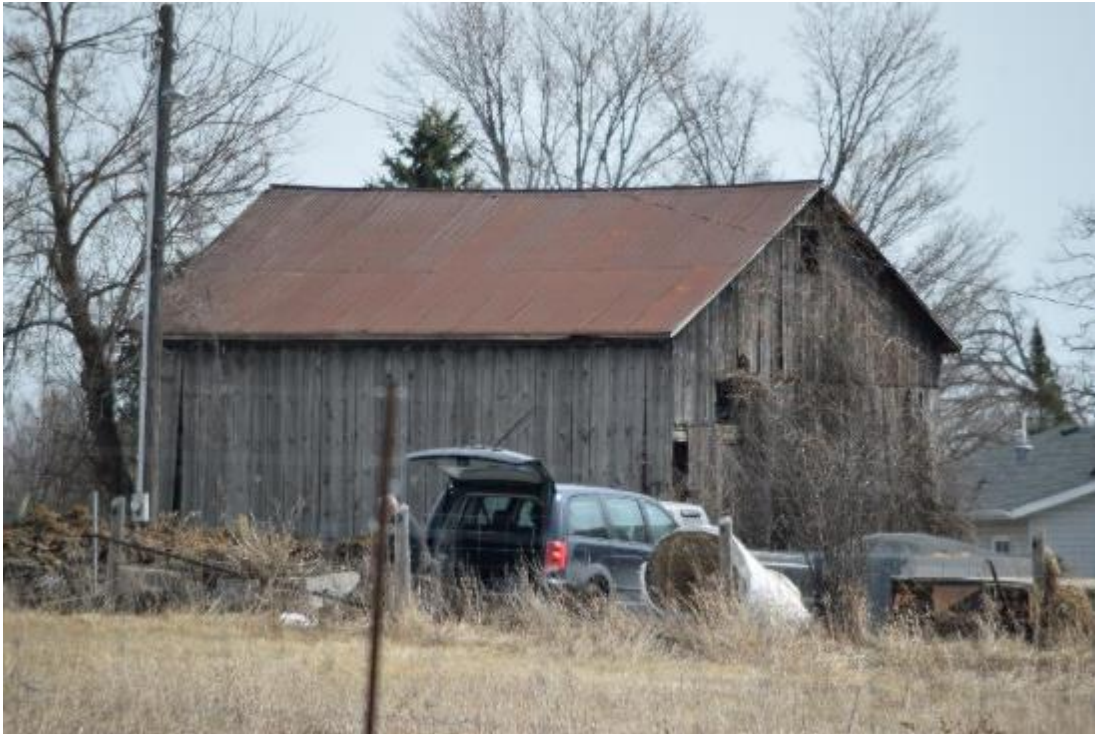
Image 95: Exterior of timber frame shed, facing northeast.

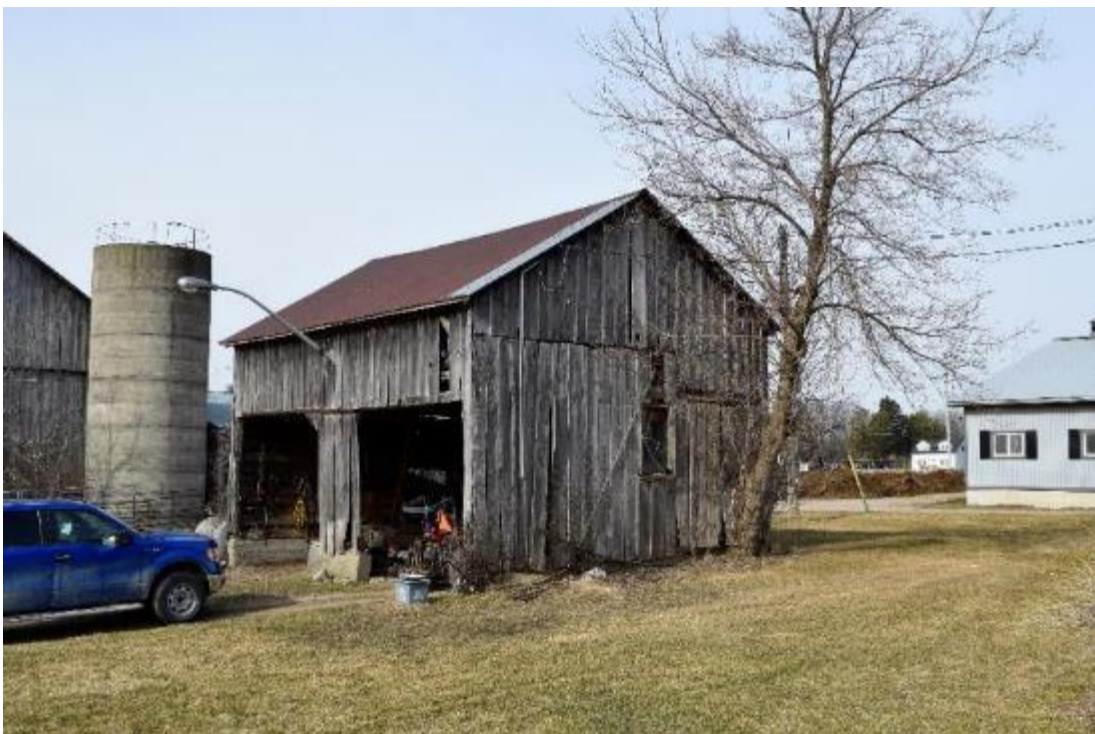
Image 96: Timber frame shed, facing west.

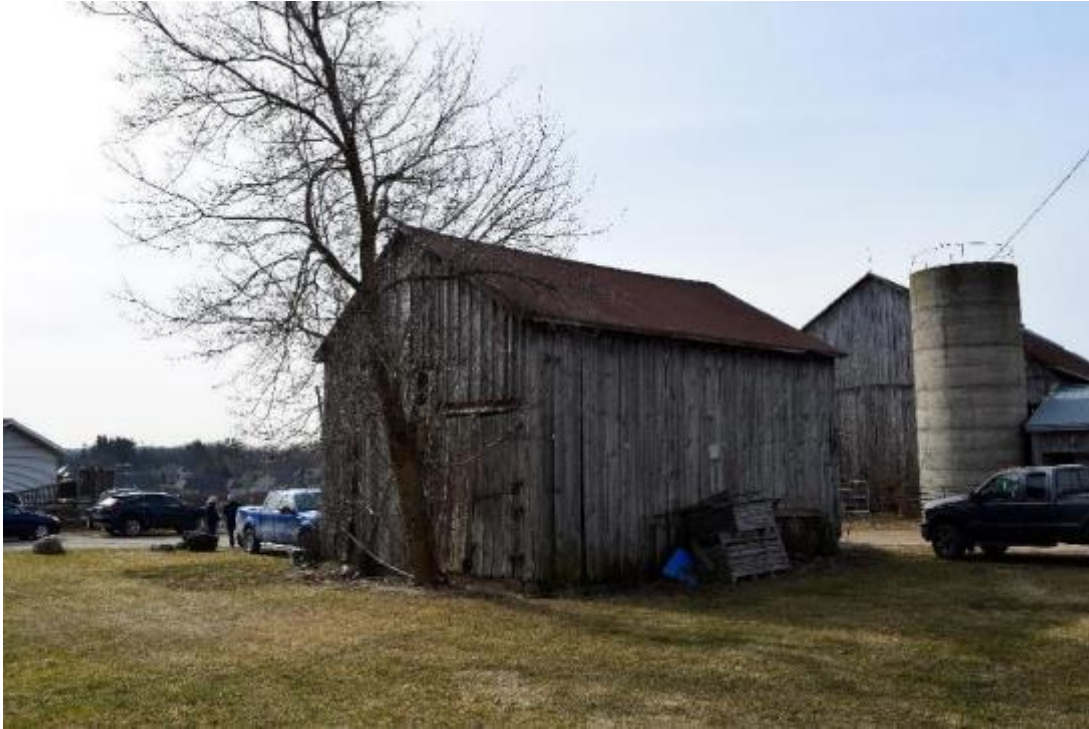
Image 97: Timber frame shed, with timber frame barn and cement silo behind, facing south.

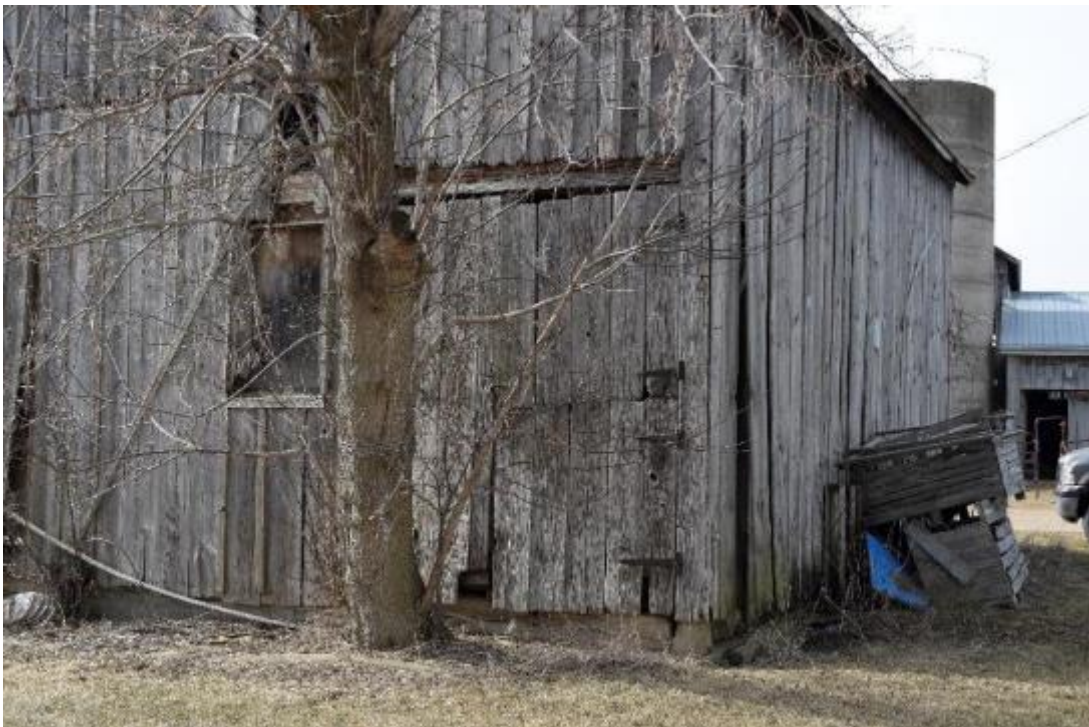
Image 98: Closeup of unused door and window in timber frame shed.

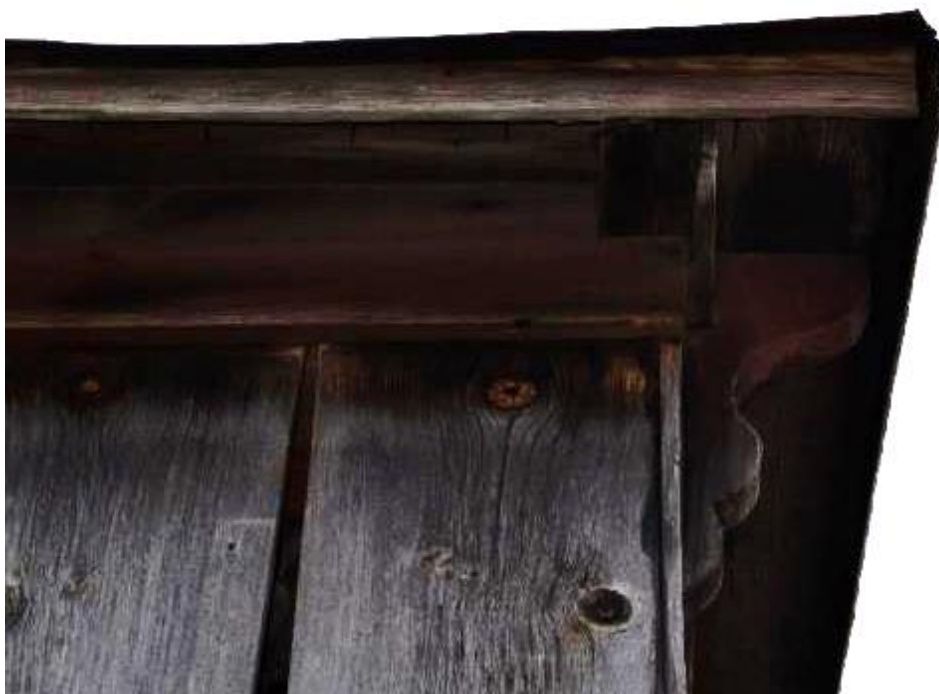
Image 99: Decorative bracket associated with timber frame shed.

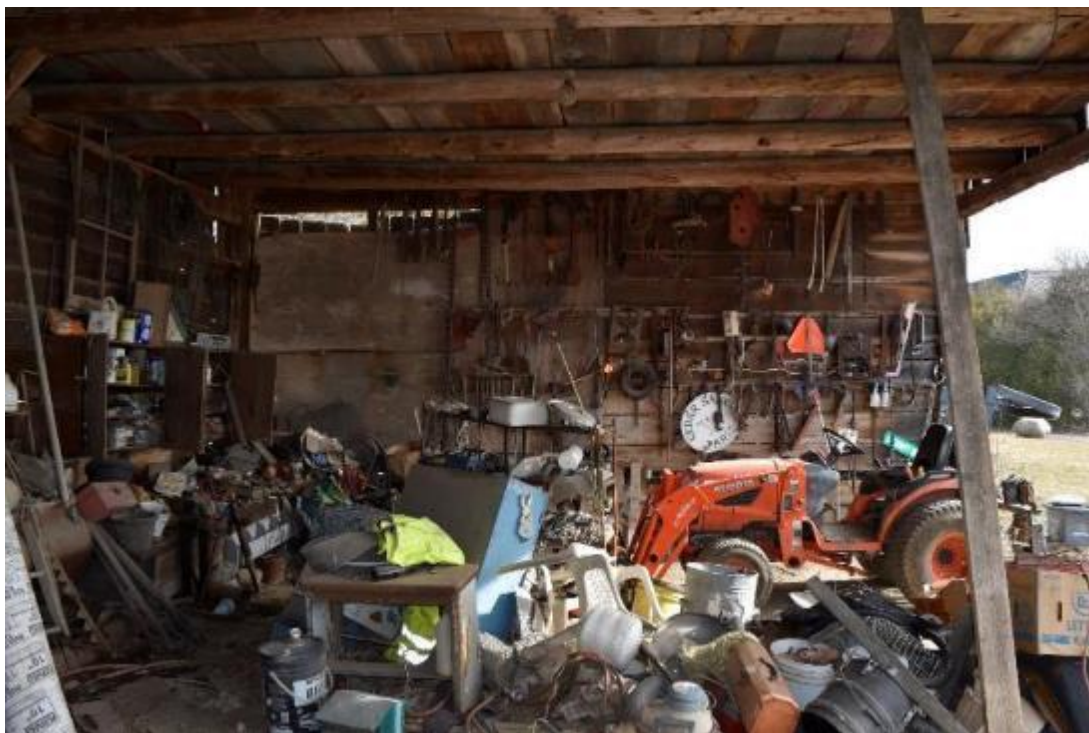
Image 100: Interior of timber frame shed, facing north.

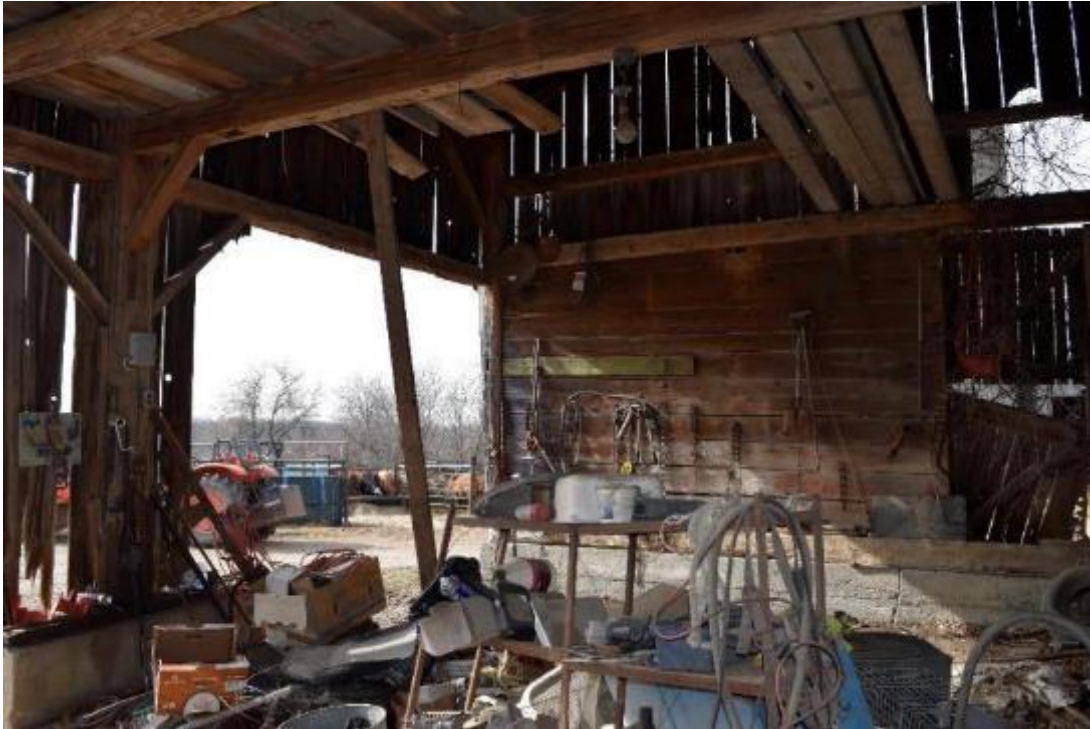
Image 101: Interior of timber frame shed, facing south.

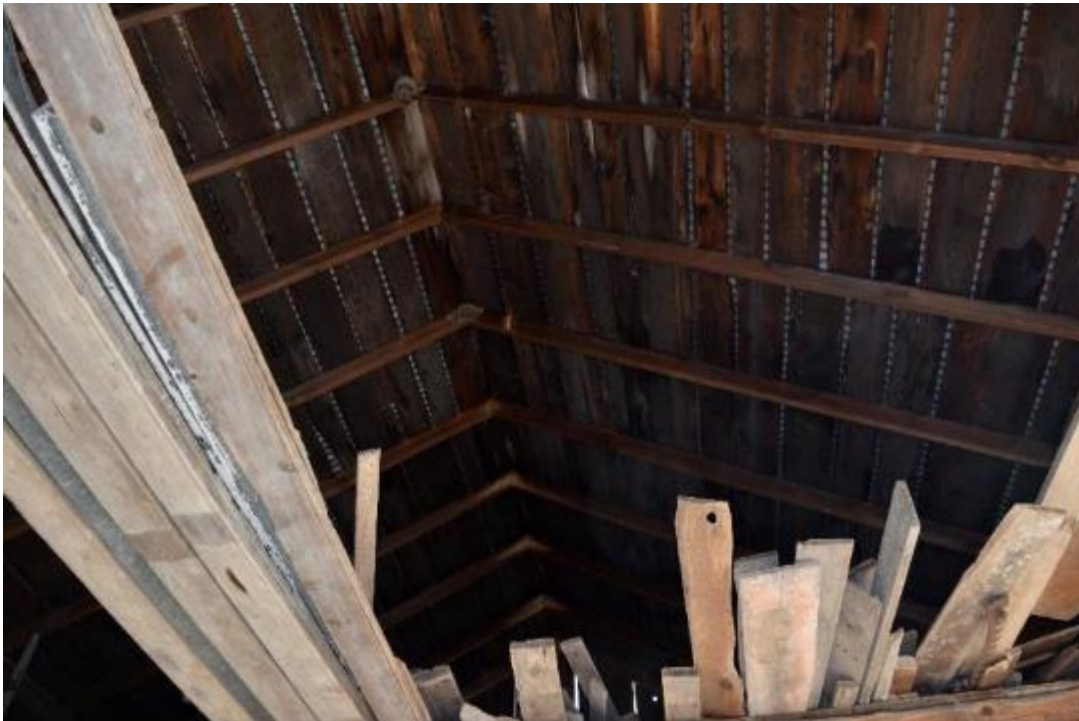
Image 102: Roof structure of timber frame shed.
