Heritage Impact Assessment, 8940 Creditview Road, Part of Lot 5, Concession 4 West of Center Road, Chinguacousy Township, Now City of Brampton, Regional Municipality of Peel

Project number: PHC-2021-027

Report Type: Revised

Report Date: 2 November 2021

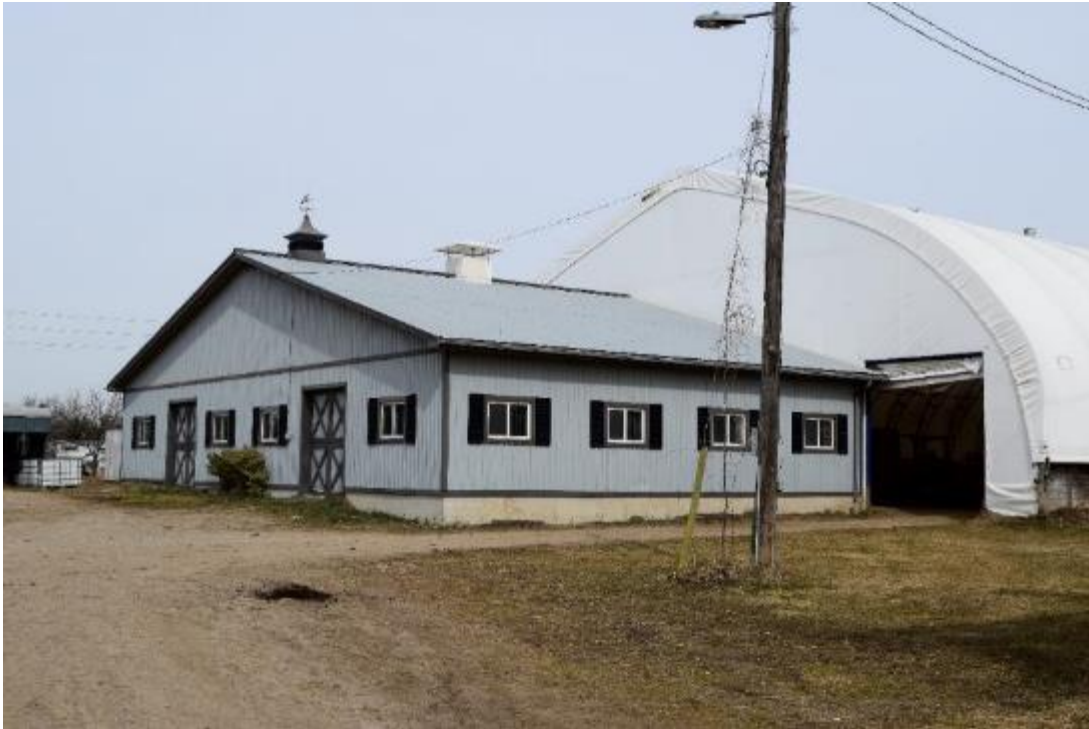
Image 103: 1998 horse stable, facing north.

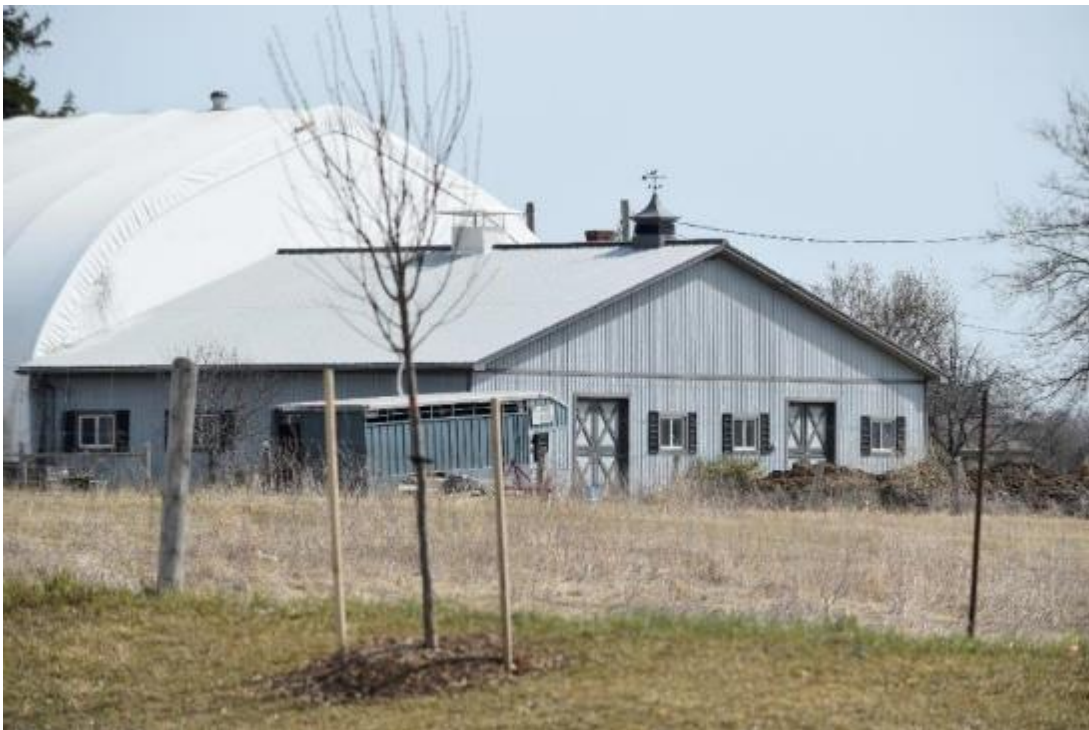
Image 104: 1998 horse stable facing east.

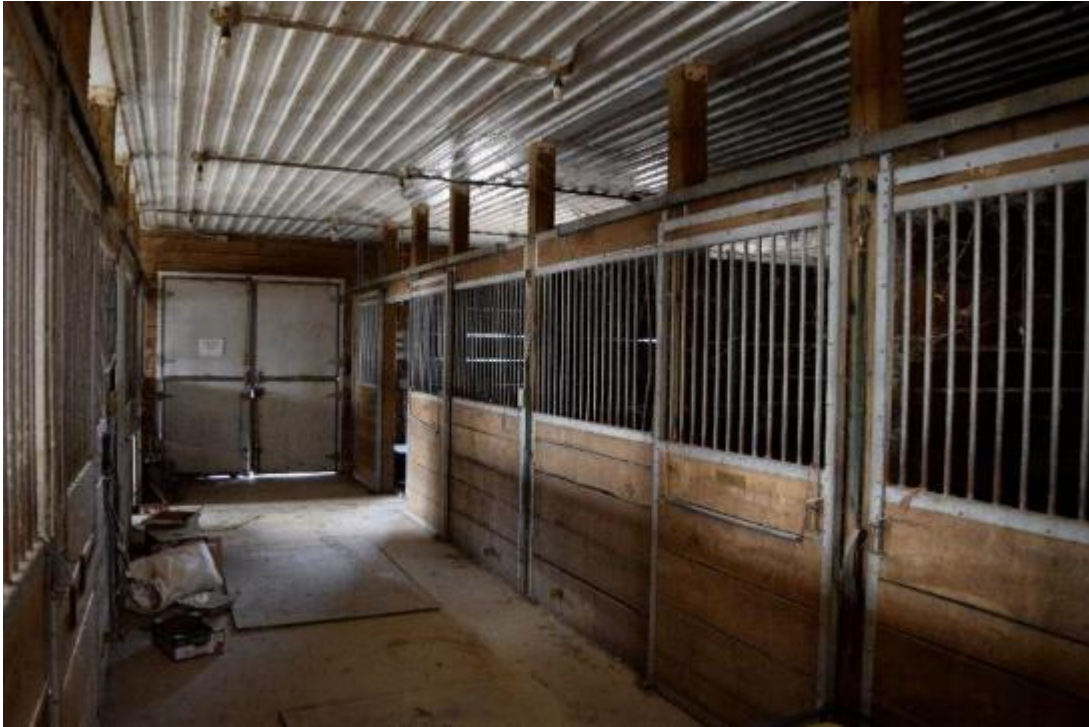
Image 105: Interior of 1998 horse stable facing southwest.

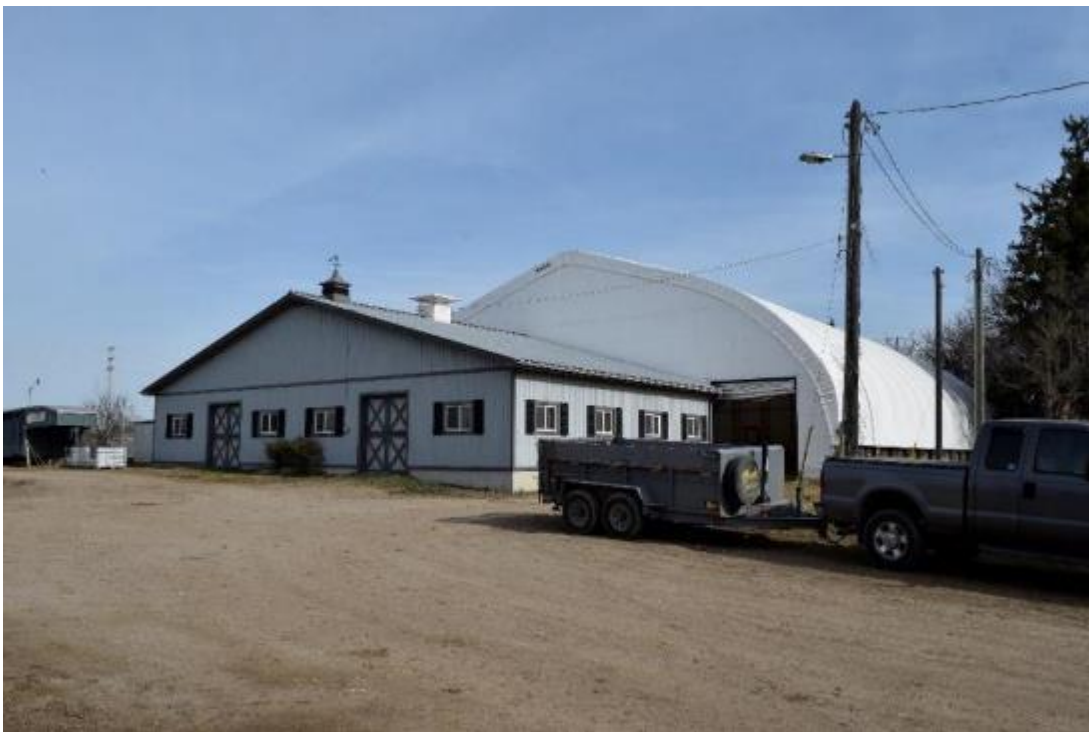
Image 106: Modern fabric Quonset hut located behind 1998 stable, facing north.

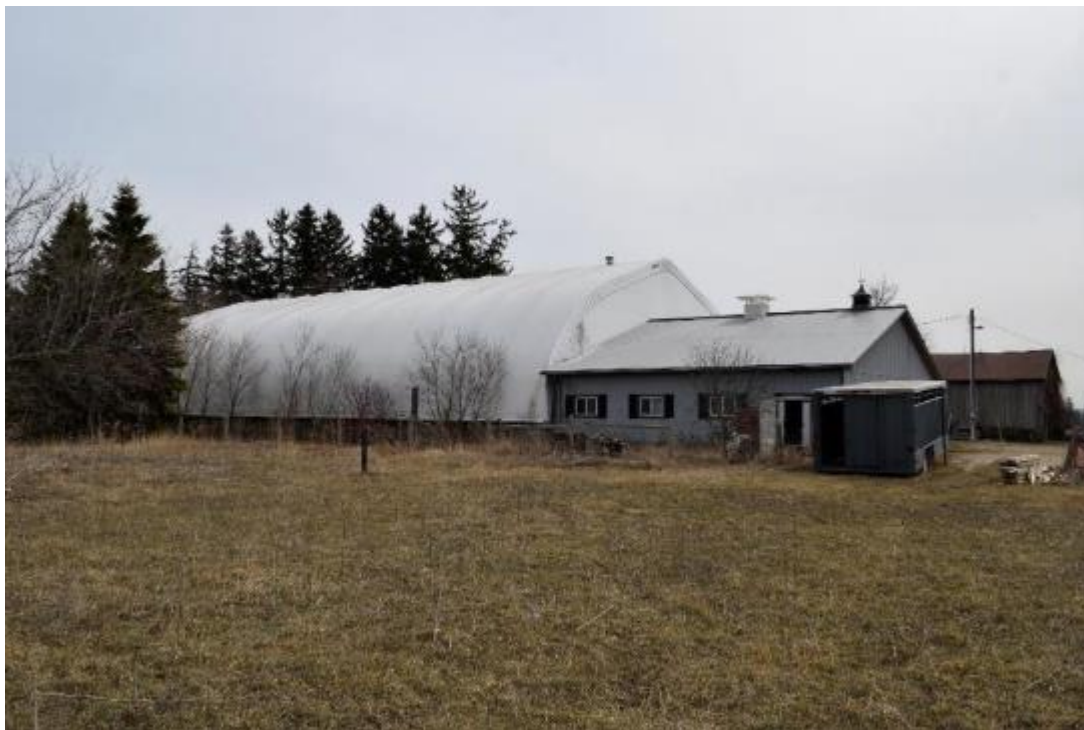
Image 107: Modern fabric Quonset hut, facing northeast.

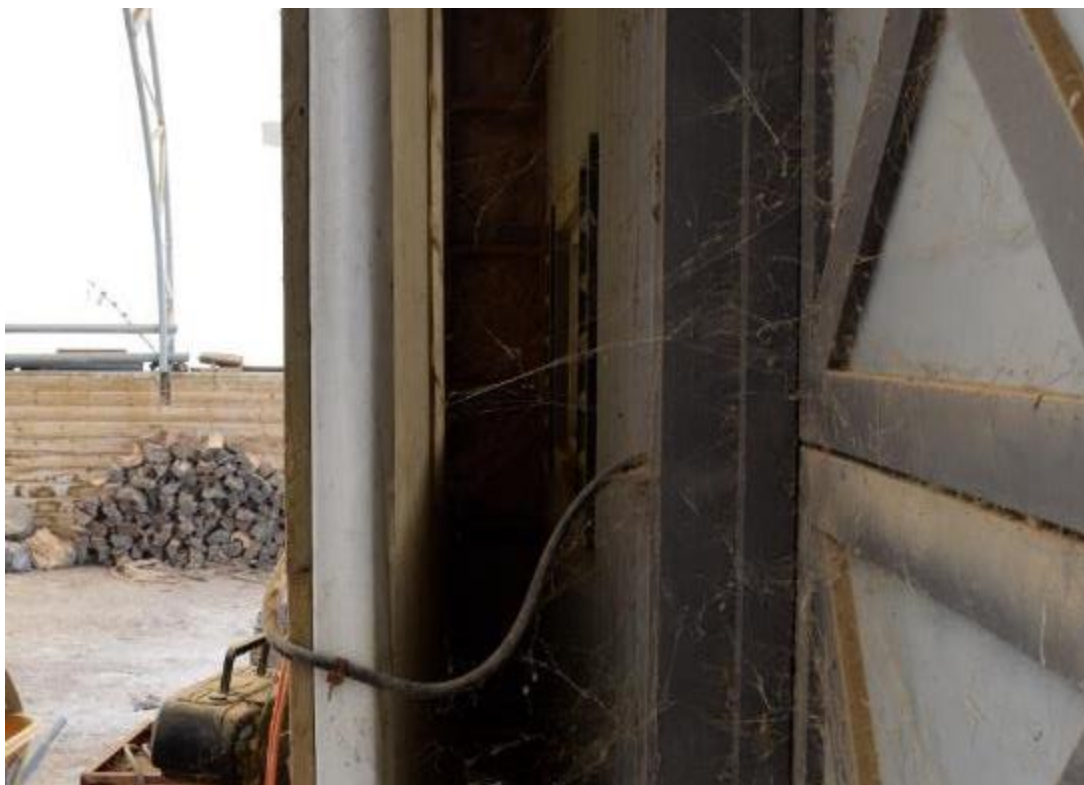
Image 108: Separation between fabric Quonset hut and 1998 horse stable.

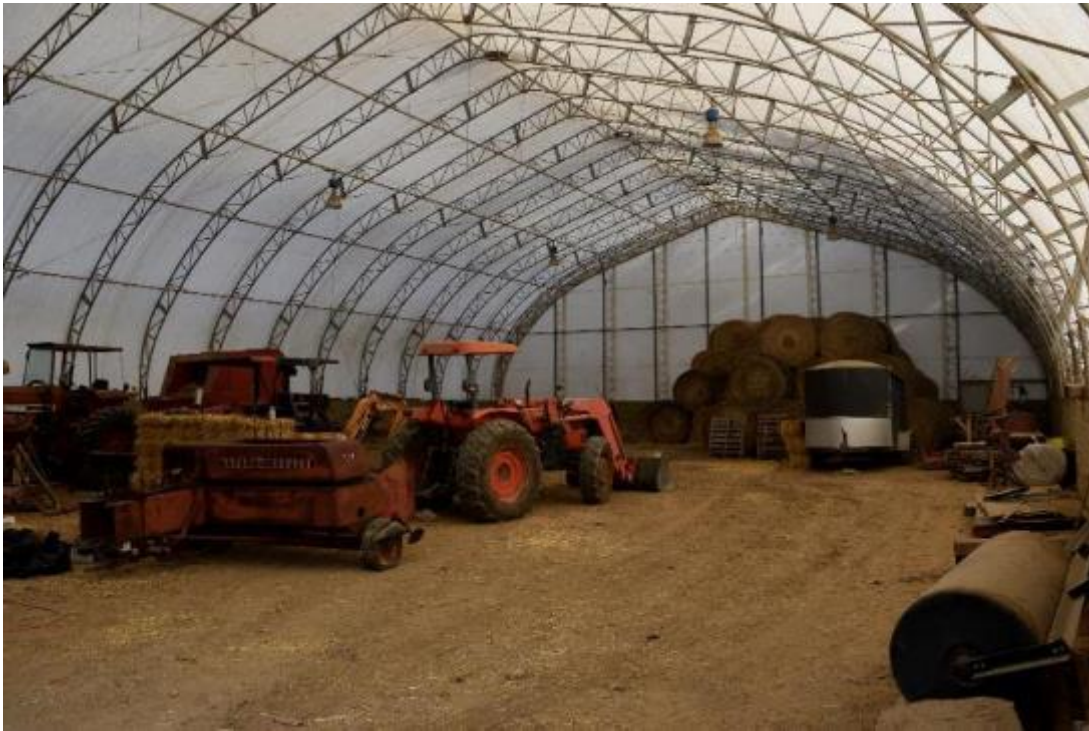
Image 109: Overview of interior of fabric Quonset hut, facing northeast.

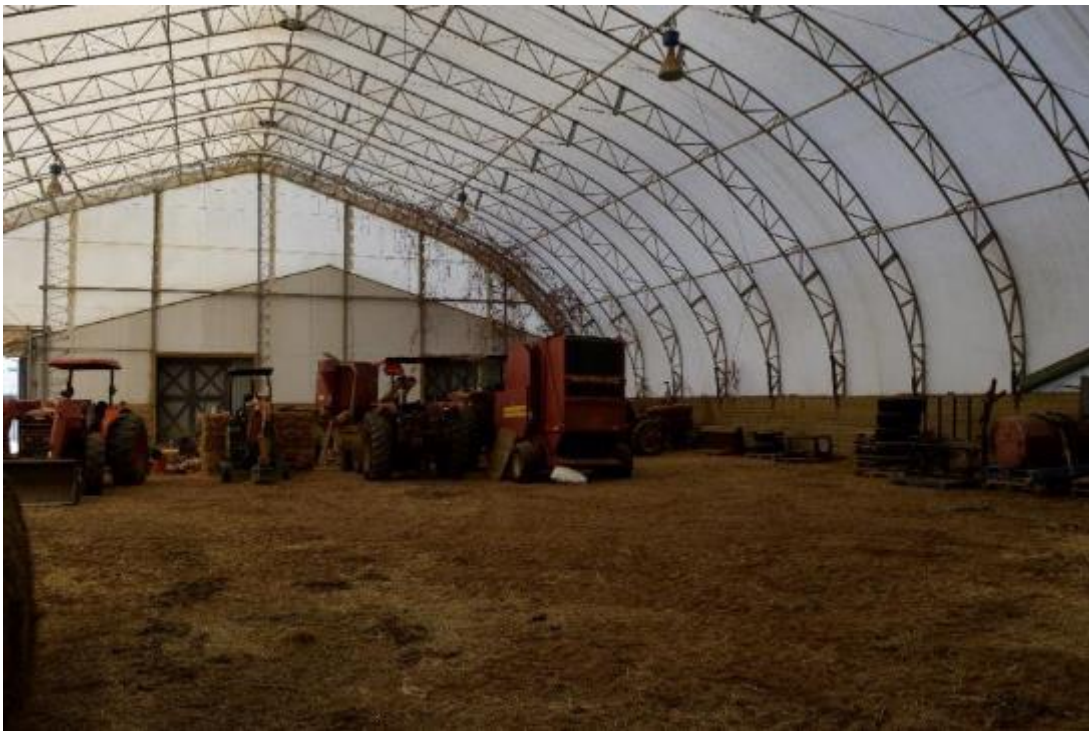
Image 110: Interior of fabric Quonset hut, facing southwest.

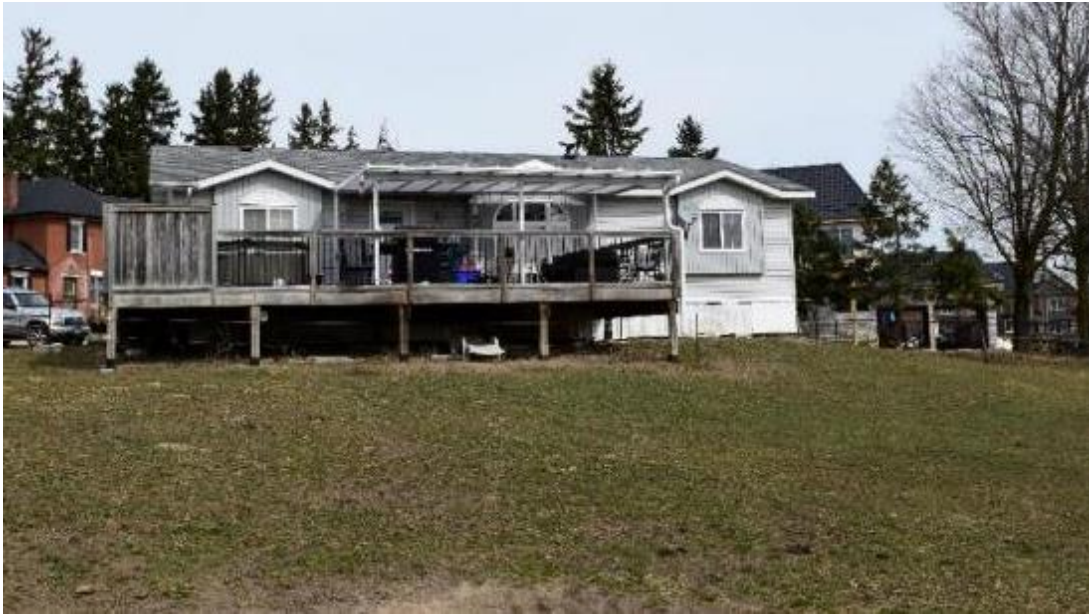
Image 111: Front façade of modern modular home, facing north.

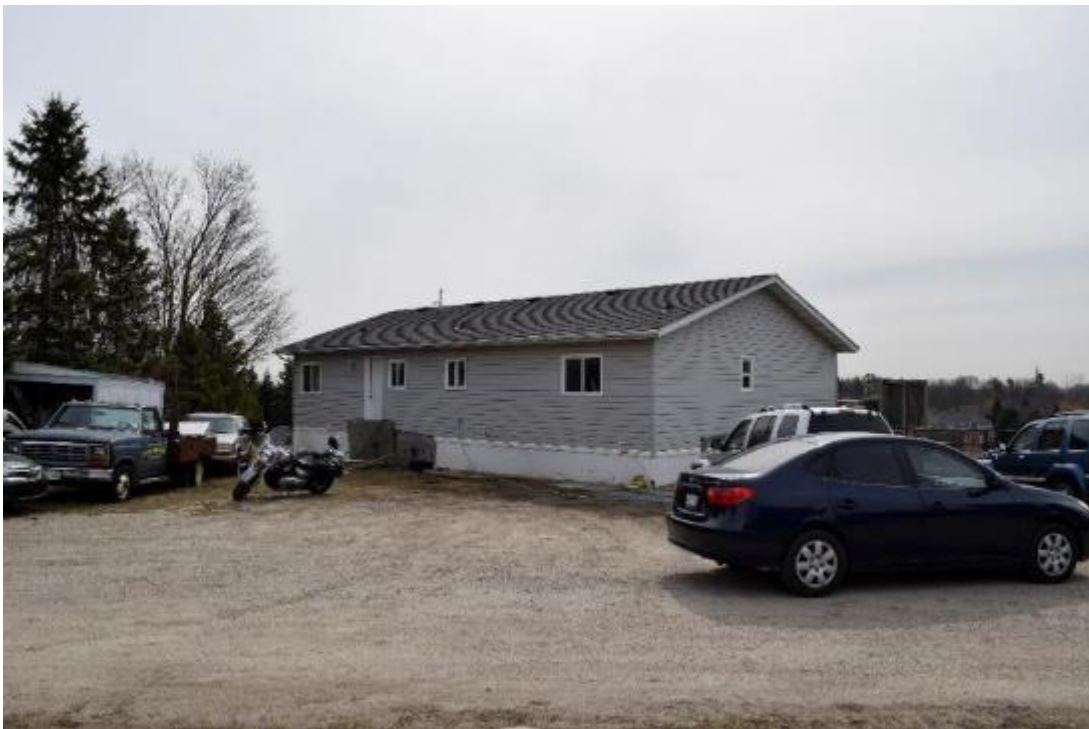
Image 112: Rear of modern modular home facing southeast.

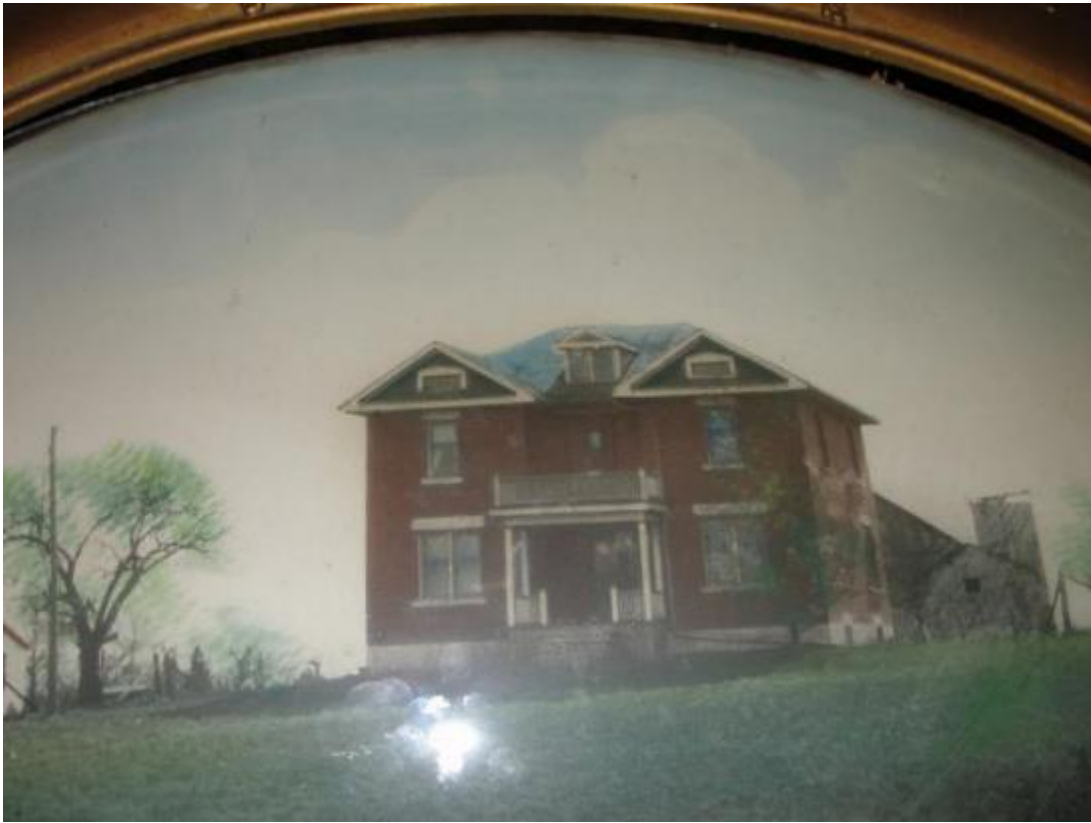
Image 113: Colorized image of Edwin Trimble House, photo provided by the City of Brampton. Notation on rear of image attributing construction to 1910.

The colorized images depicting the Edwin Trimble House appear to date post-1953. This assessment is based on the fact that Image 113 depicts the timber frame barn and shed as well as the silo that is date stamped 1953. A car is also depicted in Image 114 indicating the image does not date to the initial construction of the home. The original farmhouse is also depicted in both images and the milk house is present in Image 114.

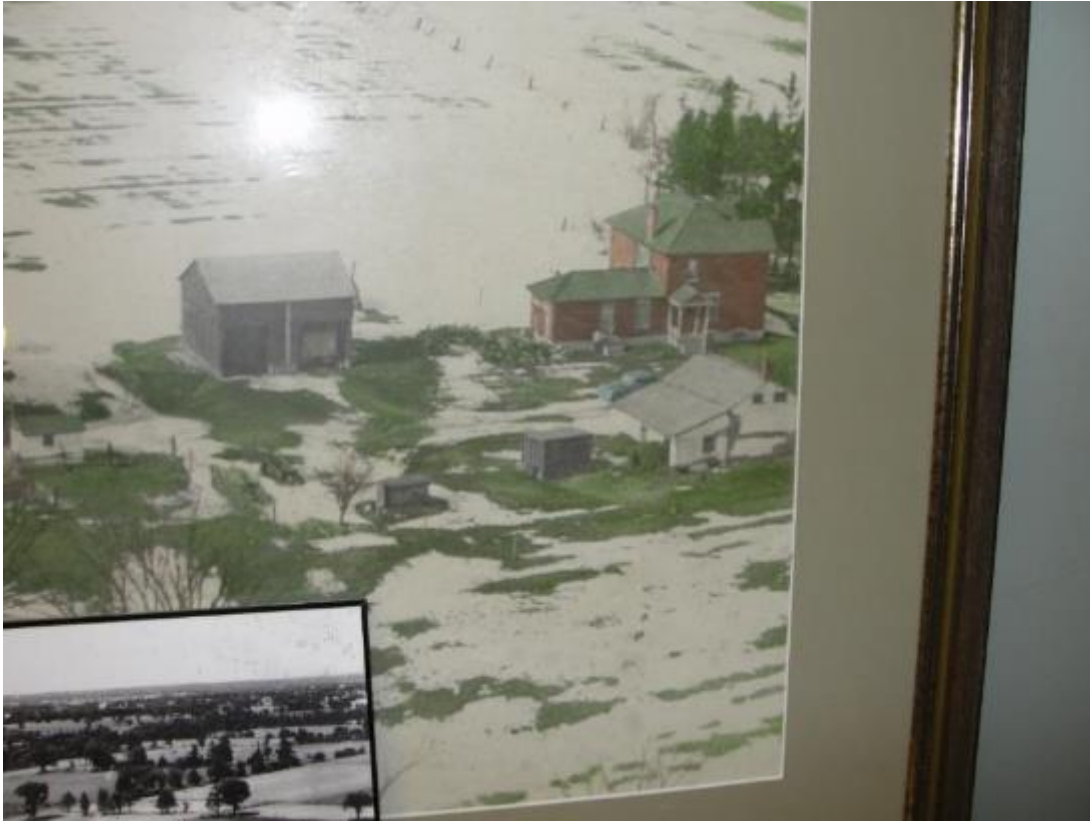
Image 114: Colourized image of Subject Property, photo provided by City of Brampton.
