8331 HERITAGE  
ROAD, BRAMPTON,  
ONTARIO  
MCCLURE  
FARMHOUSE

DATE: AUGUST 2023

PREPARED BY:  
ATA Architects Inc.

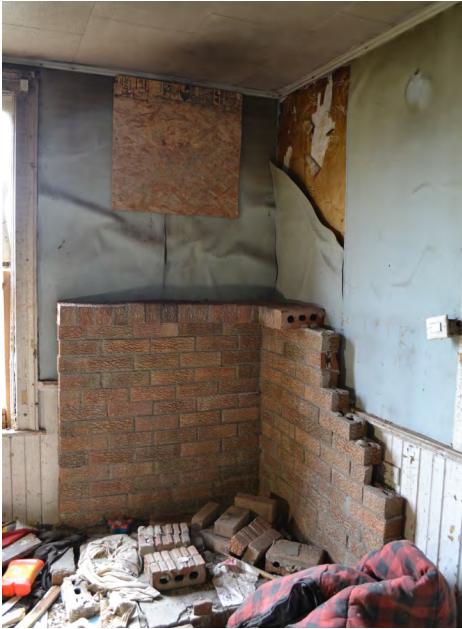
1.4) View of brick stove hearth. The hearth is not original as it was built over top of the original wainscotting. A portion of the brick has fallen off of the hearth. The brick stove has since been removed and what appears to be the location of the exhaust outlet in the south exterior wall, has been boarded up with plywood.

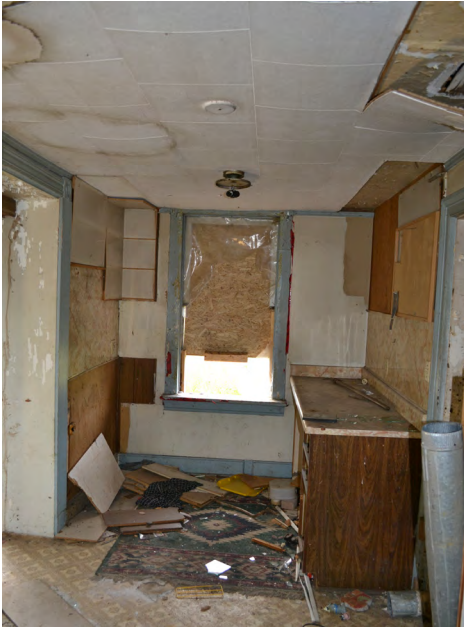
1.9) View of Kitchen 2 in original portion of the house to the south. The view looks towards a window which was added at a later date. The kitchen millwork is not original to the house.

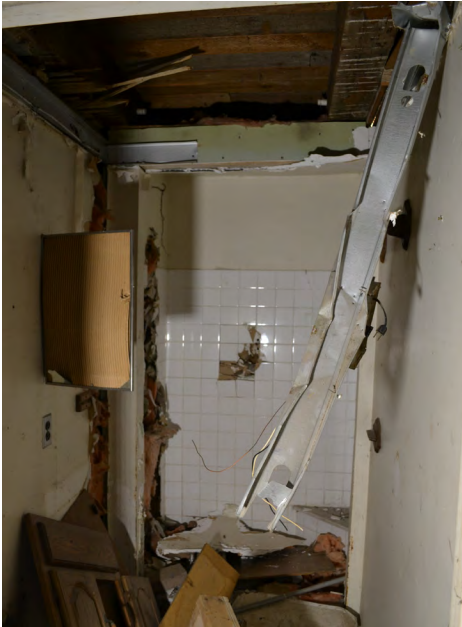
1.15) View of washroom adjacent in original portion of house. The ceiling has fallen and hand-hewn beam supporting the floor above is visible.

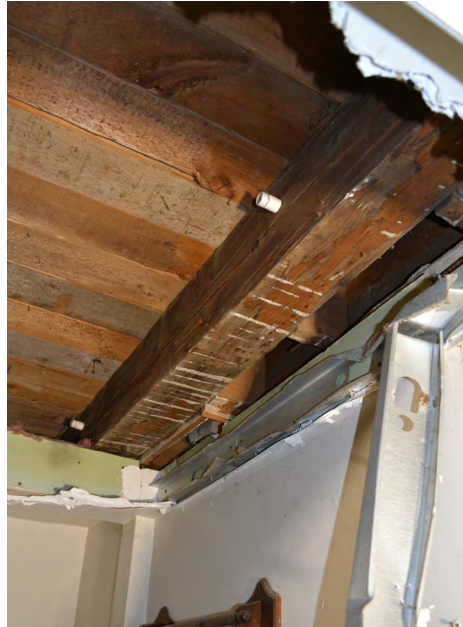
1.16) Close-up view of beam above ceiling. Tubes are sticking out from the beam, possible remnants from former knob and tube wiring.

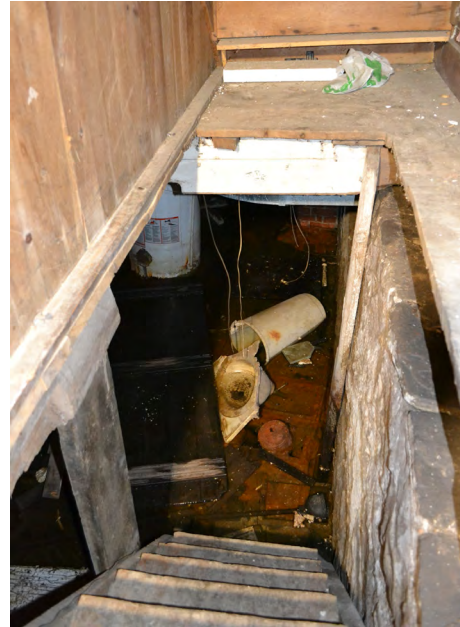
1.17) View of stairs to basement level beneath the original portion of house. The basement is flooded and thus inaccessible.

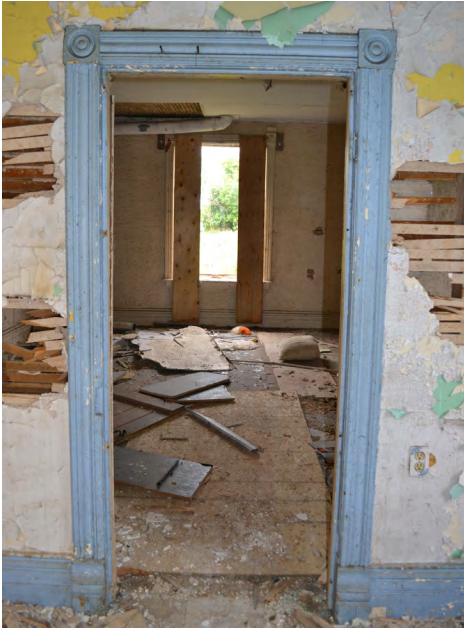
1.25) Closeup view of doorway between Kitchen 1 and dining room. The door trim features bullseye rosette corner blocks with beaded casing trim

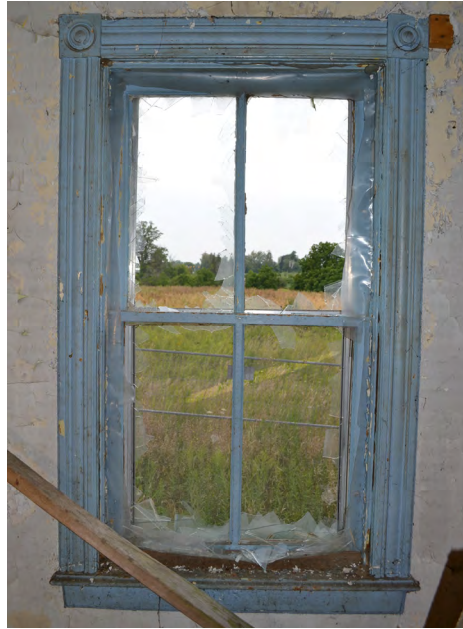
1.26) Closeup view of the window in Kitchen 1.

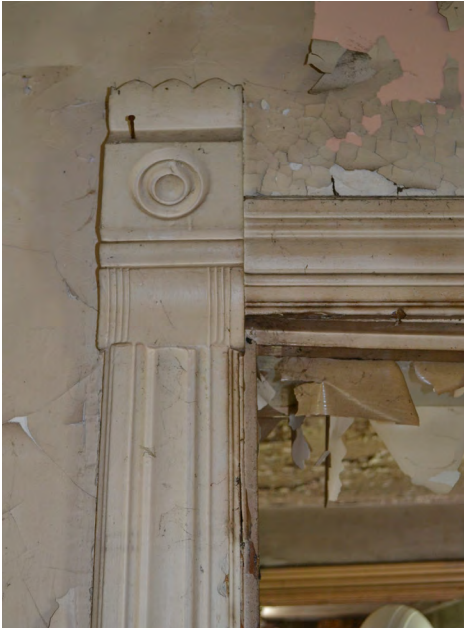
1.30) Close-up view of the door trim in the dining room.

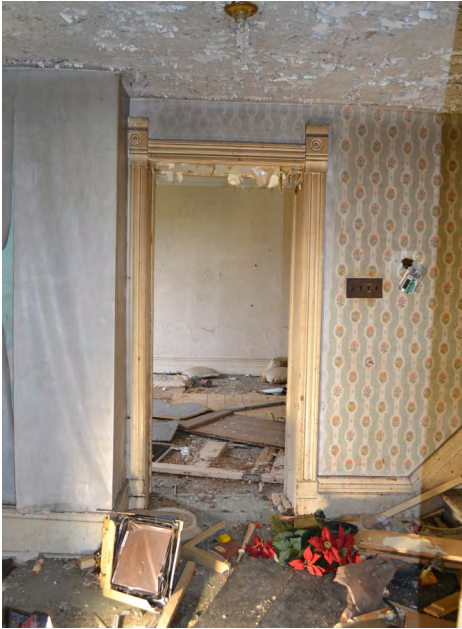
1.31) View from foyer of original portion of the house, looking to the later addition to the north. To the left of the doorway is a chimney stack, plastered over. To the right are the stairs to the 2nd floor.

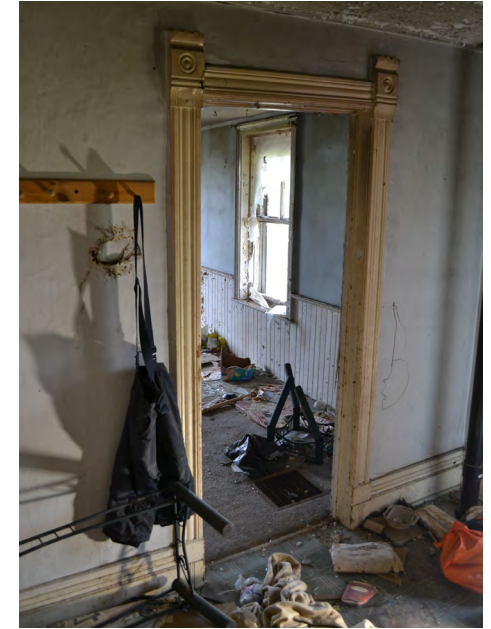
1.34) View from the foyer looking to the south. The door trim is the same as in the dining room.

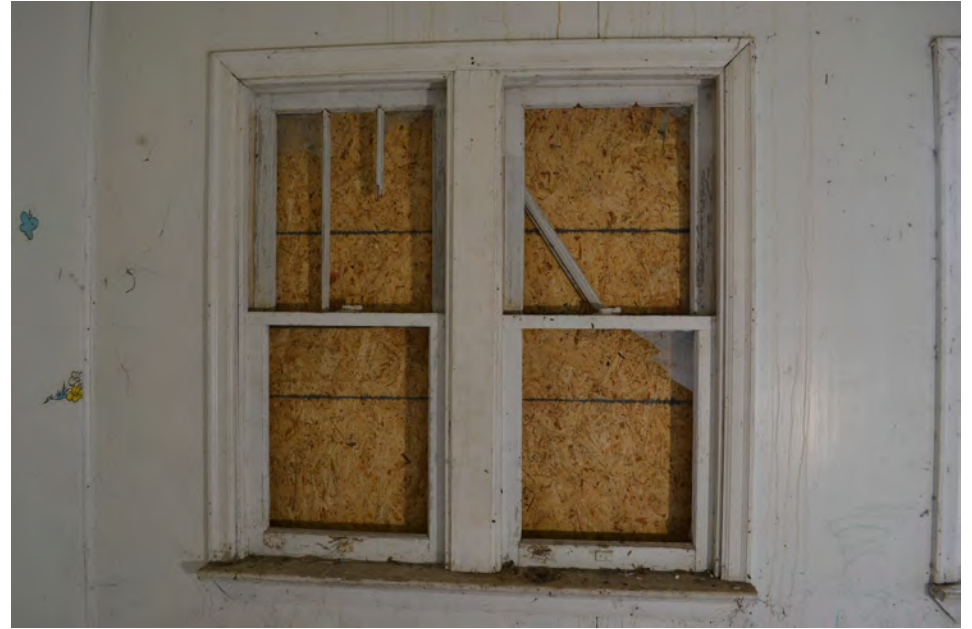
1.41) Close-up view of one of the double windows in Room 2 of the schoolhouse.

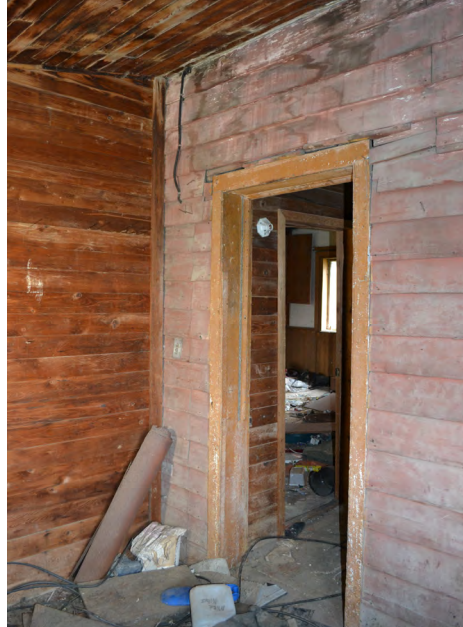
1.43) View from Room 3 of school house, looking to north. The north wall of Room 3 is clad in clapboard siding suggesting this was once an exterior wall that was later closed off.

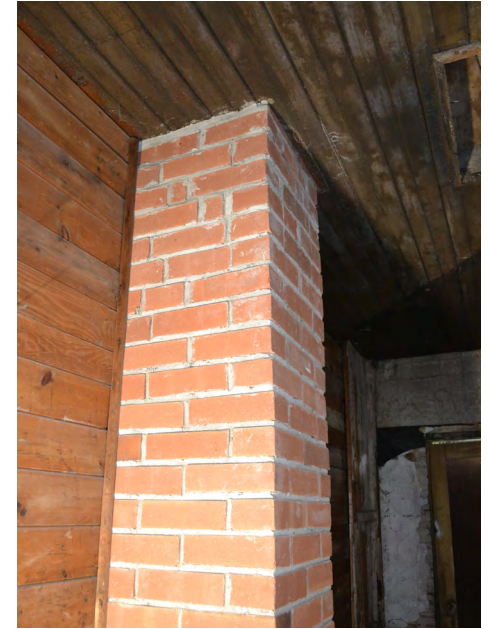
1.49) Close-up view of brick chimney within the school house corridor.

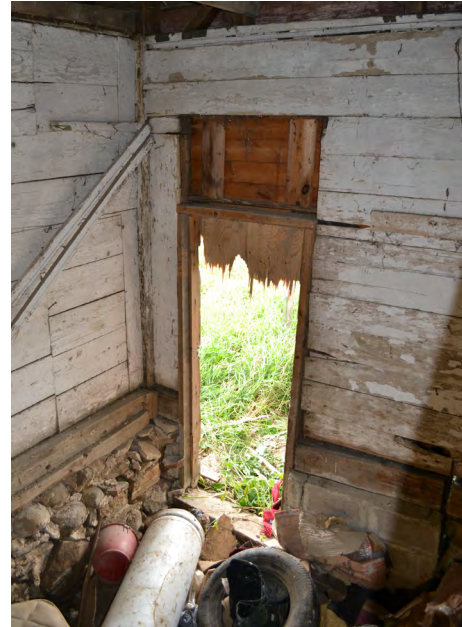
1.51) View of Room 4 of school house to south. The house rests on a fieldstone foundation which is visible along the east wall.

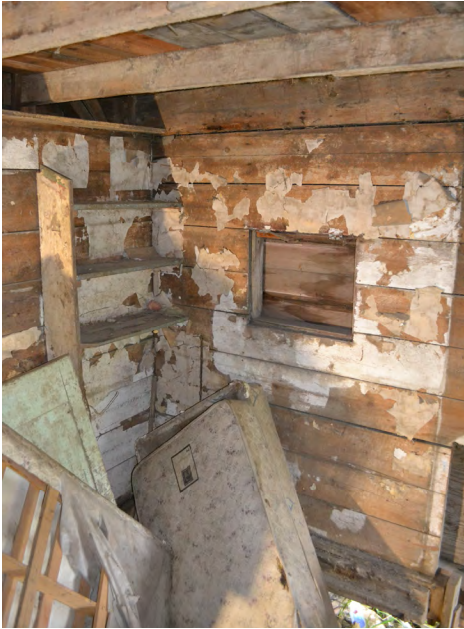
1.53) View of Room 4 of school house to north-east. The ceiling is framed with heavy timber beams and smaller joists.

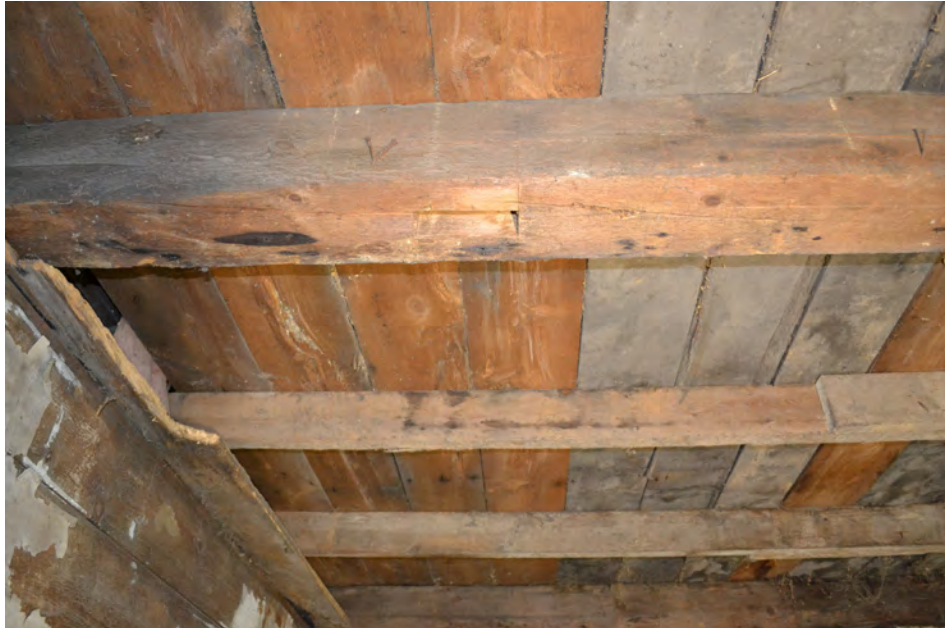
1.54) Close-up view of the solid-sawn heavy timber beam supporting the ceiling

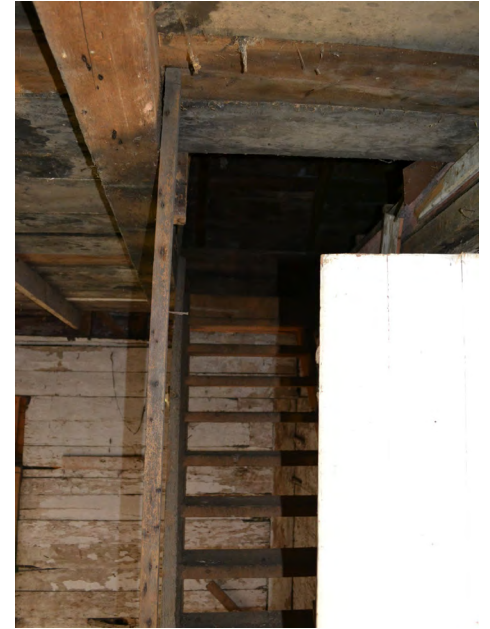
1.55) View from Room 4 to the stair case to the attic above the school house.

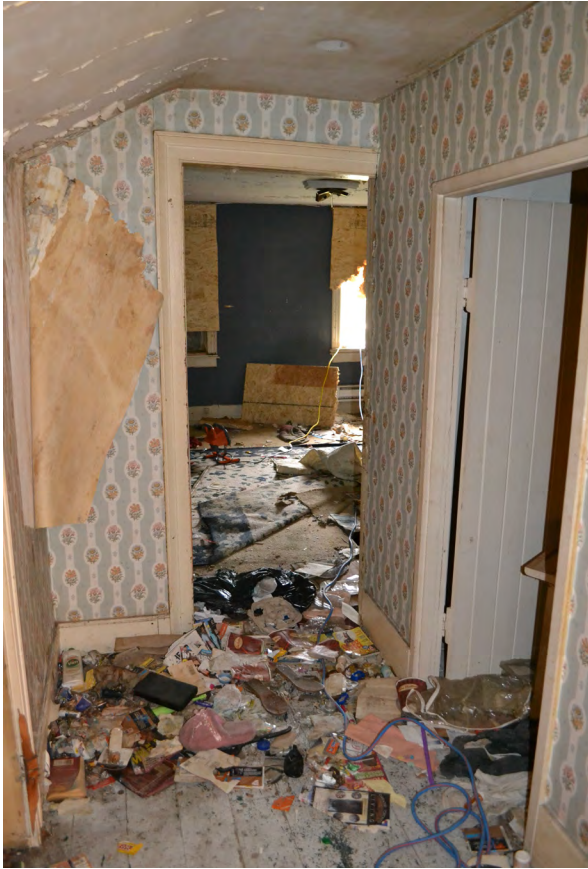
2.4) View from landing towards Bedroom 1. An entrance to a storage space is on the left hand side and the entrance to the second floor bathroom is on the right hand side.

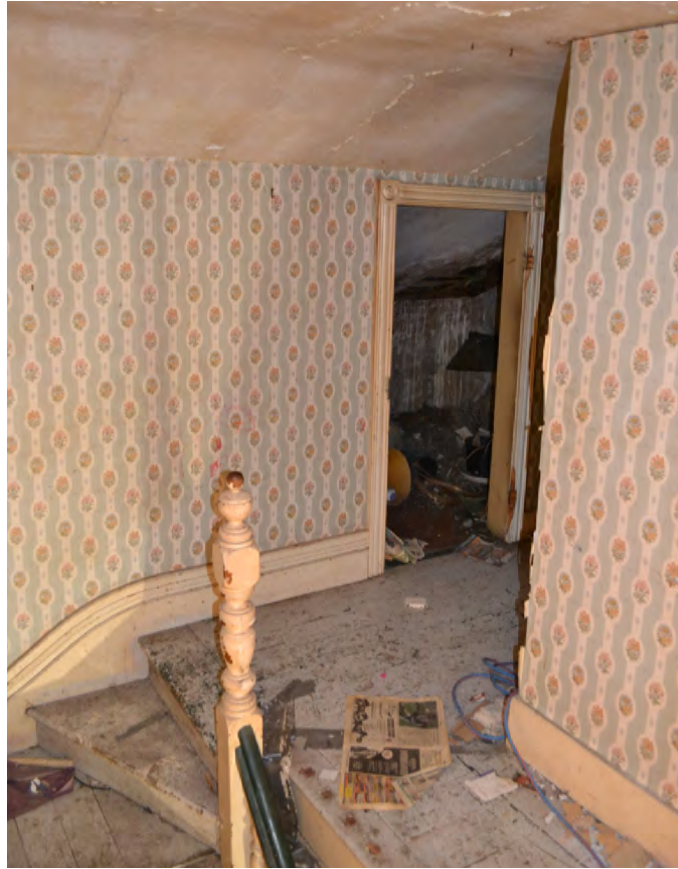
2.5) View from landing above stairs looking across to the entrance to the storage space.

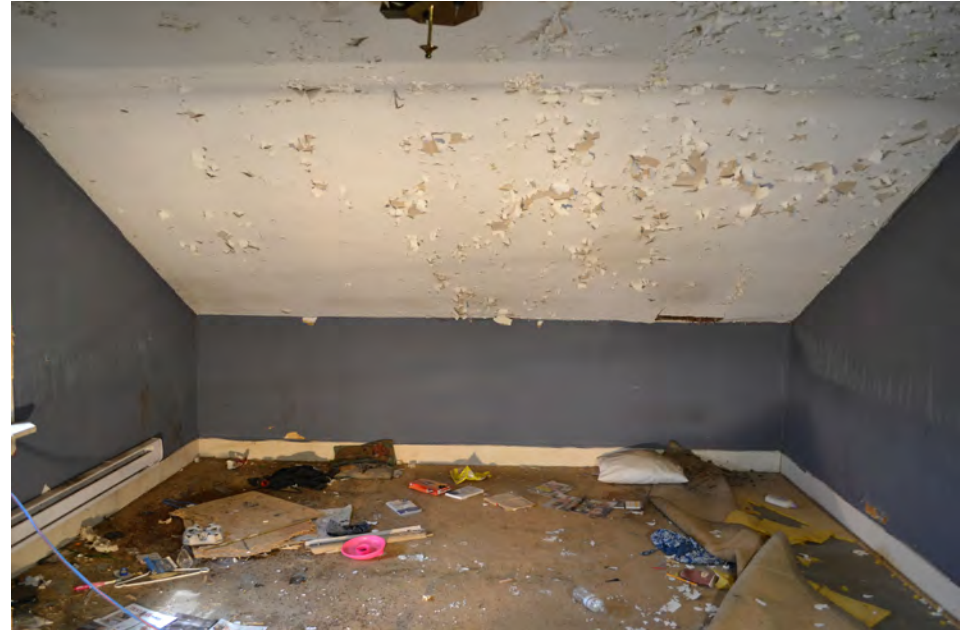
2.6) View towards west wall of Bedroom 1. Ceiling slopes down towards the west wall.

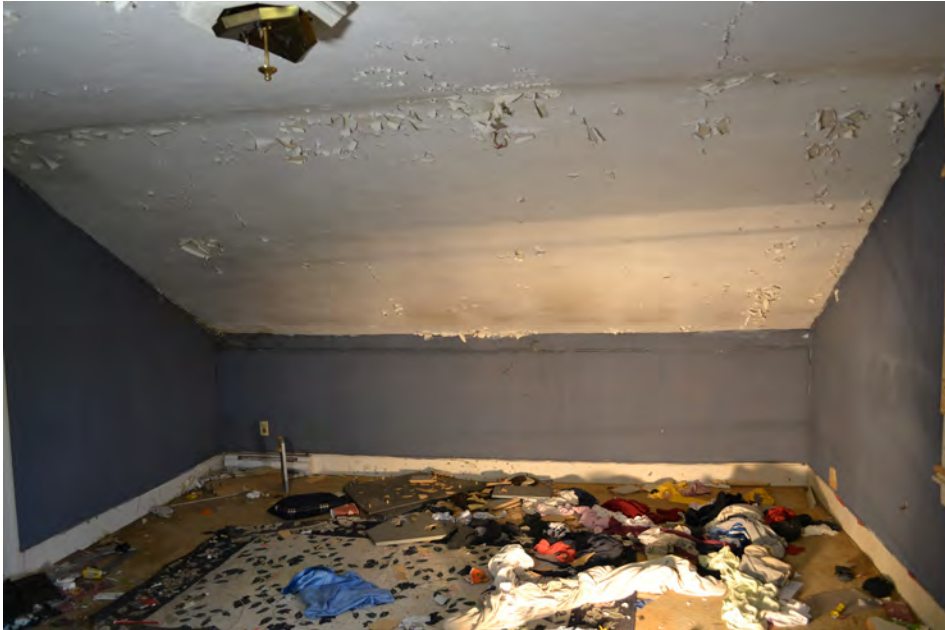
2.9) View towards east wall of Bedroom 1. Ceiling slopes down towards the east wall.

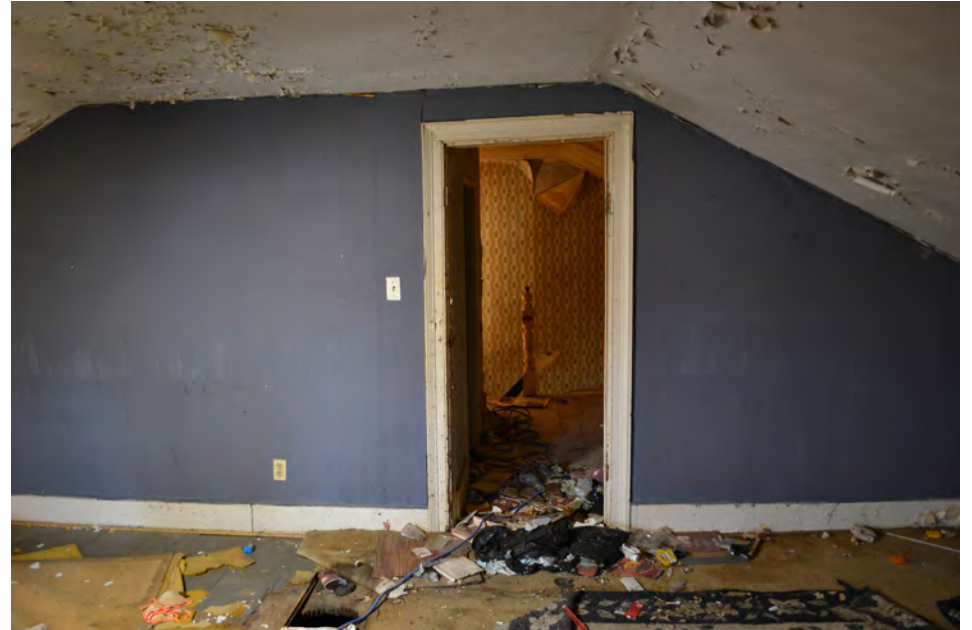
2.10) View towards north wall of Bedroom 1. Doorway opens on to the small corridor and landing at the top of the foyer stairs.

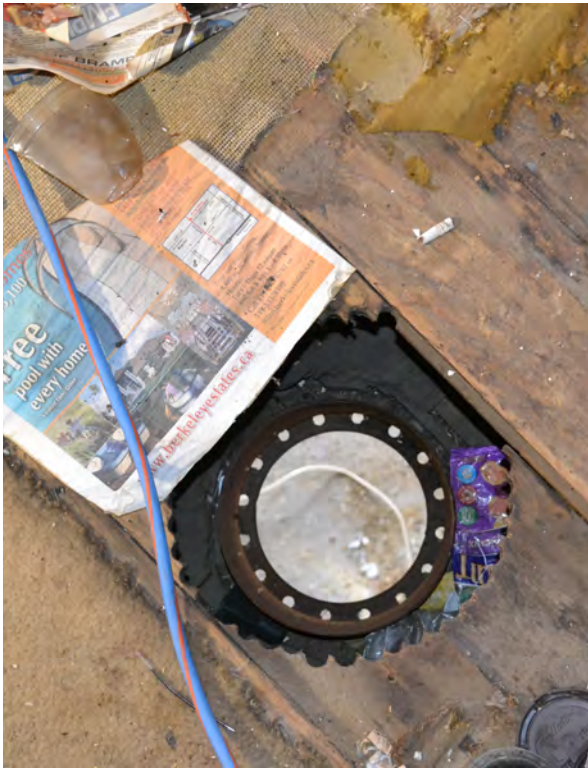
2.11) Opening within the floor of Bedroom 1, possibly for duct work or a vent stack of some sort.

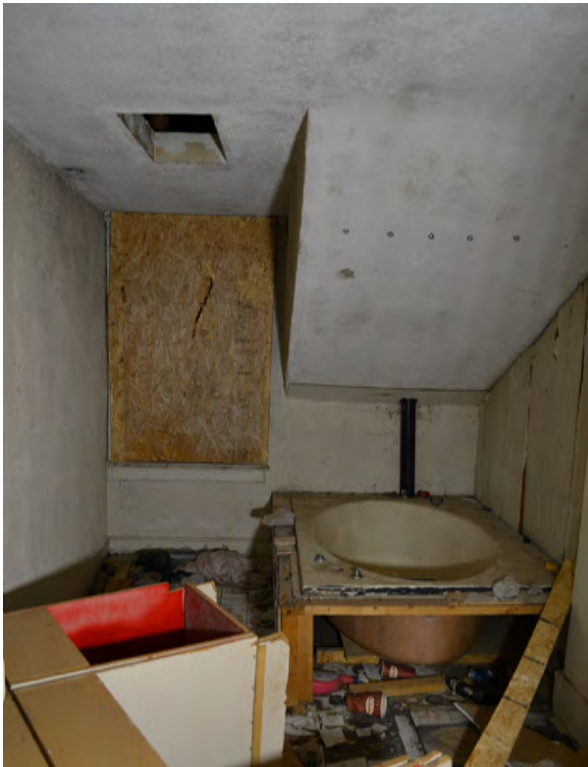
2.14) View into the second floor Bathroom towards the west wall. Visible is a boarded up window, the remnants of a bathtub under a section of sloped ceiling and a hatch up into the attic space.

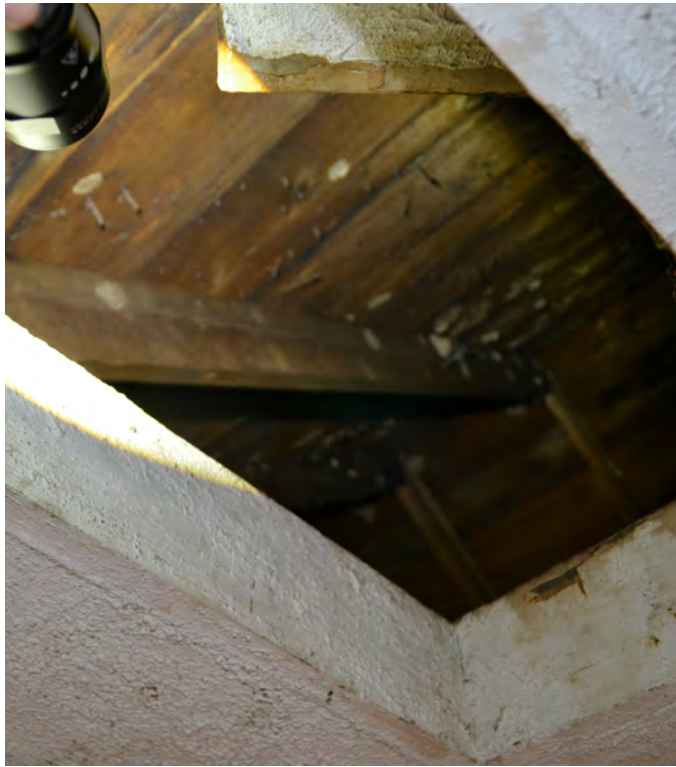
2.15) View through the hatch into the attic space. Wood rafters and roof boards are visible.

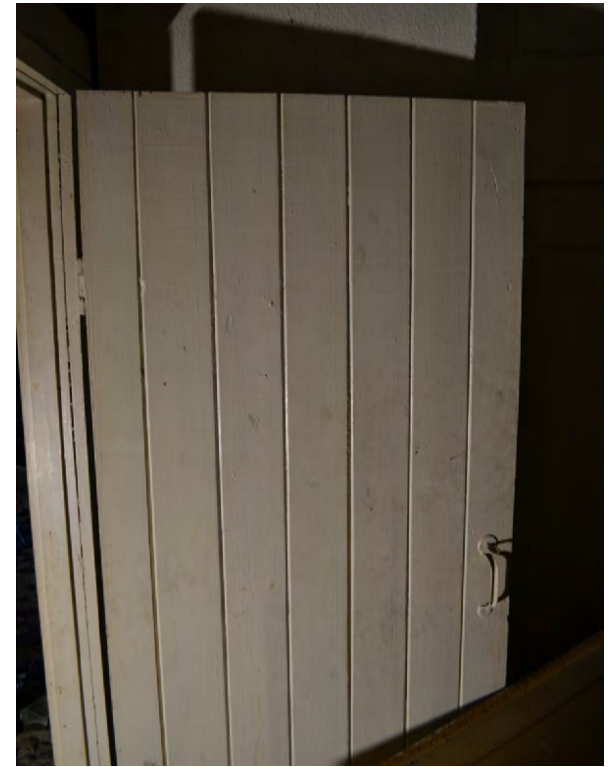
2.16) Door to the bathroom. No visible locking mechanism from the hallway side, just a simple handle instead of a knob. Consists of vertically oriented wood slats.

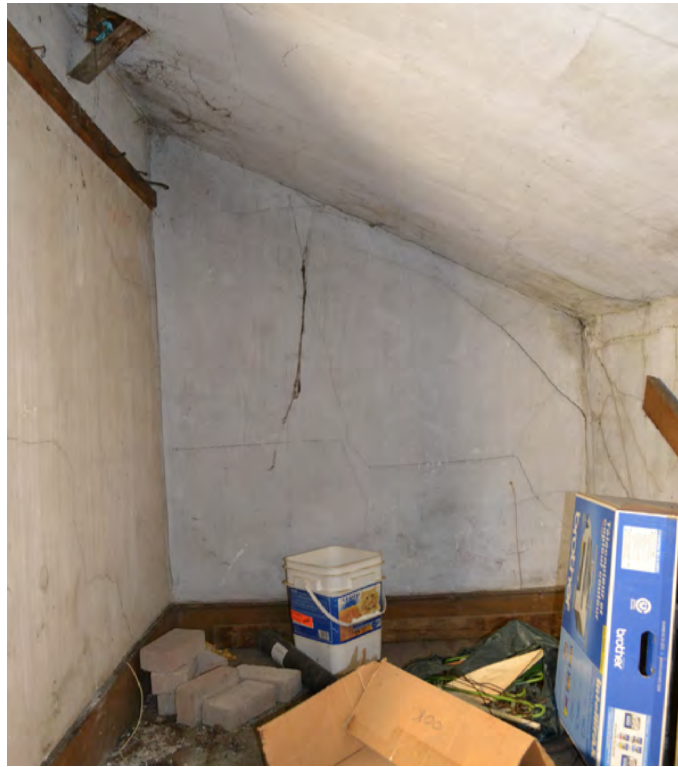
2.18) View to the north wall of the storage space. Ceiling of storage space slopes toward the east.

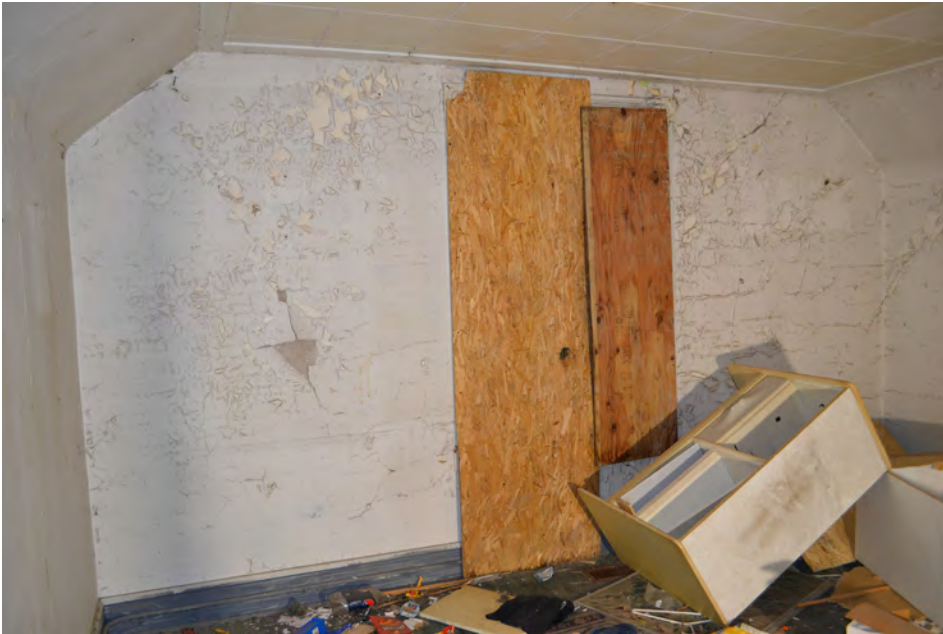
2.25) View in Bedroom 2 looking towards east wall. One window exists in the centre of the wall, currently boarded up. The ceiling can be seen to slope down at the north and south sides of the room.

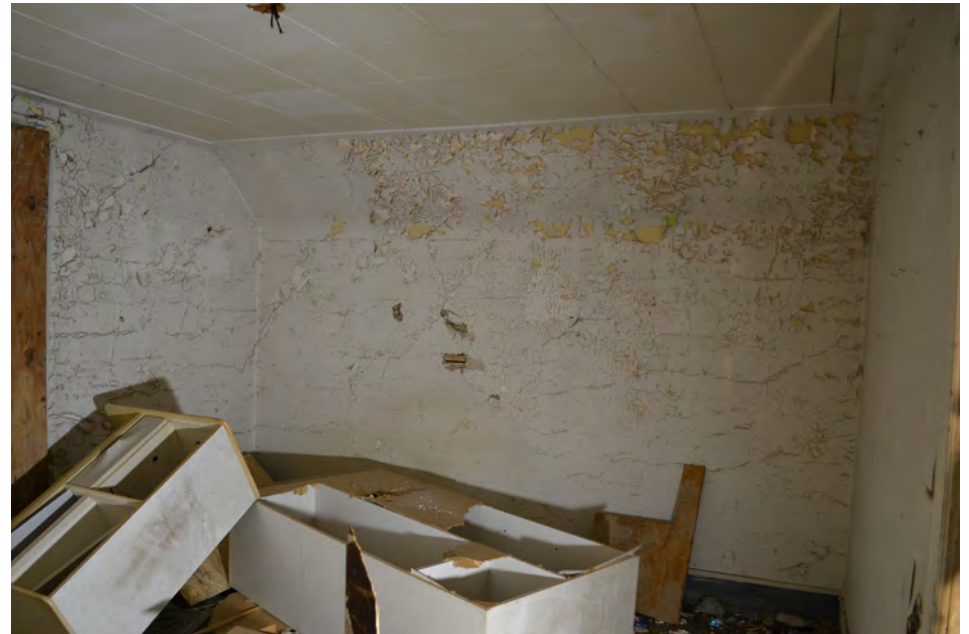
2.26) View of the Bedroom 2 north wall looking towards the northwest corner. The space is playing and fairly bare bones. Some trim around window and door as well as a baseboard.

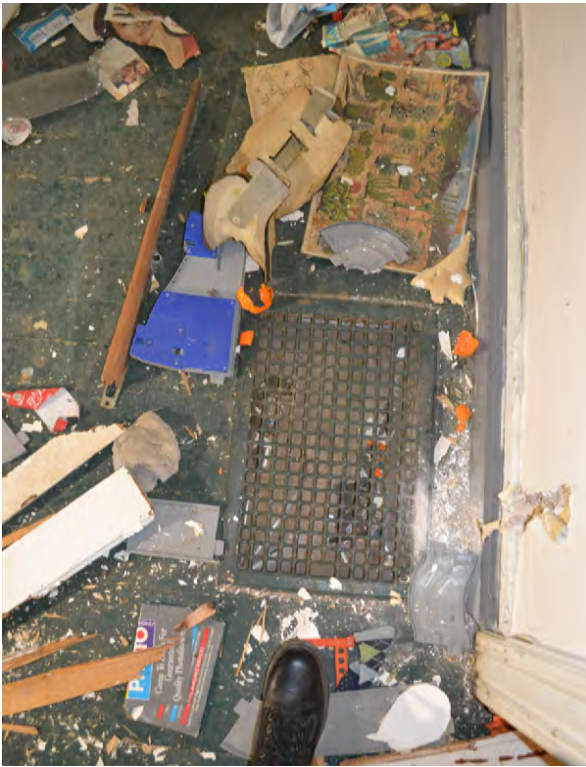
2.29) Large vent, set into painted wood flooring.

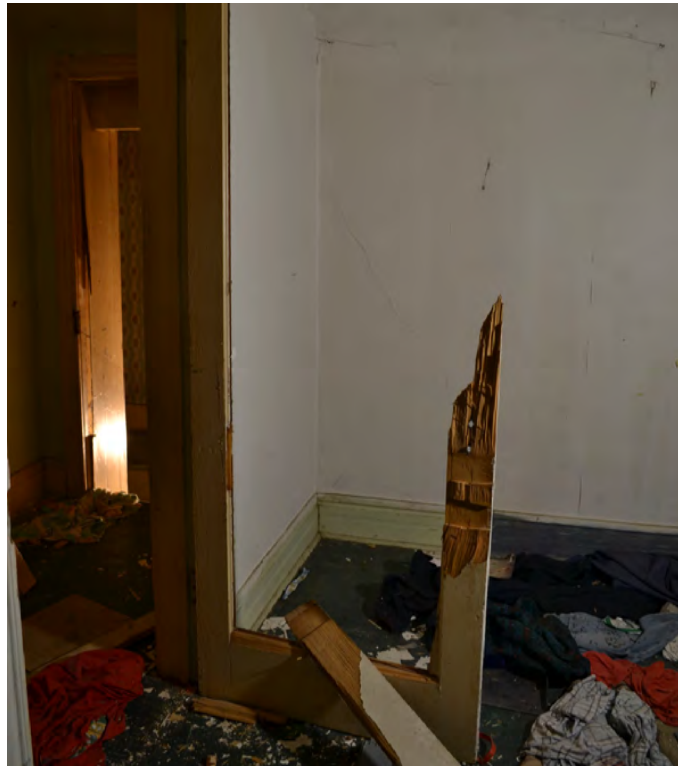
2.30) Remnants of the door into Bedroom 2.

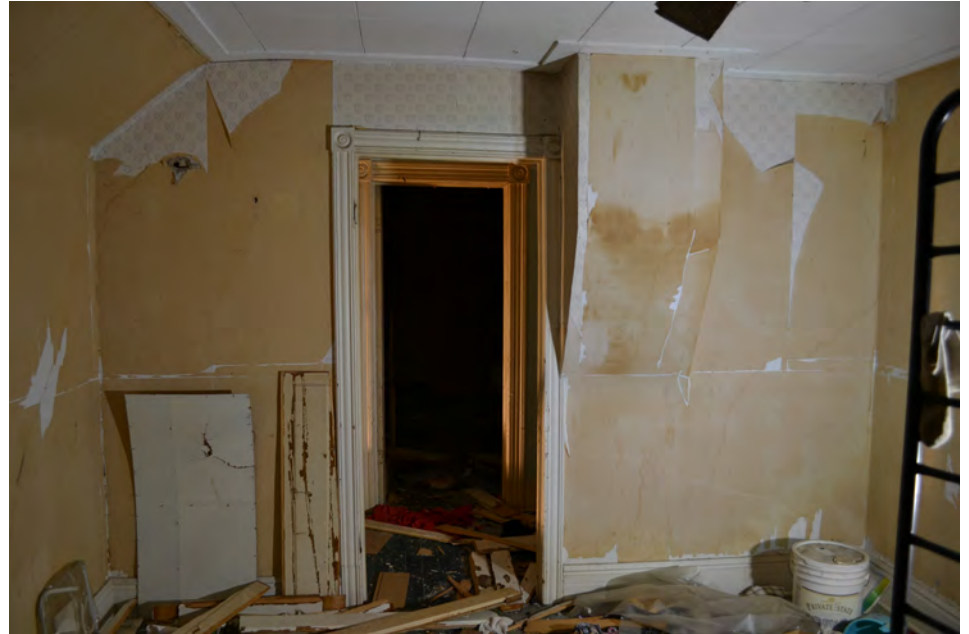
2.33) Bedroom 3, view of west wall. Visible are the doorway and a bump out in the wall, most likely for duct work. The ceiling can be seen in the upper left corner to slope down to the south.

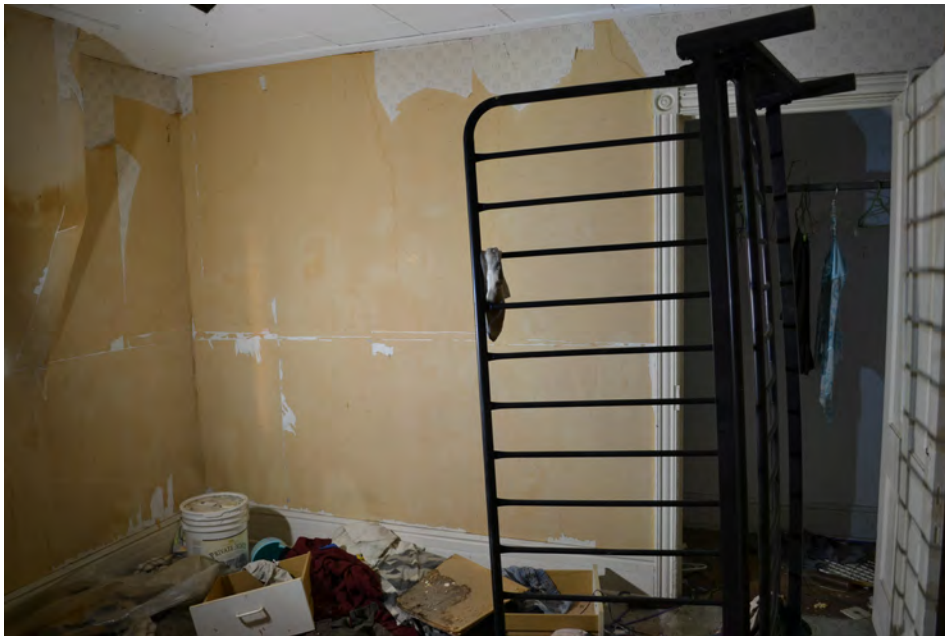
2.34) Bedroom 3, view of north wall. A closet is behind this wall, it's entrance is on the right..

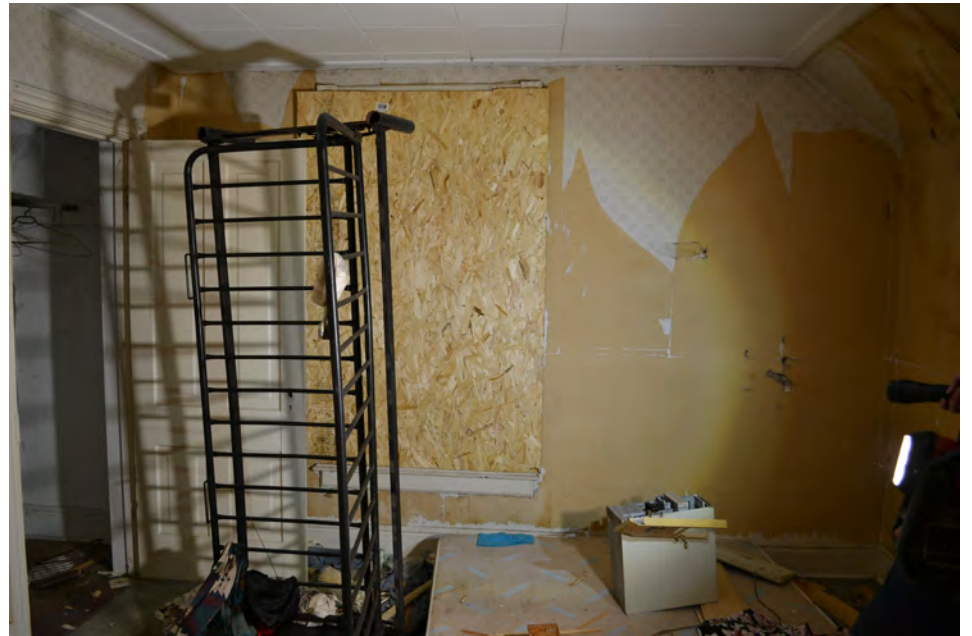
2.35) Bedroom 3, view of east wall. Window opening in the wall has been boarded up.

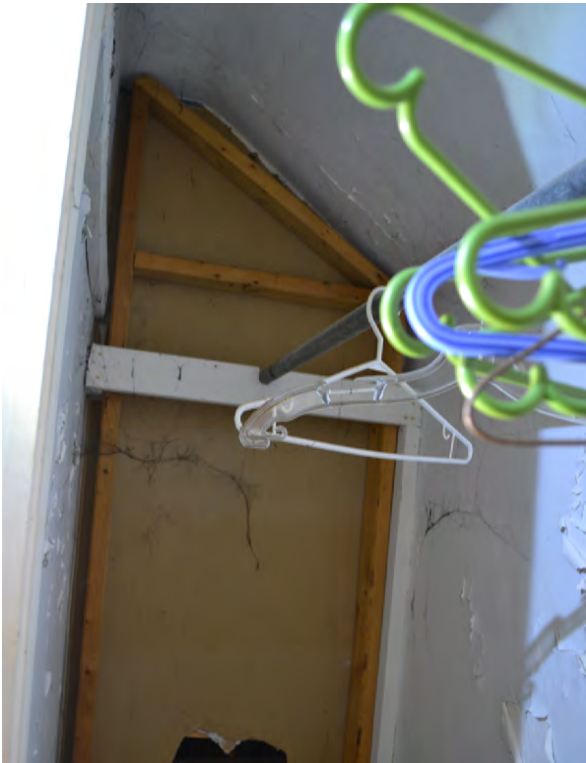
2.36) Closet of Bedroom 3, looking west. Ceiling slope down to the north.

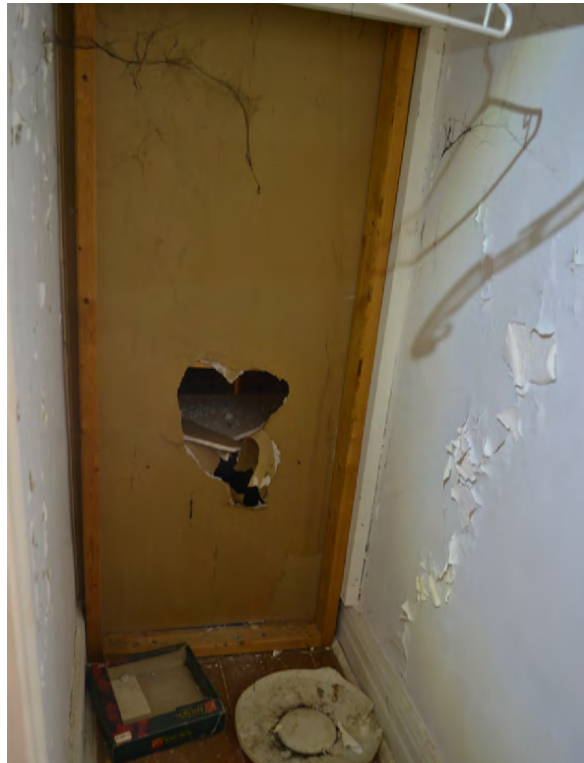
2.36) Closet of Bedroom 3, looking west. West wall divides this closet from the hallway closet.

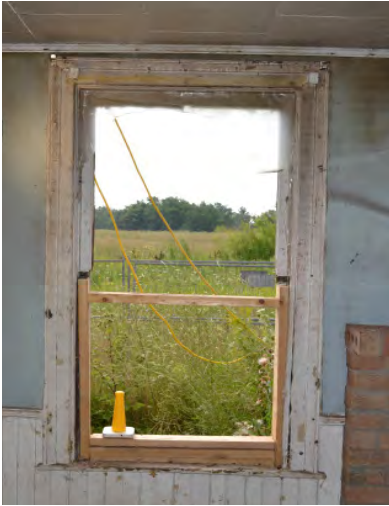
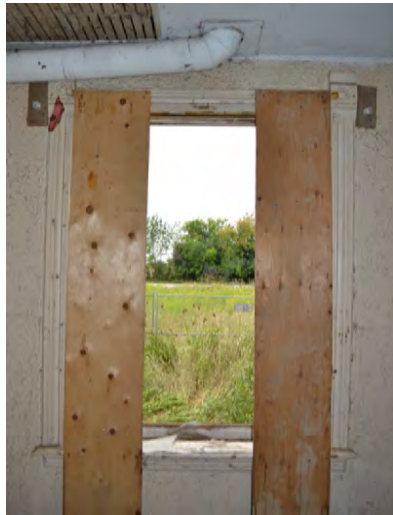
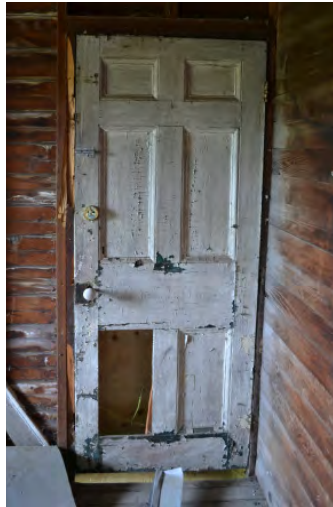
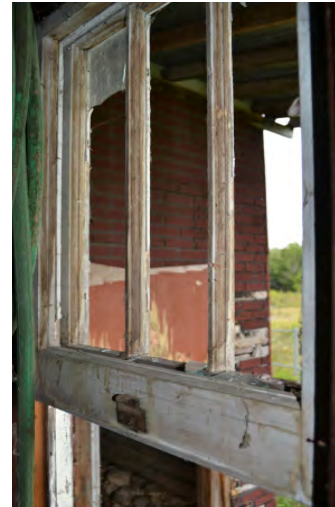
Material	Importance	Plan	Use
Windows and Doors	No longer significant, poor condition or broken.	Not salvageable.	----
Wood Wall Studs	Not significant historically.	No retail market currently available, not needed for commemorative structure.	Can be made available to the City of Brampton if some members are needed.

3.5  
Windows and Doors, significantly  
weathered- Taken by ATA Architects inc.  
August 18, 2023
